The easy entry and exit feature function deactivates itself

Topic number	LI91.10-P-078305
Version	5
Function group	91.10 - Front seats
Date	3/26/26
Validity	Vehicles with code: code 525 (Connect 20 High (NTG7)) code 521 (Connect 20 Mid (NTG7)) code 534 (Connect 20 Premium (NTG7)) code 535 (Connect 20 Premium + (NTG7))
Reason for change	updating remedy

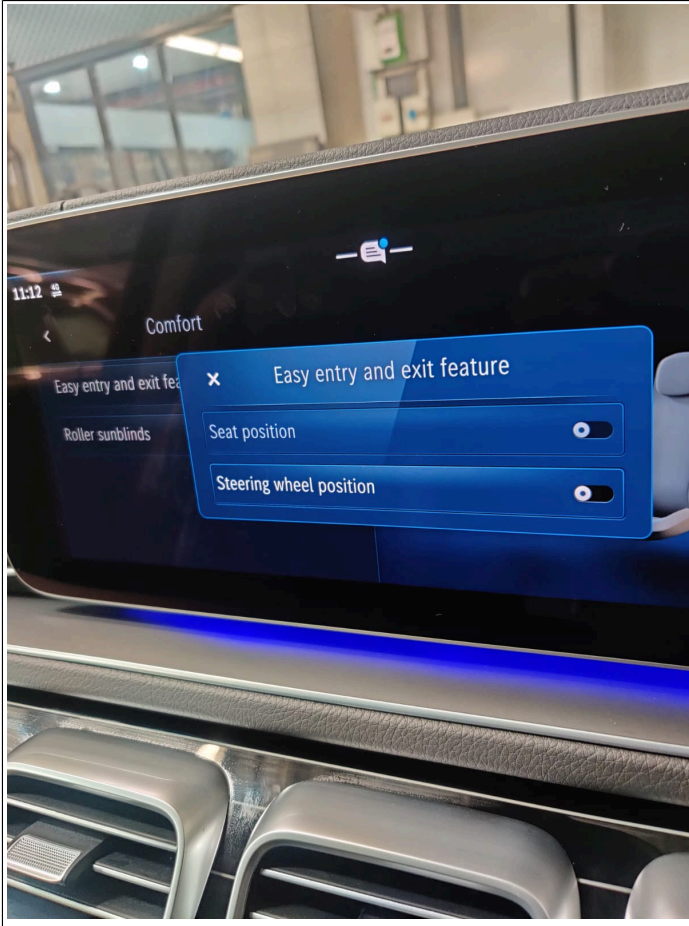
The "easy entry and exit feature" function deactivates itself after a brief period. (see attachment)

Attachments	
File	Description
Function+decativated+condition_infotainment+display.jpeg	Example of deactivated function

Update the HU7 to the latest software version, then perform a factory reset of the HU7.

Steps to perform factory reset: Navigate to Settings > System > Reset > Reset to factory settings and confirm

If the problem persists, please record HU7 log and also a trace of the Body CAN (For Star 2 Body Can 1 and for Star 3 Body Can 2) during the symptom and send via a TIPS case to the Body/Chassis/Entertainment inbox.
