# TECHNICAL SERVICE BULLETIN

**TECHNICAL SERVICE BULLETIN: 103-2044**  
**SERVICE CAMPAIGN: 001279**  
**\*\*\*EXPIRATION DATE: April 1, 2027**

Forest River is alerting you to an issue involving certain 2026 Catalina Travel Trailer Recreational Vehicles.

# TECHNICAL SERVICE BULLETIN 103-2044 REMEDY INSTRUCTIONS

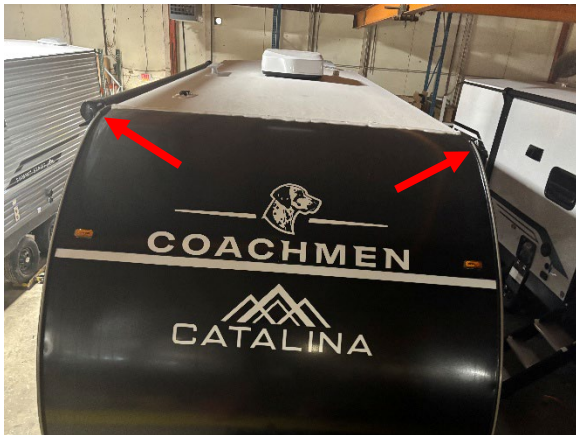
FIG. 1 – LOCATION OF EXTERIOR TRIM PIECES

The external roof radius trim on the curbside and roadside may not have been properly prepared with primer prior to being sealed. This condition may allow the sealant to not adhere to the external roof radius trim, which may lead to a leak in the roof.

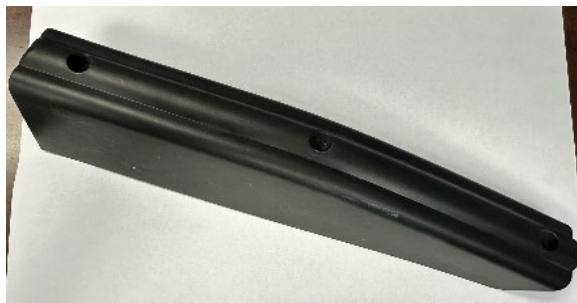
FIG. 2 – EXAMPLE OF COMPONENT

STEP 1: AT THE ROOF EXTERIOR, FRONT, LOCATE THE BLACK PLASTIC ROOF RADIUS TRIM (FIG. 2);

SHOWN AS CURB SIDE – ROAD SIDE IS OPPOSITE

STEP 1: PEEL BACK THE ROOF SEALANT AND APPLY PRIMER TO ALL SURFACES, INCLUDING THE EXTERIOR BLACK ROOF RADIUS TRIM (FROM FIG. 2)

STEP 2: APPLY THE APPROPRIATE AMOUNT OF ALPHA SEALANT TO THE ROOF AND NEWLY PRIMERED AREAS;

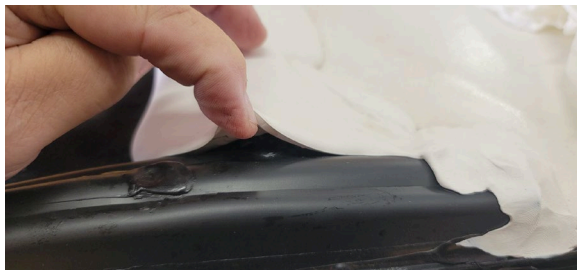
FIG. 3 – NON-PRIMED EXAMPLE

- IF THE ROOF SEALANT PEELS UP WITHOUT EFFORT, CONTINUE TO REMEDY (FIG. 3);
- IF THE ROOF SEALANT DOES NOT PEEL UP WITH LITTLE EFFORT, CLAIM INSPECTION ONLY;

STEP 3: ALLOW CURE;
