PRODUCT CAMPAIGN BULLETIN

APPLICABILITY: 2023-2025 MY Solterra

NUMBER: WRD-25R

SUBJECT: Safety Recall and Stop Sale: Solterra HVAC ECU Reprogramming

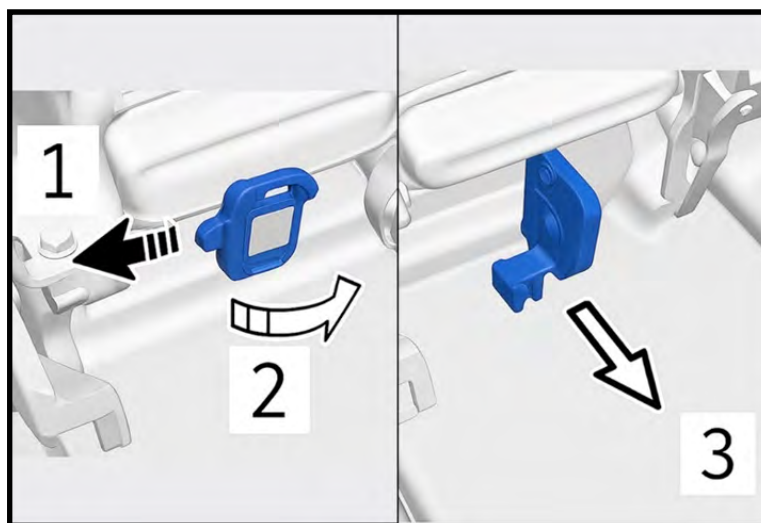
(1) Wearing insulating gloves, pull out the service plug grip following the procedure shown in the illustration.

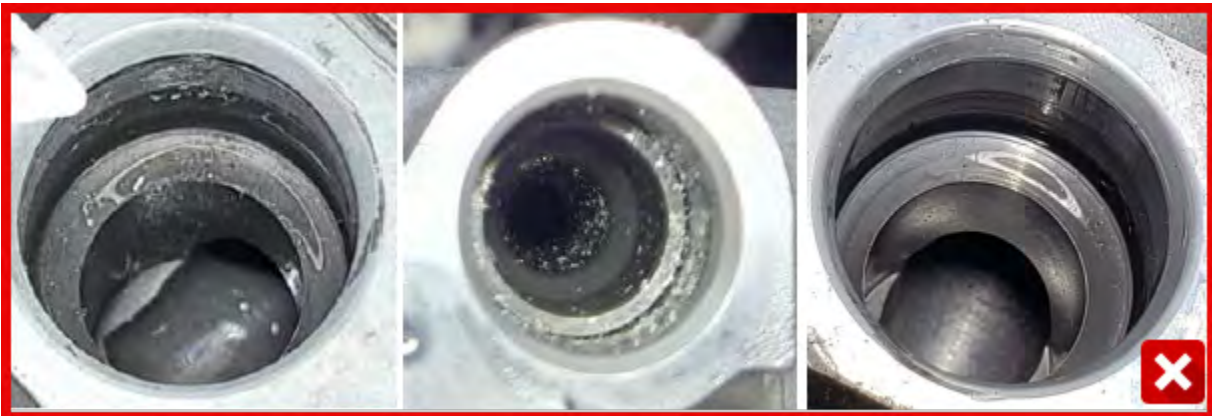
STEP 3: Inspect the compressor discharge port and the discharge hose for any signs of foreign material such as metal flakes or dust. If needed, a cotton swab can be used for further inspection. See the example images below.

NOTE: Blackened oil is not a sign of debris. Metal flakes/debris is a sign of failure.

Example images of foreign material found at the A/C compressor discharge port connection:

YES: Replace the compressor and receiver dryer.

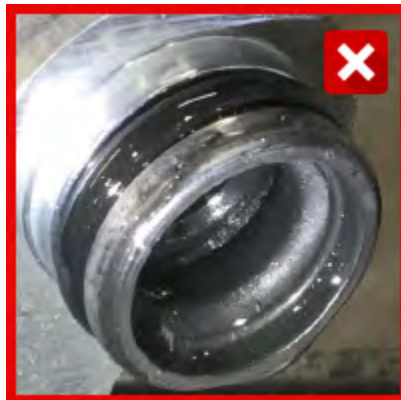
Example image of foreign material found at the A/C discharge hose connection:

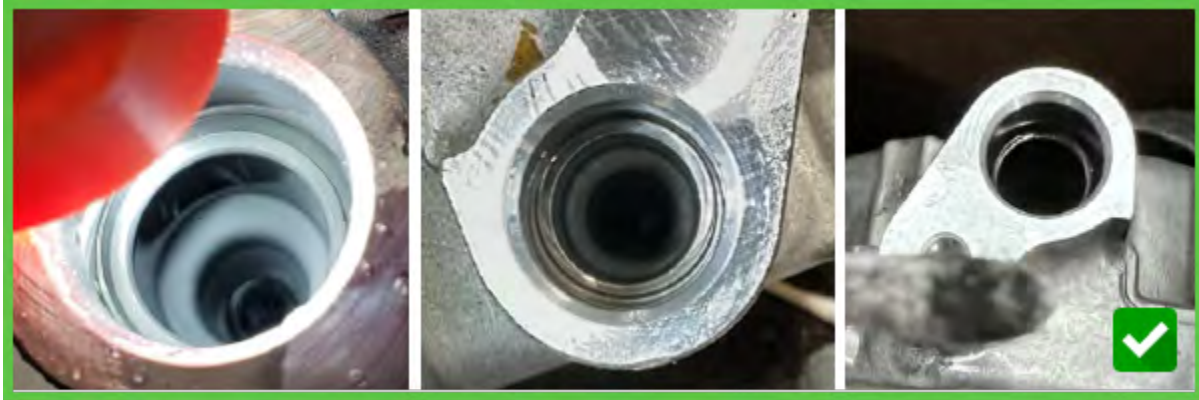
Example images of foreign material **NOT** detected at the A/C compressor discharge port connections.

NO: Replace the compressor **ONLY**.
