## SERVICE BULLETIN

**APPLICABILITY:** 2019-24MY Ascent

**NUMBER:** 06-92-24R

**SUBJECT:** Front Brake Pulsation/Squeal Diagnosis & Repair Front Brake Warranty Extension

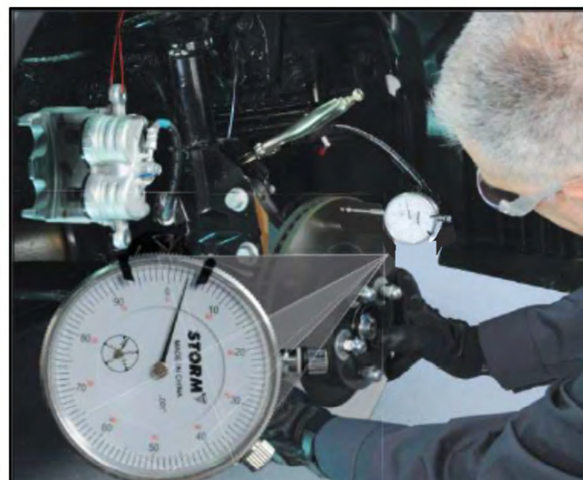
**STEP 8:** Install the new brake disc. Secure the disc to the hub using the five lug nuts in conjunction with matching suitable washers. Torque the lug nuts in a star pattern to **120 Nm (88.5ft-lb)**. Using a dial gauge, inspect the outer brake disc runout. Confirm the observed measurement does not exceed 0.05 mm (0.002 inch). If the measurement exceeds the specified value, remove the brake disc from the hub. Using the wheel studs as a guide, rotate the disc clockwise one wheel stud position and reinstall the brake disc. Inspect the runout using the procedures described above. The brake disc position can be rotated up to 4 more times to confirm the position with the least amount of runout. Install the brake disc at this position. In rare cases of the measurement not reading within specification after the five position inspection, exchange the brake disc with the other side of the vehicle and repeat the measurement. If the measurement continues to produce results out of specifications, replace the brake disc. Record and note all measurements.

**IMPORTANT:** For best accuracy, the runout measurement should be taken 10mm from the outer circumference of the brake disc. See the example image below.
