Technical Service Bulletin

Topic	Left-Hand Muffler - No Exhaust Gas Flying Spur V6 PHEV
Market area	Bentley: worldwide (2WBE),China 796 VW Import Comp. Ltd (Vico), Beijing (6796)
Brand	Bentley
Transaction No.	2080971/1
Level	EH
Status	Released for publishing
Release date	Mar 4, 2026

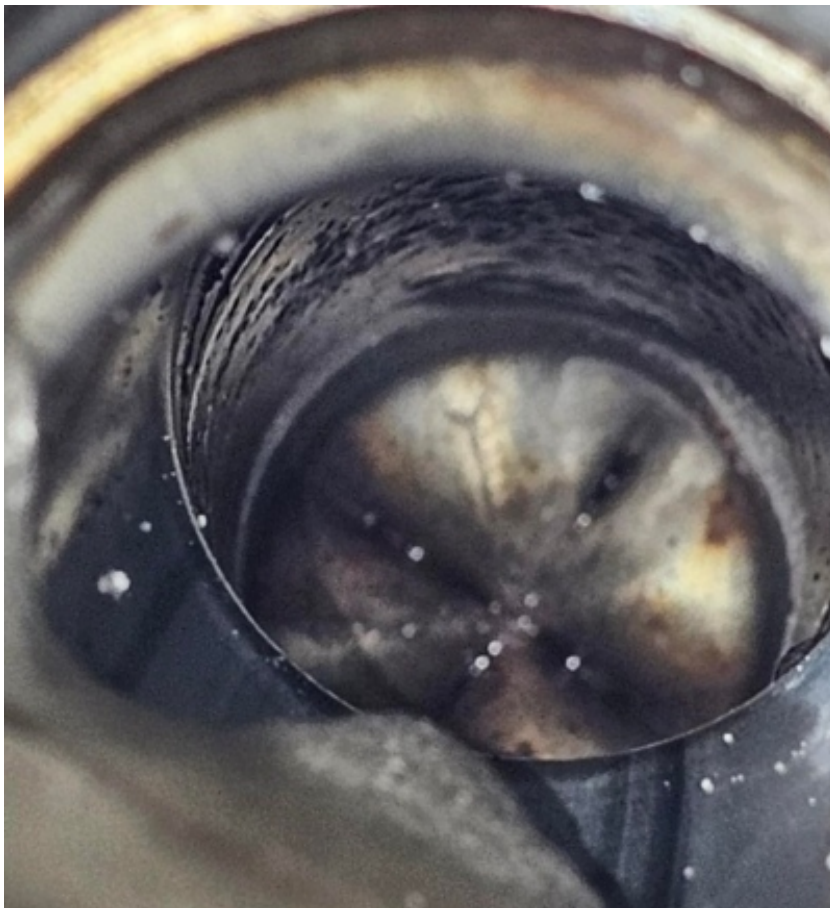
Figure 1. Left-hand muffler outlet

During inspection, it is observed that the left-hand muffler outlet shows no exhaust flow from the tailpipe, while the right-hand muffler operates normally. No DTCs are stored following a diagnostic scan.

This condition is design intent, the left-hand muffler is manufactured with an internal blockage, and exhaust gases are routed exclusively through the right-hand muffler via a cross pipe positioned upstream in the exhaust system. This is normal behaviour and not a defect.

Do not replace the left-hand muffler. The blocked exhaust outlet is part of the intended system configuration.

Inform the customer that the left-hand muffler on this powertrain variant is non-functional by design, with all exhaust gas routed through the right-hand muffler.

No diagnostic or mechanical intervention is required.
