SERVICE ACTION

Global Service Action
Number: D092

Subject: Incorrect Front Fender Vent Trim Panel Installed	Publication No.: D092
	Model: Range Rover Sport (L1)
	Model Year: 2026
	Date of Issue: 05 March 2026
	Expiry Date: 30 March 2028

A concern has been identified on certain 2026 model year Range Rover Sport Autobiography wrapped vehicles, where the incorrect front fender vent trim panel has been installed. Vehicles in this condition do not meet the JLR intended build specification.

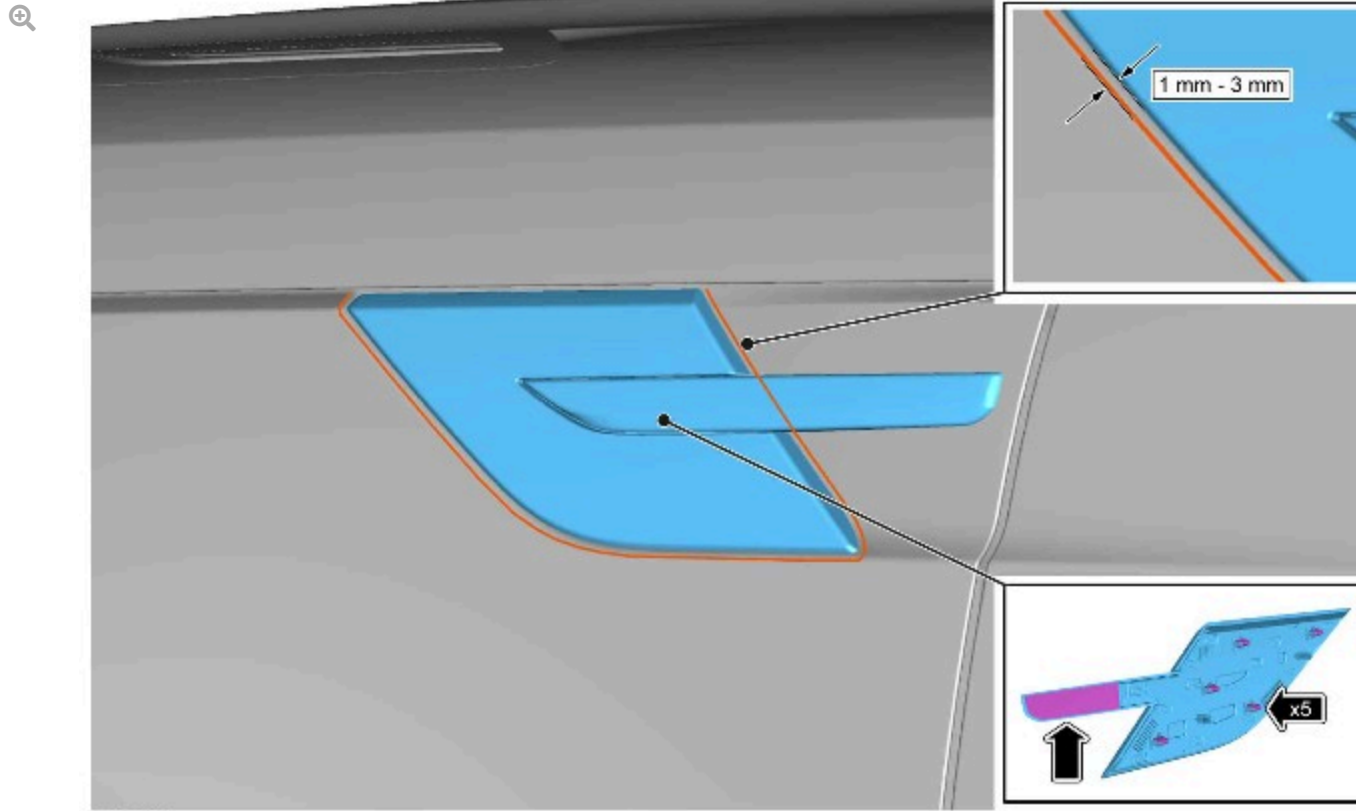
E408478

1. The front fender vent trim panel is installed with 5 clips and adhesive tape as shown in the illustration.

- The front fender vent trim panel extension is installed over the top of the vehicle wrap.
- The front fender vent trim panel extension is installed to the vehicle with adhesive tape.
- The vehicle wrap has a 1 mm to 3 mm clearance around the front fender vent trim panel.
- Isopropyl alcohol must be used to clean the area after the original front fender vent trim panel extension is removed, before installing the new part.

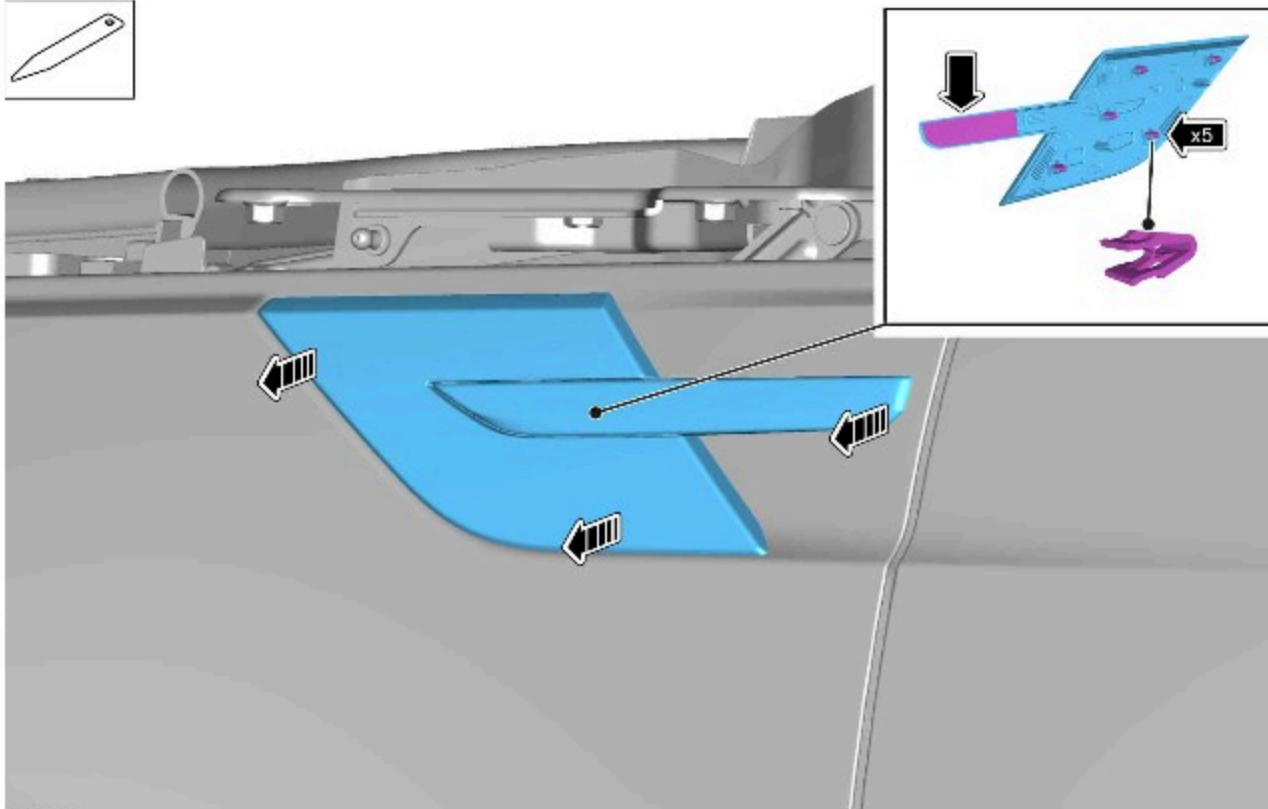
E408479

The front fender vent trim panel extension is installed on top of the wrap, great care must be taken during removal of the front fender vent trim panel extension to avoid damaging the vehicle wrap.

Use a suitable tool to release the 5 clips and adhesive tape.

- Remove the left front fender vent trim panel.

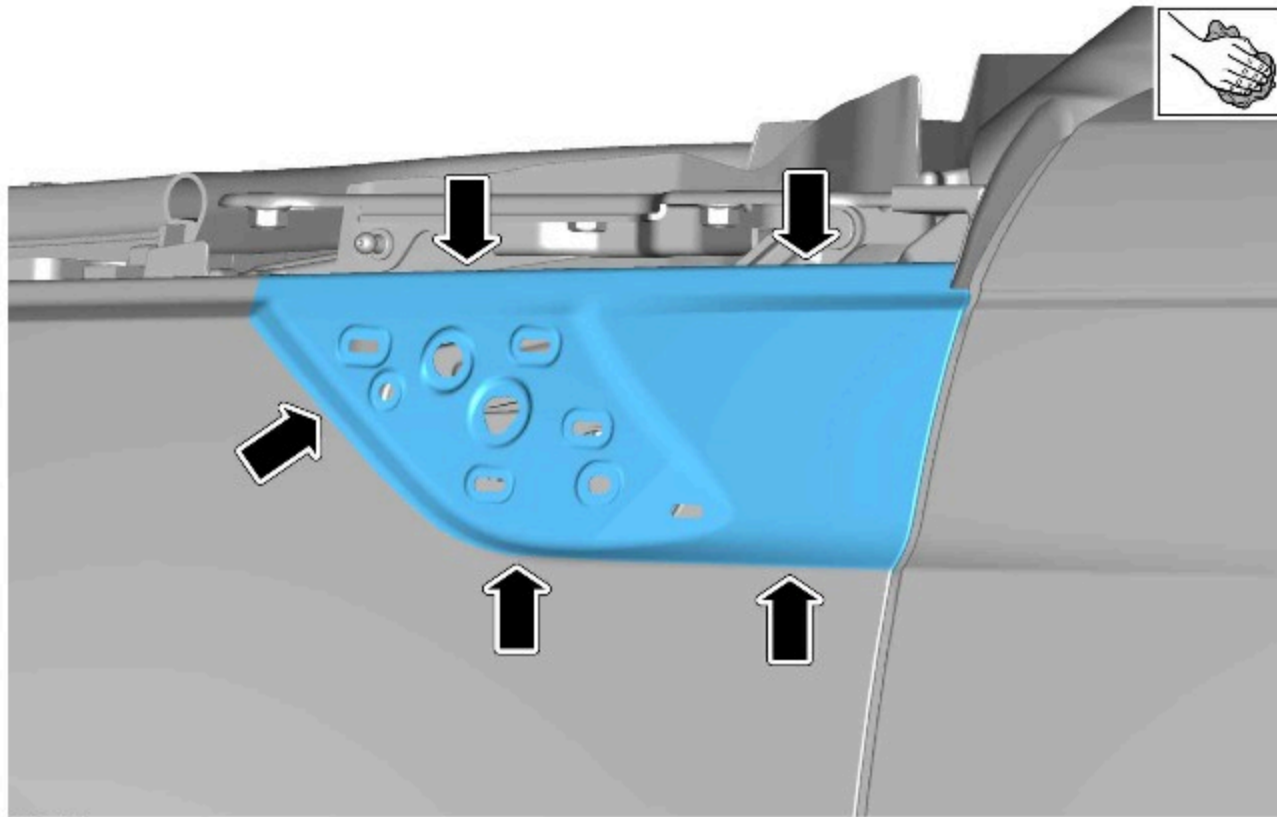
E408480

- Care must be taken to avoid damaging the vehicle wrap and surrounding paintwork.
- All isopropyl alcohol must be cleaned off of the vehicle wrap and not allowed to dry on the surface.

Clean the area using isopropyl alcohol. All adhesive tape remnants must be removed.

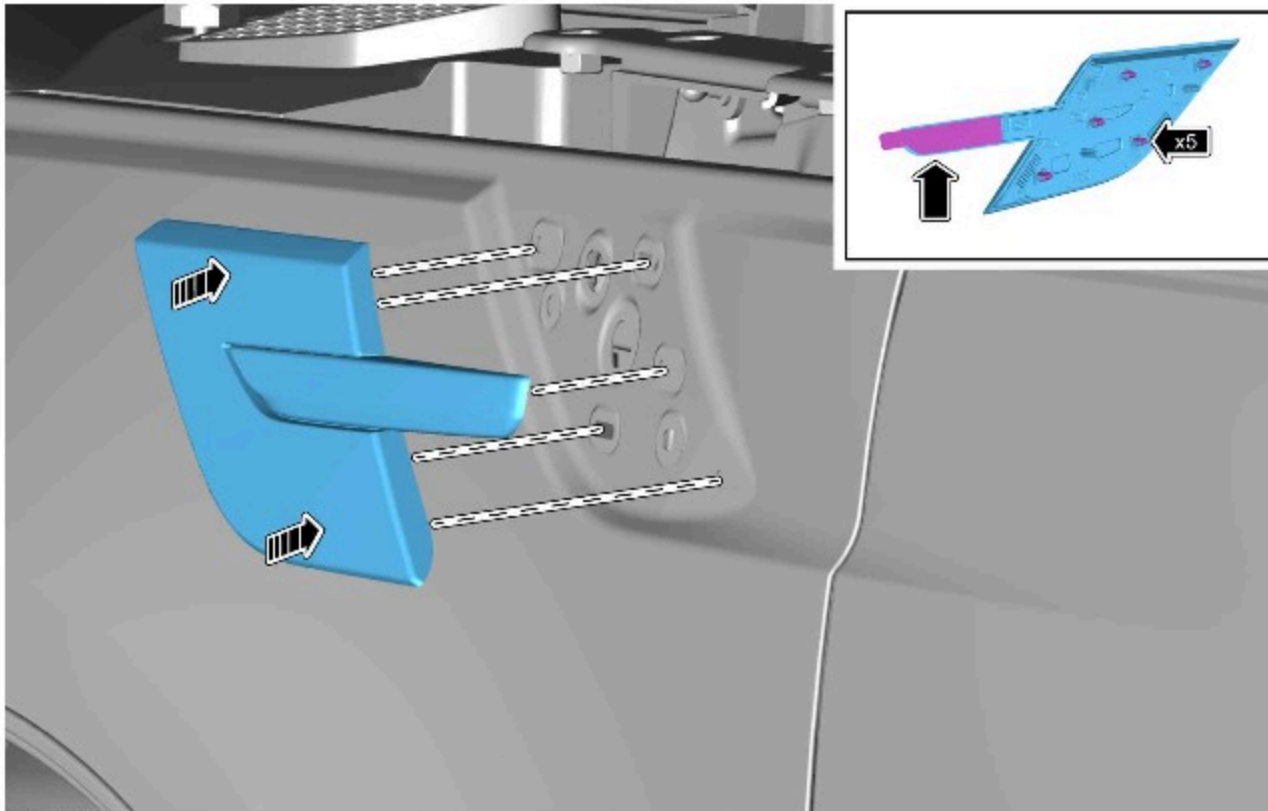
E408481

The front fender vent panel must be aligned as shown in the illustration.

Remove the adhesive tape backing from the left front fender vent trim panel extension.

- Align the left front fender vent trim panel clips to the fender.
- Install the left front fender vent trim panel.
