WSG4 - Replacing Luggage Compartment Cover (Workshop Campaign)

Model Line: **Macan (XAB)**

Concerns: **Luggage compartment cover**

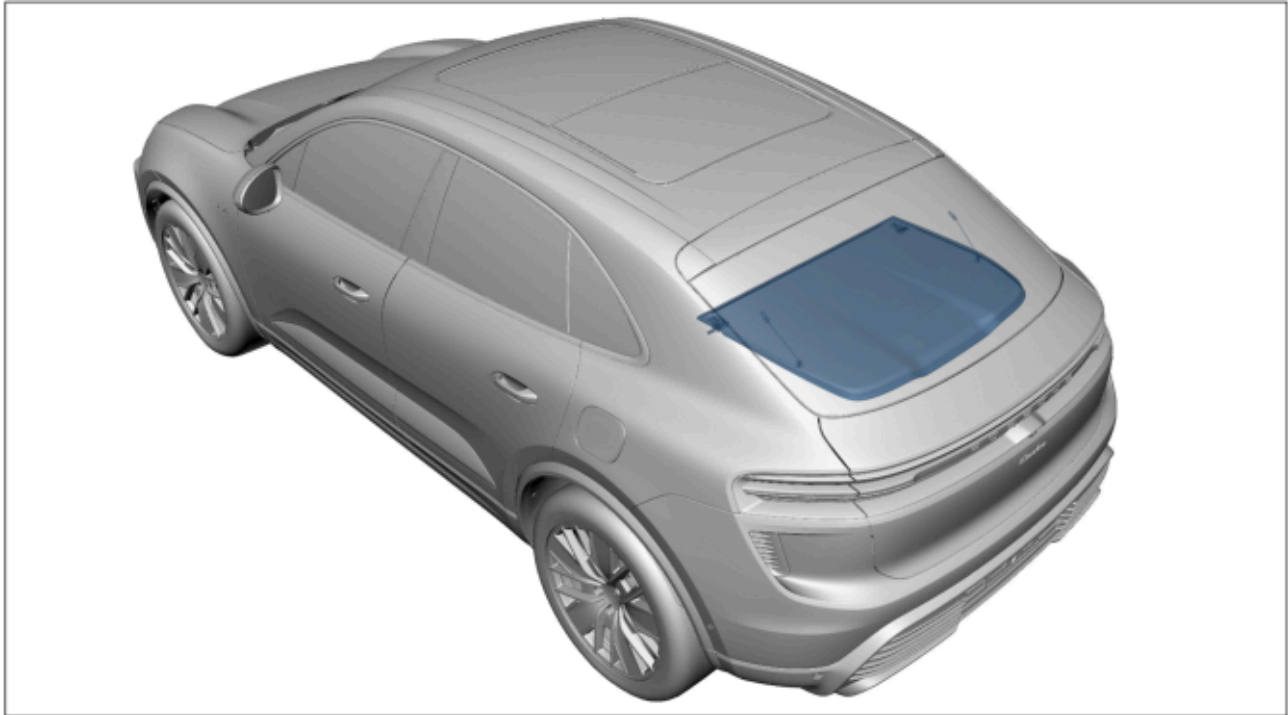
Installation position

Installation
Position:

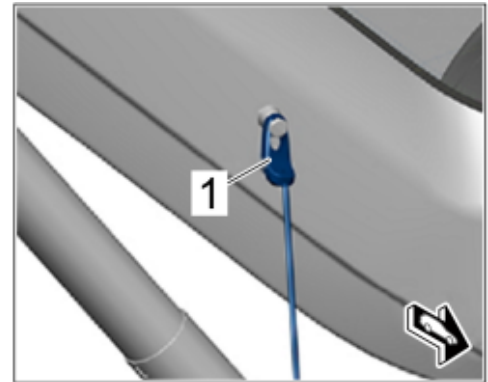
Retaining strap

Work Procedure: 1 Disengage retaining strap ⇒ *Retaining strap -1-* at the left and right.

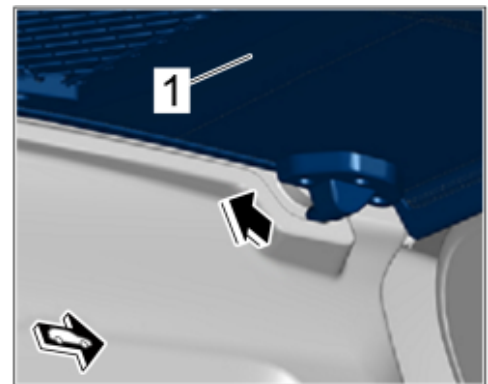
Luggage compartment cover

- 2 Guide luggage compartment cover ⇒ *Luggage compartment cover -1-* in ⇒ *Luggage compartment cover -Arrow direction-* out of the side trim panel for the rear luggage compartment and remove it.
- 3 Insert the **new** luggage compartment cover in the rear luggage compartment side trim panel and install retaining straps at the left and right.
- 4 Enter the campaign in the Warranty and Maintenance Logbook.
