Ventilation Does Not Function, Fault Memory Entry for Heating / Fresh-Air Blower "U125000" in the Main Control Unit for Body Electronics (HCP4) (SY 19/26)

Model Line: **Macan (XAB)**

Model Year: **As of 2024**

Concerns: **Front end fuse box**

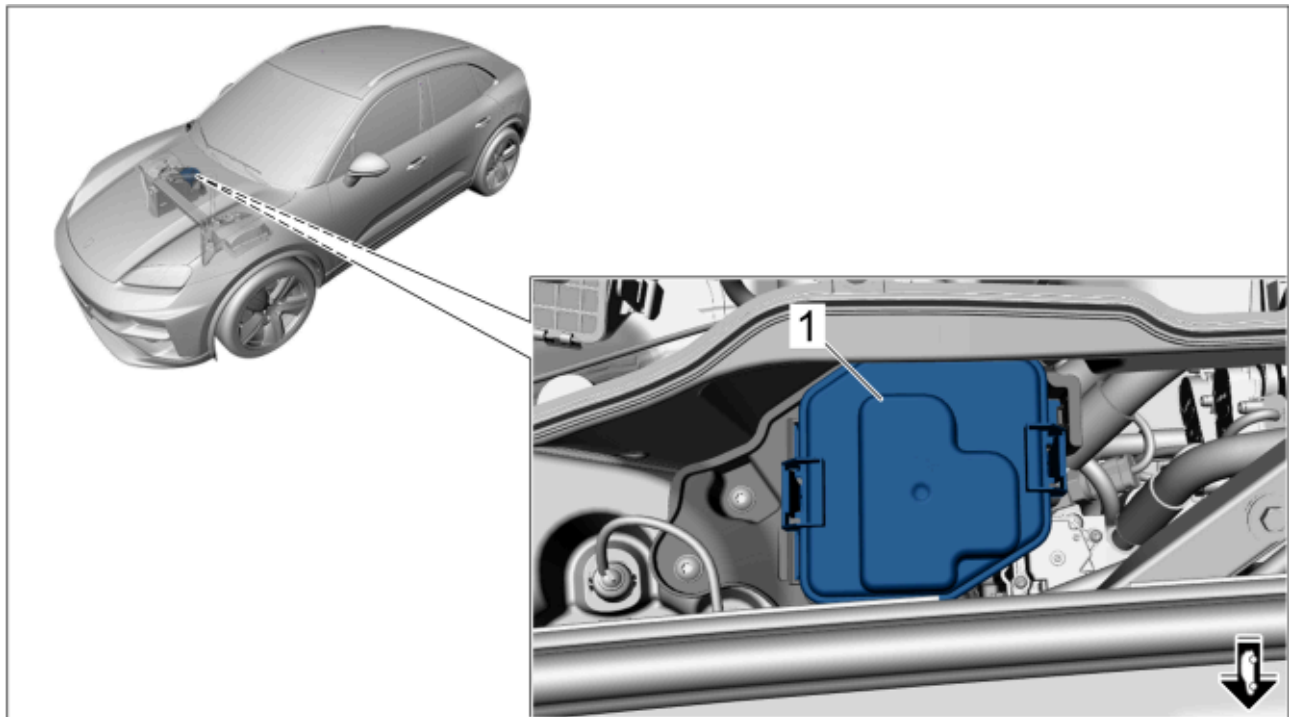
Installation position of front end fuse box (shown on left-hand drive vehicle)

1 – Front end fuse box

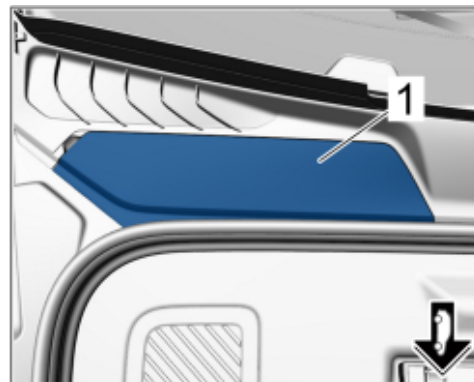
Work Procedure: 1 Unclip cover ⇒ *Unclipping cover -1-*.

Unclipping cover

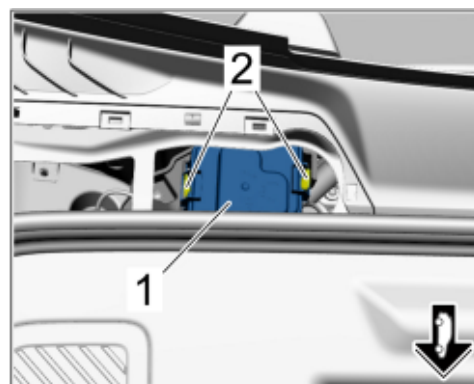
- 2 Unclip and remove cover ⇒ *Remove cover for front end fuse box -1-* of front end fuse box at retaining clips ⇒ *Remove cover for front end fuse box -2-*.
- 3 Remove fuse for heating / fresh-air blower (J126) and check contact marks on the plug contacts.

Remove cover for front end fuse box

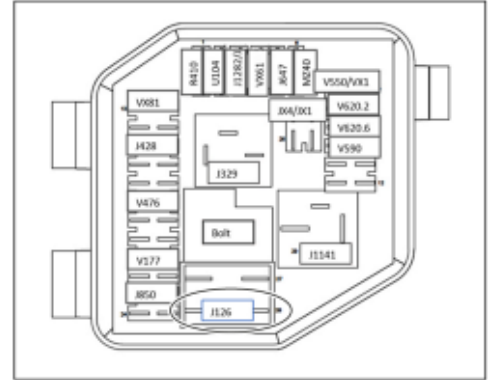
The fuse (40A) for the heating / fresh-air blower (J126) is located on the **front end fuse carrier (fuse holder A)**, slot F28.

Overview of front end fuse carrier (fuse holder A) (shown on left-hand drive vehicle)

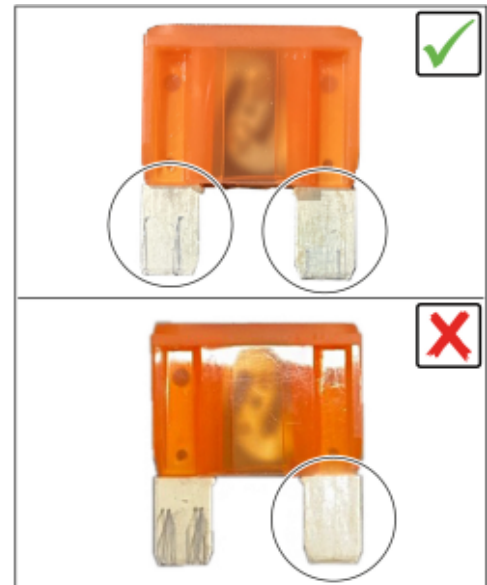
Cause: The stored fault code can indicate that the fuse for the heating / fresh-air blower (J126) may have improper contact. This can be caused by a damaged fuse carrier in the front end fuse box.

Check fuse for contact marks on plug contacts

Remedial Action Check fuse for heating / fresh-air blower (J126) and replace front end fuse box if necessary.

Assessment		Action
(✓)	Contact marks can be seen on both plug contacts of the fuse.	Front end fuse box OK <ul style="list-style-type: none"> ▪ Re-insert the fuse ▪ Continue troubleshooting elsewhere ▪ Reassemble the vehicle again after repairs End of action.
(✗)	Contact marks cannot be recognized on both plug contacts of the fuse.	Front end fuse box not OK. Replace front end fuse box For work procedure, see: ⇒ <i>Technical Information '97841901 Removing and installing front end fuse box fuse carrier'</i> End of action.
