Technical Journal Title Roller blind, rattle noise when opening		Ref. No. TJ 33183.9.1	
Issuer (Dept.) Technical Service		Issue Date 3/3/26	Status Date 3/3/26
Car Market United States and Canada	Partner 3 US 7510 Volvo Car USA	Function Group 8364	
Function Description Sun visor, roof hatch		Page Page 1 of 15

TJ Instruction VCC-519080-1

TJ Instruction VCC-519080-3

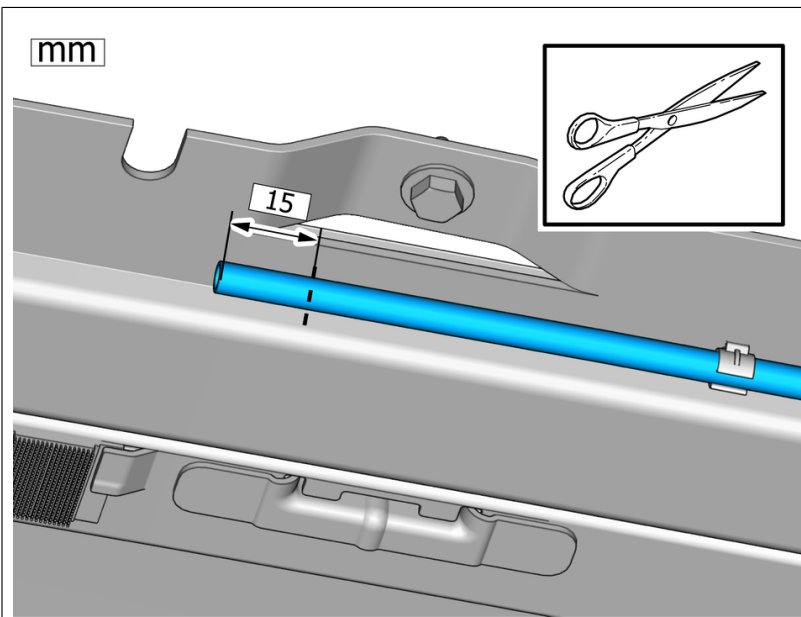
Right-hand side
Cut the component according to the image.

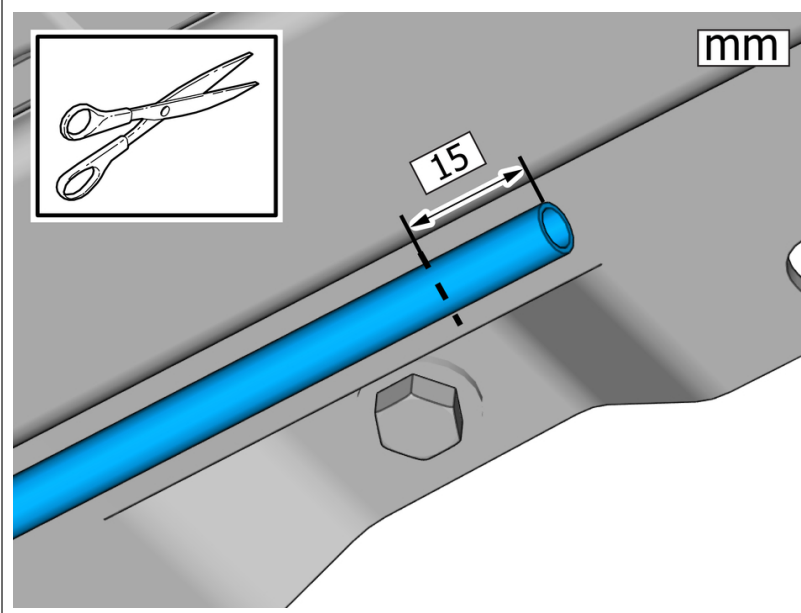
Left-hand side
Cut the component according to the image.
