**Volvo Car USA LLC**
**Technical Journal**

Technical Journal Title <b>Lidar Cover Panel, Drone Noise When Driving</b>		Ref. No. <b>TJ 37321.1.0</b>	
Issuer (Dept.) <b>Technical Service</b>		Issue Date <b>2/12/26</b>	Status Date <b>2/19/26</b>
Car Market <b>United States and Canada</b>	Partner <b>3 US 7510 Volvo Car USA</b>	Function Group <b>8373</b>	
Function Description <b>Generated in Batch</b>		Page <b>Page 1 of 3</b>

## Technical Journal 37321.1.0

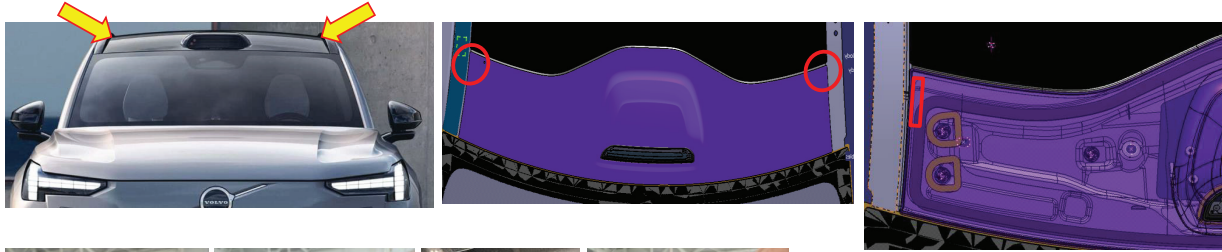
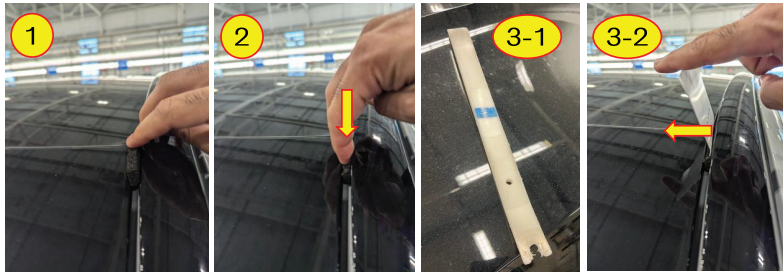
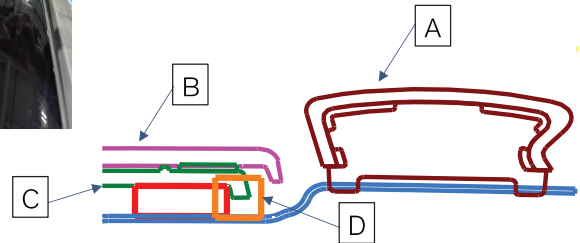
## TJ 37321

A = Rail  
B = Lidar cover panel  
C = Lidar cover panel carrier  
D = Foam

To prevent the noise from occurring, apply a foam piece with part number 32459450 on left and right side of the lidar cover panel according to attachment "TJ pdf". If there are already foam pieces mounted, please remove them and apply new ones to quality assure the foam application.

1. Place the foam piece in the channel between the lidar cover panel and the roof side, at the rear part of the lidar cover panel.
2. Press the foam downwards to the bottom of the channel.

3. With the tool, press the foam piece towards the lidar cover panel so that the foam is placed underneath the lidar cover panel according to the picture in the attachment "TJ\_37321\_1.pdf", where below parts are shown:
