Title: MV Chassis Lean Complaint - IROS Suspension

Applies To: MY2018, MY2019, MY2020, MY2021, MY2022, MY2023, MY2024, MY2025, MY2026 MV w/ IROS rear suspension

This article addresses chassis lean conditions on MV with IROS suspension. **It does not include any diagnostics for body leans, such as a cab lean.** Keep in mind that a chassis lean may cause or accentuate a cab lean.

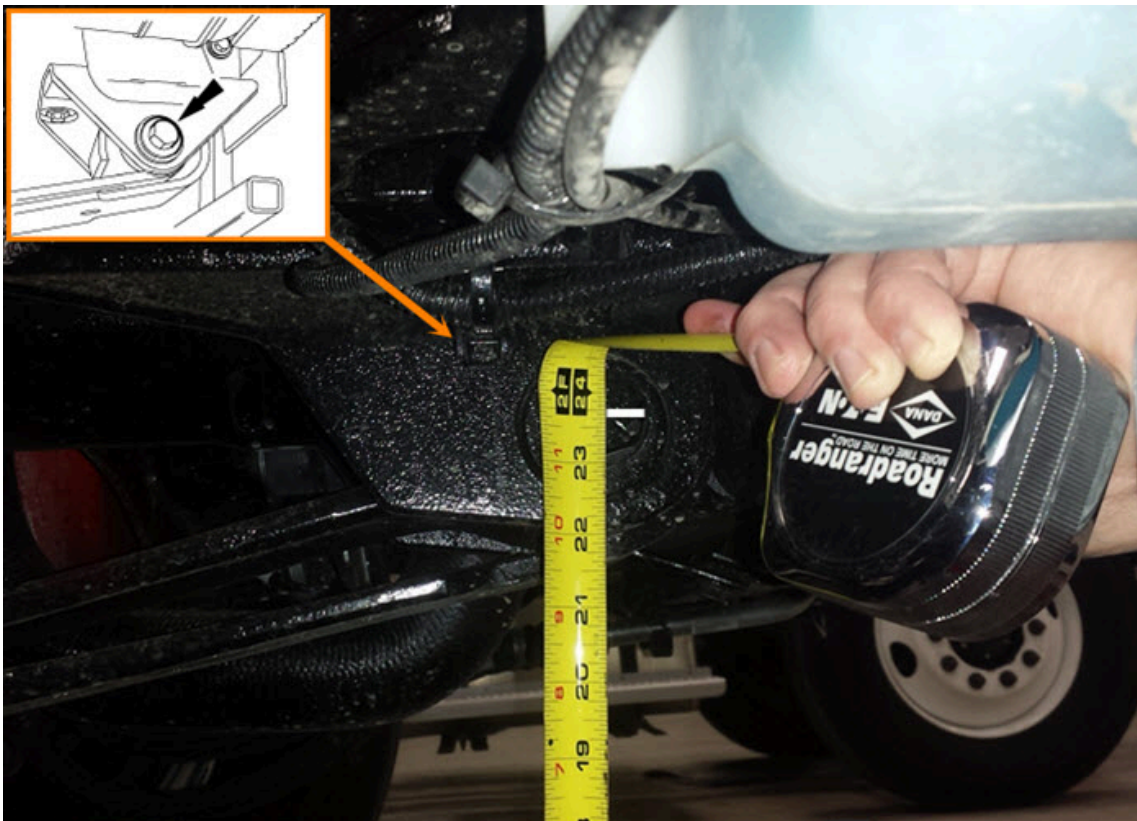
Right Front Spring Shackle Bolt

Proper locations to measure for chassis lean:

- o The front tires MUST be pointed straight forward to prevent any influence on the lean from the King Pin Inclination.
 - o Measure the front suspension at the spring shackles as shown in Figures 4 and 5. Mark the bolt with a paint pen so you have a reference point for future measurements that may be required.

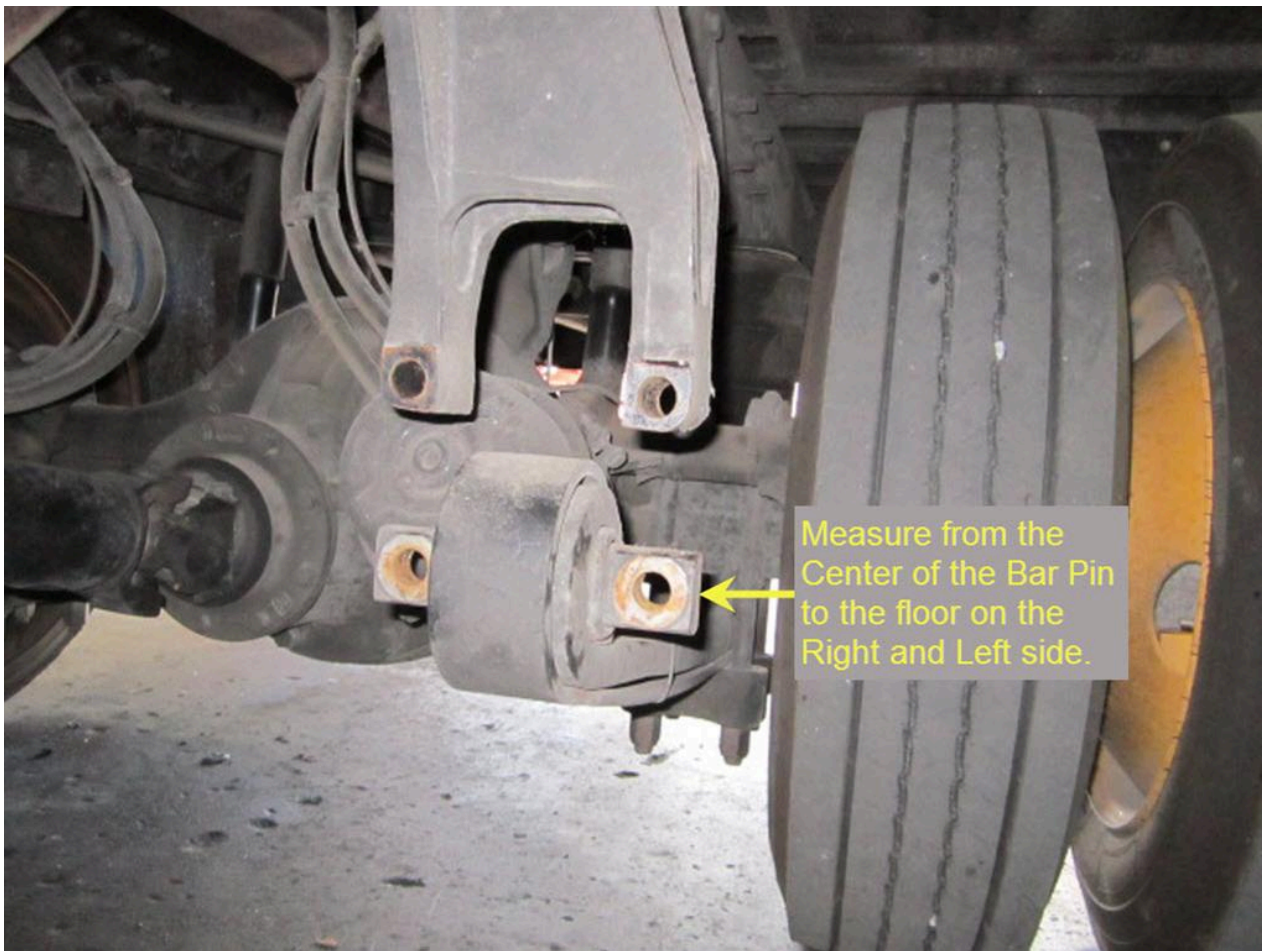
Figure 9

- *Use this information together with #7. Suspension reaction with a block, together with the suspension difference when the suspension is dumped.*
9. Measure from the center of the bar pin to the ground and record. (This step only applies to Single Rear Axle vehicles.)

- Remove the wooden block if previously installed.
 - You must remove the Spring Eye Bushing mounting bolts.
 - Using a frame jack at the rear of the vehicle, raise the frame evenly until the Bar Pin clears the Mounting Bracket on both sides.

- The rear tires should still be on the ground during this procedure. Only lift the rear of the frame until the Bar Pin clears the mounting bracket.
 - This will help determine if there is an issue with a rear seat or rear seat mounting.

- See Figure 8 below.
 - Do not perform this step on 6x4 configurations.
 - *If the Pin Bar Height is greater than 7/16" difference, the repair will require changing a seat out on one side.*

- *If the Pin Bar Height is 7/16" or less, shimming the front suspension (steer axle) will be required to correct the lean.*
 - *You will need to watch what the result is in #8 closely when this measurement is off.*

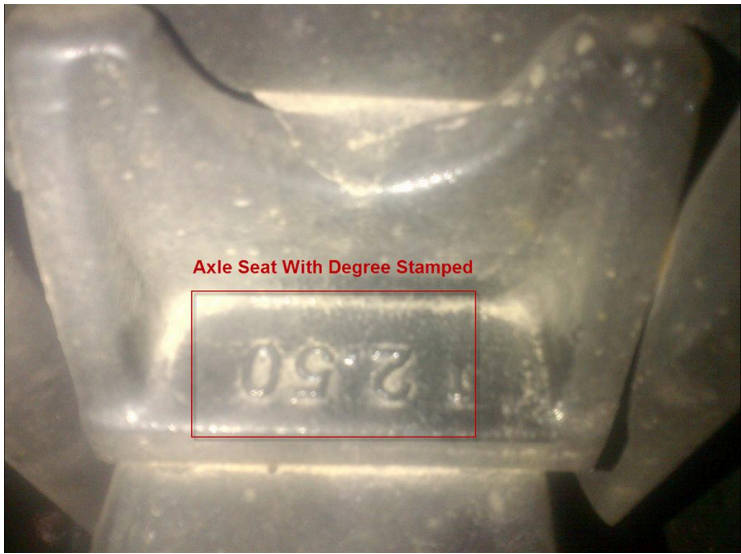
10. Record the axle seats' degrees or part number on the physical part if possible. See Figure 10 and Figure 11 below.
- *If a seat change is required to correct the lean, only change 1 seat size. (Only 1 seat will be replaced, and it must be a 1-degree or larger change).*
 - *The seat that needs to be changed is the Pin Bar measurement that is smaller. (Only 1 seat will be replaced).*
 - *The change should increase the Pin Bar height on the Low Side.*
 - *If the seat is changed, measure drive line angles BEFORE and AFTER, as these measurements may change.*
 - *If the seat is changed, make sure the correct Seat Plate is installed or changed if needed.*
 - *If the thicker side of the seat is facing forward (towards the steer axle) choose a seat one size smaller.*
 - *If the thicker side of the seat is facing rearward (away from the steer axle), choose a seat one size larger.*
