Date: 11.03.2026 **Affected Models:** Emira 4-Cylinder Vehicles **Affected Regions:** All Markets **Affected Volume:** N/A **Number:** 131-26007

Diagnosing medium temperature engine coolant thermostat operation to prevent unnecessary thermostat replacement.

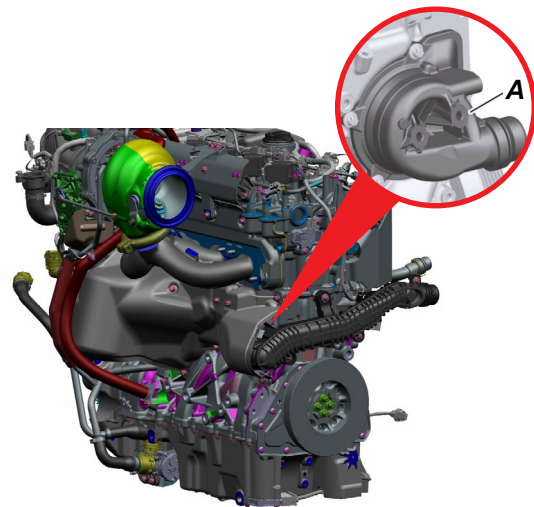
The information in this bulletin is intended as a procedure that should be performed if a 4-cylinder Emira has generated Diagnostic Trouble Code (DTC) P2CEF00 Auxiliary Thermostat “A” Stuck Open (see image for thermostat location). Generation of DTC P2CEF00 may also result in:

If DTC P2CEF00 has been generated, then raise a technical ticket on LCMS (Lotus Cars Management System) and follow the procedure shown below.

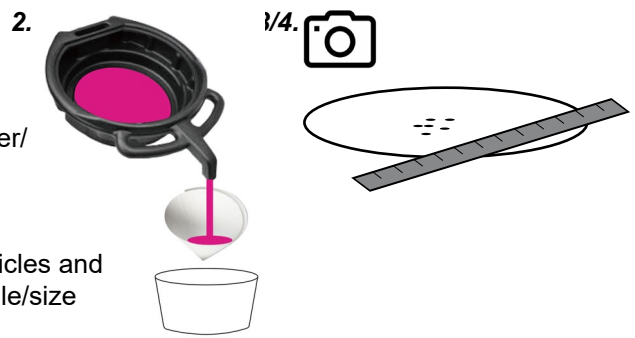
1. Drain the engine coolant into a clean container*.
2. Filter the coolant through a 200-micron filter paper/ sock.
3. Inspect the filter paper/sock.
4. Place a rule over the filter paper next to any particles and take photographs to give an indication of the scale/size of any particles.
5. Flush the engine coolant system with clean water using a suitable automotive air-powered flushing tool.
6. Remove medium thermostat from engine*.

*Refer to Emira service notes available to view on TIS for coolant drain and vacuum filling process.. Coolant drain, see service notes section: 2 Cooling and A/C > C220 46.01 - Engine Cooling System and Fan > Coolant Replace - 4 Cylinder, replacement.

Medium thermostat removal, see service notes section: 1 Power > 71 Engine > 185 40.13-Water Pump Assemblies and Thermostats-I4 > Medium temperature thermostat - I4, replacement.

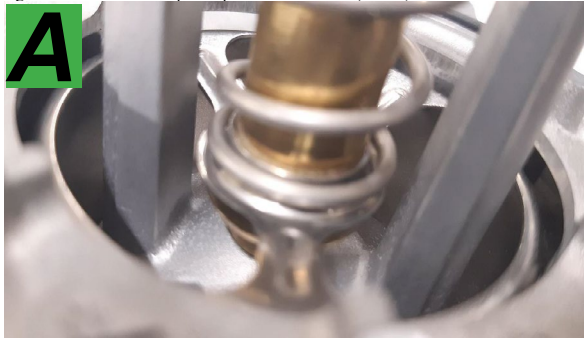
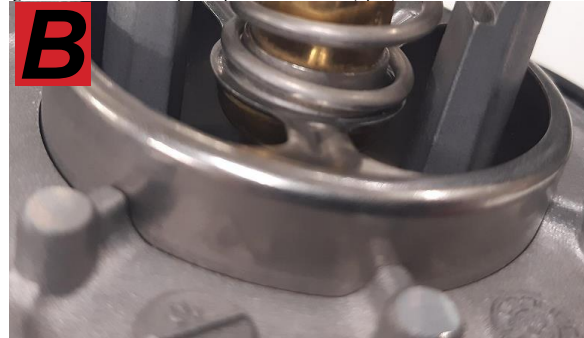
Inspect for the cold/closed position of the medium temperature thermostat piston.

✓ The piston should be recessed into the thermostat housing as shown in image A, which is the CORRECT closed position for a cold thermostat.

✗ If the piston is not recessed or protrudes out of the thermostat housing as shown in image B, then it is in the partially or fully open/hot position which is INCORRECT for a cold thermostat.

- Carefully package the thermostat and contact Emira Support using LCMS to arrange collection.
- Fit a new thermostat and gasket and refill the engine with new antifreeze/coolant.

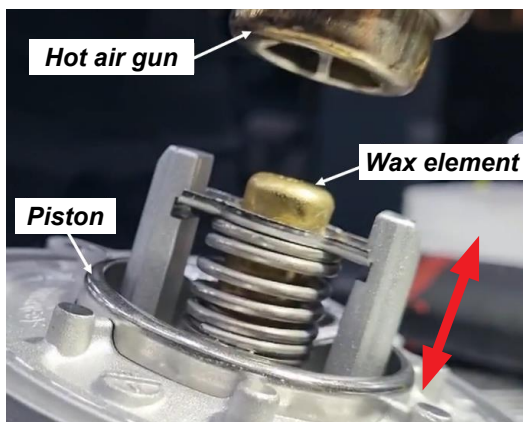
Check that the thermostat piston moves freely by applying heat from a hot air gun as shown.

1. When heated, the thermostat should open (rise out of the housing) ↑.
2. When allowed to cool, the thermostat should close (lower into the housing) ↓.

- 1.If the thermostat **MOVES FREELY** when heated and cooled, then refit the original thermostat with a new gasket and refill the engine with new antifreeze/coolant.
- 2.If the thermostat **DOES NOT** move freely when heated and cooled, then fit a **NEW** thermostat and gasket and refill the engine with new antifreeze/coolant. Carefully package the thermostat and contact Emira Support using LCMS to arrange collection.

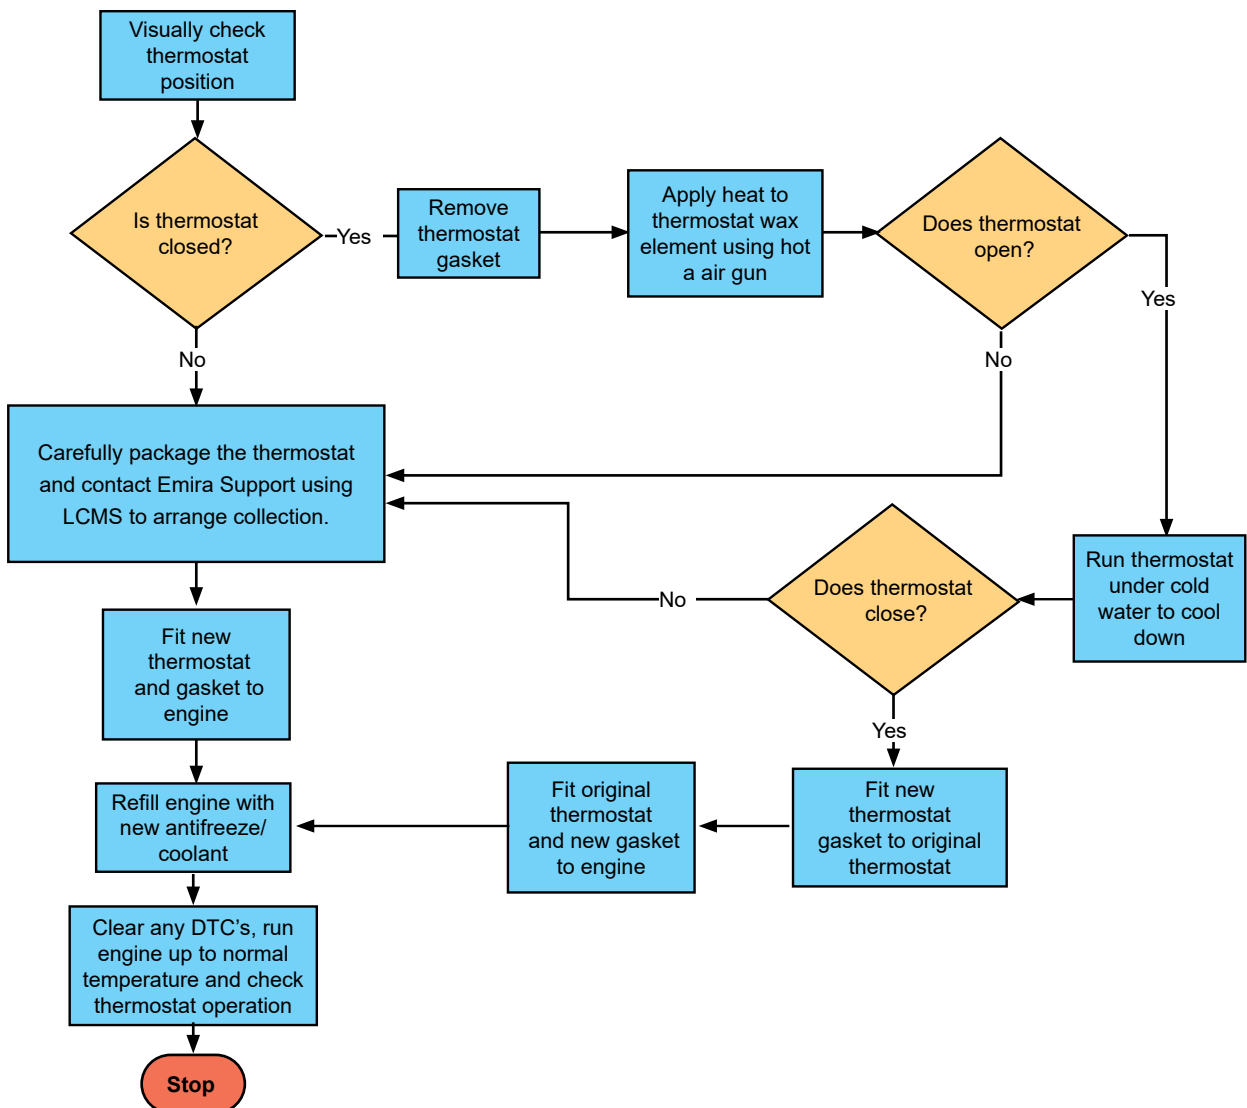
Thermostat Piston Movement Check

A process flow chart showing all the steps of the thermostat checking procedure is shown on page 4 of this bulletin.
