April 03, 2026

Version 1

## Product Update: 2023-25 Accord Hybrid PCU Radiator Guard Inspection

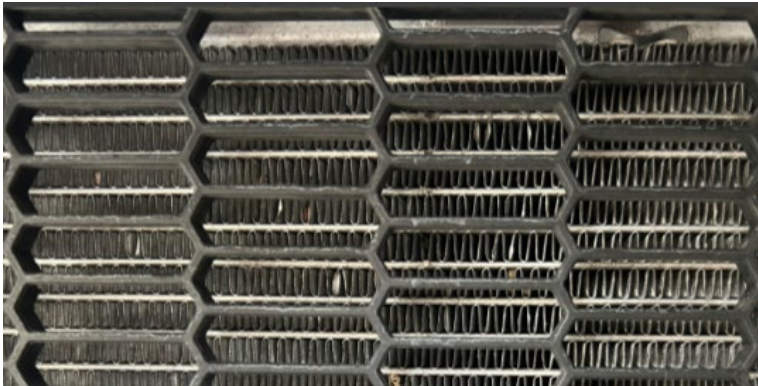
Look through the front bumper lower grille and inspect the guard mounted on the PCU Radiator.

- If the guard has a honeycomb design, proceed to **PCU Radiator Inspection**.

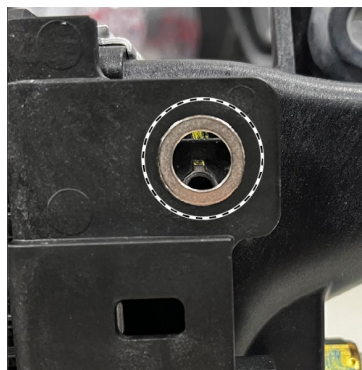
**COUNTERMEASURE PART NOT PROPERLY FITTED ON TOP OF RADIATOR AND BOLT HOLES DO NOT ALIGN.**

There is a gap  
between pieces.

1. [Remove the PCU Radiator Guard.](#)
2. Install new countermeasure PCU Radiator Guard, making sure fitment is correct.

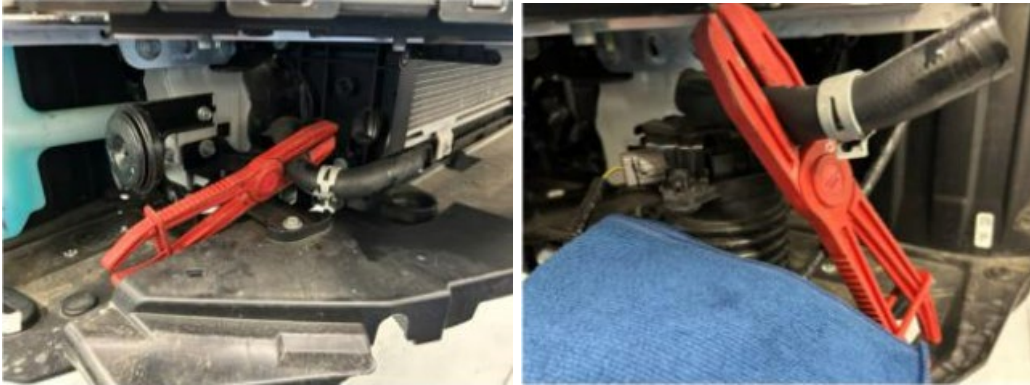
1. Attach coolant hose pliers onto the PCU Radiator coolant hoses.
