Product Update: 2025-26 Civic Hybrid PCU Radiator Guard Inspection**APPLIES TO**

Year	Model	Trim Level	VIN Range
2025-26	Civic Hybrid	ALL	Check the iN VIN status for eligibility.

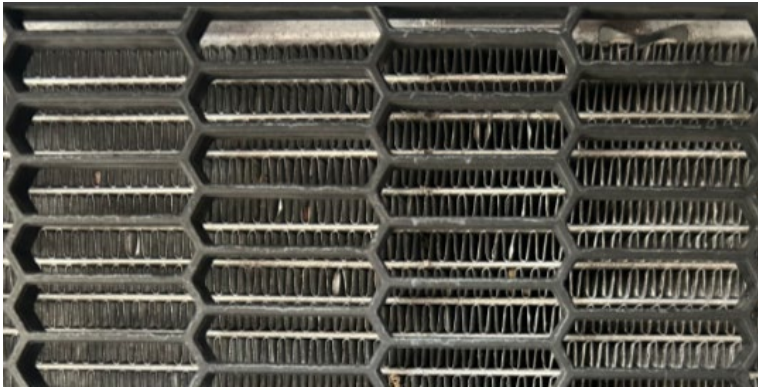
- If the guard has a honeycomb design, proceed to **PCU Radiator Inspection**.

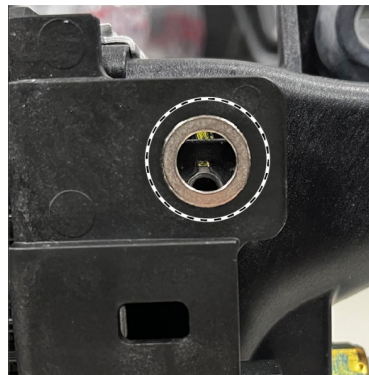
There is a gap
between pieces.

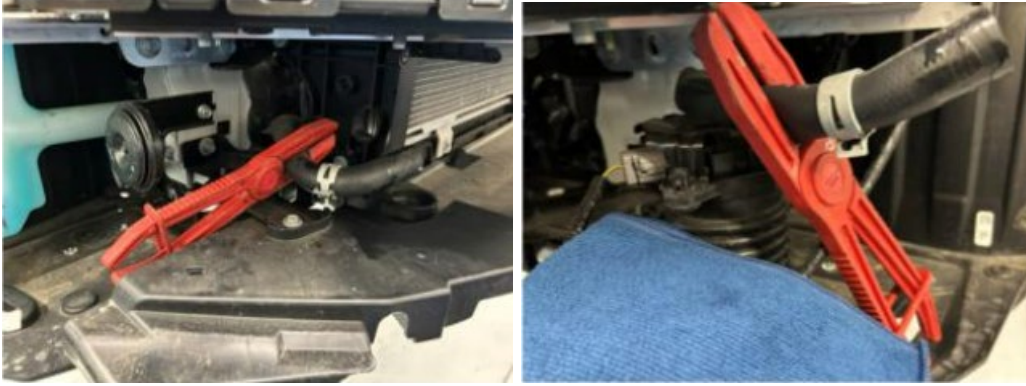
1. Attach coolant hose pliers onto the PCU Radiator coolant hoses.

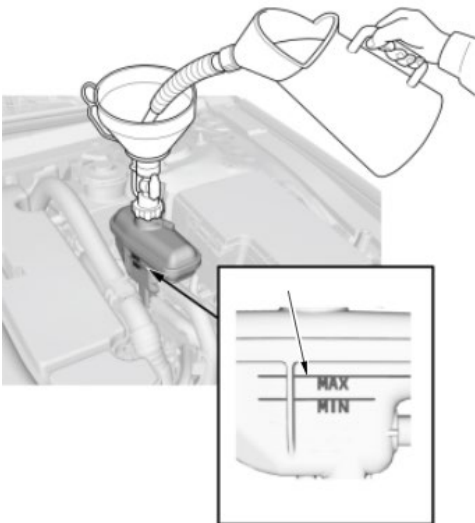
9. After 10 minutes, press **STOP**.
10. Check the coolant level and add coolant as necessary until it is at the **MAX** mark, then install the expansion tank cap.
