Technical Information

Black Exhaust Tip Repair Procedure

DATE: April 15, 2026

This bulletin outlines the refinishing procedure for restoring the black coating on exhaust tips affected by peeling or flaking paint. This validated process is intended to avoid unnecessary replacement of the entire exhaust silencer assembly.

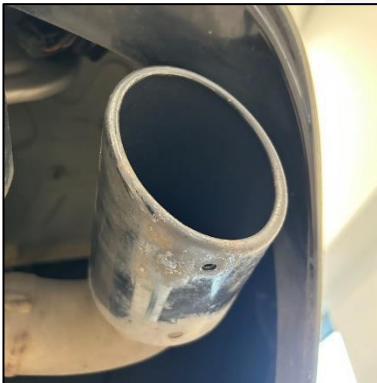
Grecale MHEV

- Peeling or flaking black paint on one or more exhaust tips
- No structural damage or corrosion—only surface coating degradation

→ See image examples below.

⚠ Important: if any exhaust tip is experiencing peeling, it is mandatory to repaint all of them to avoid color mismatch.

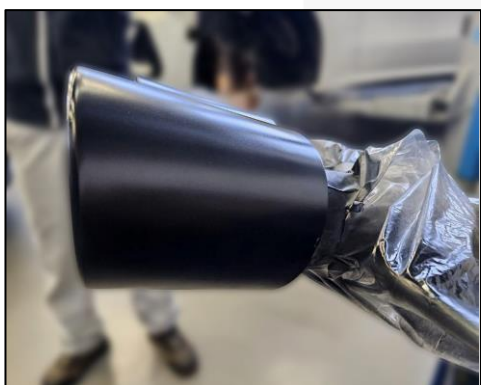
- ✓** The final result should match the appearance shown in the reference image above.

11. Cure the painted parts in an oven for 30 minutes at 180°C (356°F).

Curing the 1760 thermoceramic coating must be performed in a temperature-controlled oven at **180°C (356°F) for 30 minutes**. This step is **mandatory** to ensure proper adhesion, durability, and heat resistance of the coating. **Do not use a heat gun or other localized heat source**, as it will not provide the consistent temperature required for effective curing.
