Diagnostic Sheet

FROM: Maserati TSO

Rear Exhaust Silencer – Noise and Bypass Valve Diagnostic Guide

DATE: April 9, 2026

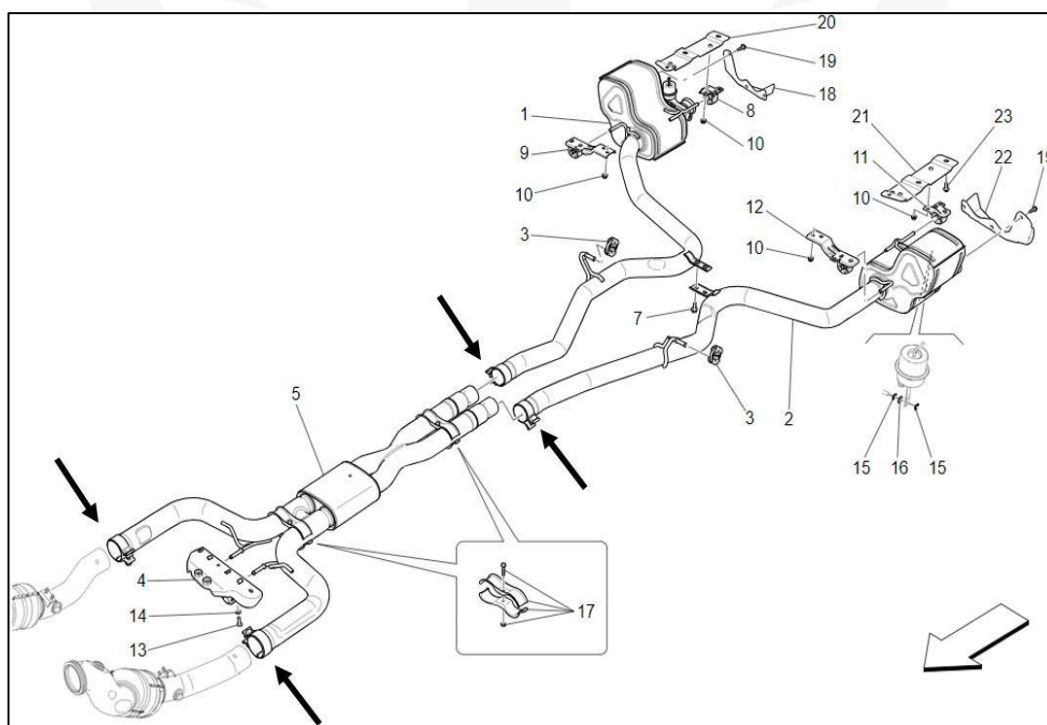
- **3a:** Check the tightening and condition of all anti-vibration pads (components 8, 9, 11, 12).
- **3b:** Check the tightening of the exhaust collars at the indicated arrows.
- **3c:** Check the tightening of the nuts on the central silencer support (component 17).

If the issue is fixed (BOL not necessary):

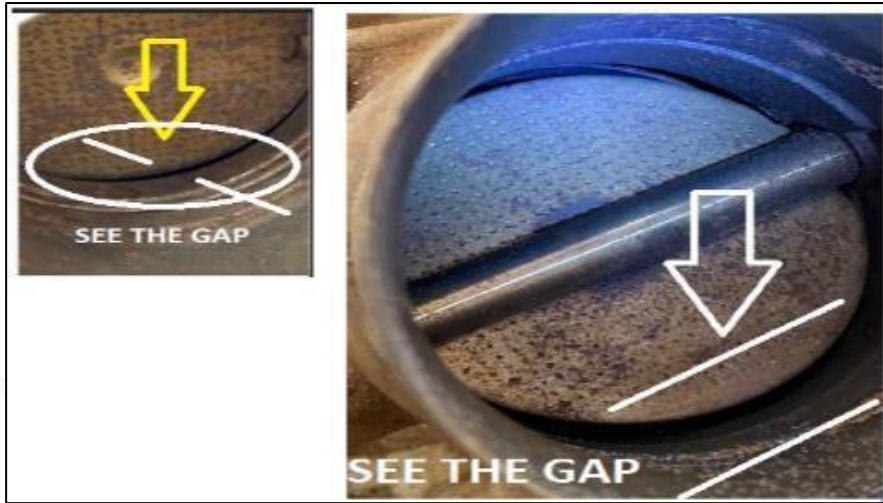
- Remove both rear silencers.
- Check if the bypass valves fully close in "Normal" mode. A valve that does not close can cause rattling or vibration.
- Compare against the photo example below (poor closing of the valve); inspection must be performed on both the silencers:

- Replace the rear silencer (or both silencers).

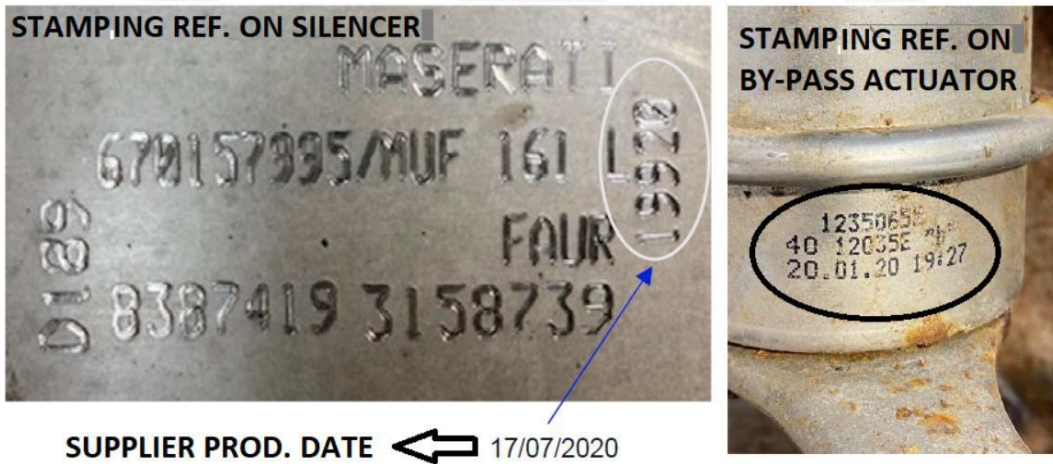
- Open a **Blue On Line** as "Support Request".
- Attach pictures of valve behavior and identification numbers stamped on both silencers.

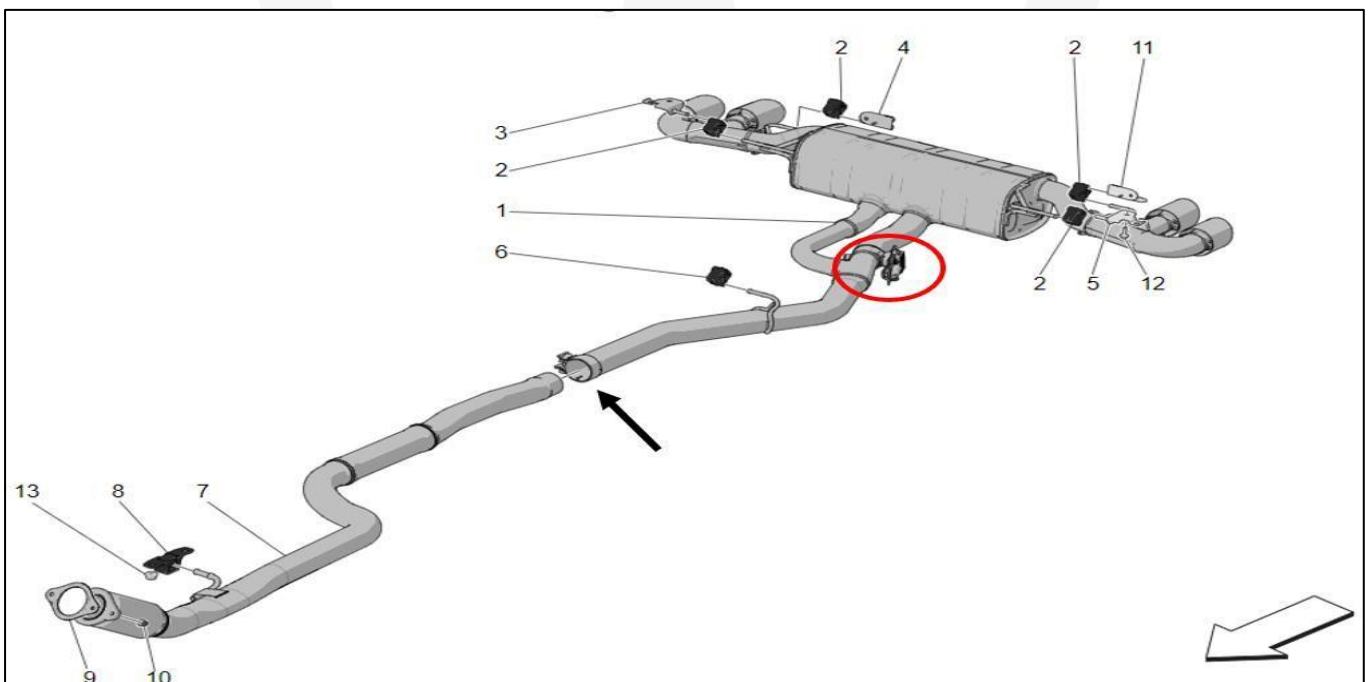
- **3a:** Check the tightening/condition of the rear anti-vibration pads (component 2).
- **3b:** Check tightening of the exhaust collar at the indicated arrow.
- **3c:** Check tightening/condition of the central silencer support pad (component 8).

IMPORTANT: Do NOT remove the by-pass valve actuator from its seat (see red circle in diagram).

If fixed (No BOL necessary):

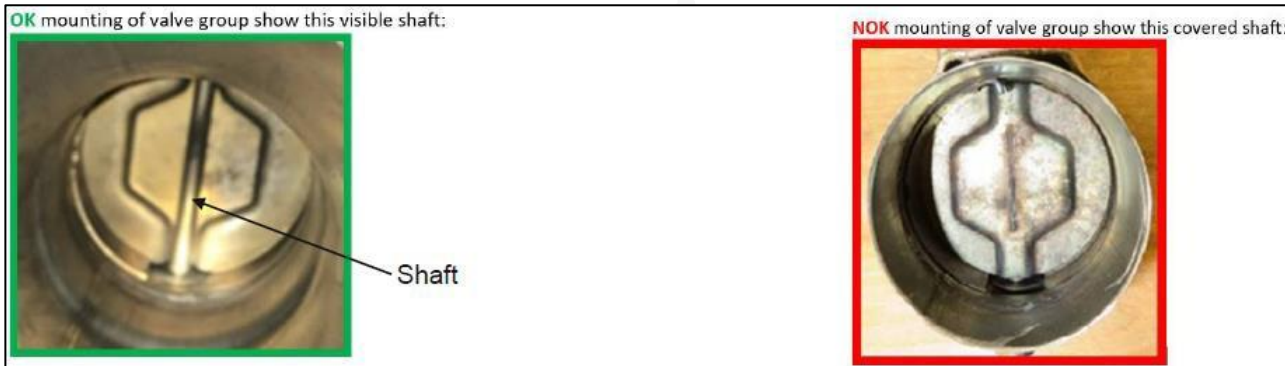
- Select "GT" mode and start engine at idle.
- Disconnect the by-pass valve connector (valve should stay closed).
- Turn engine off.
- Disconnect rear silencer from center silencer.
- Inspect the valve using an endoscope.
- Compare images: correct vs incorrect valve mounting.
- Document with photos.

- Replace the rear silencer.

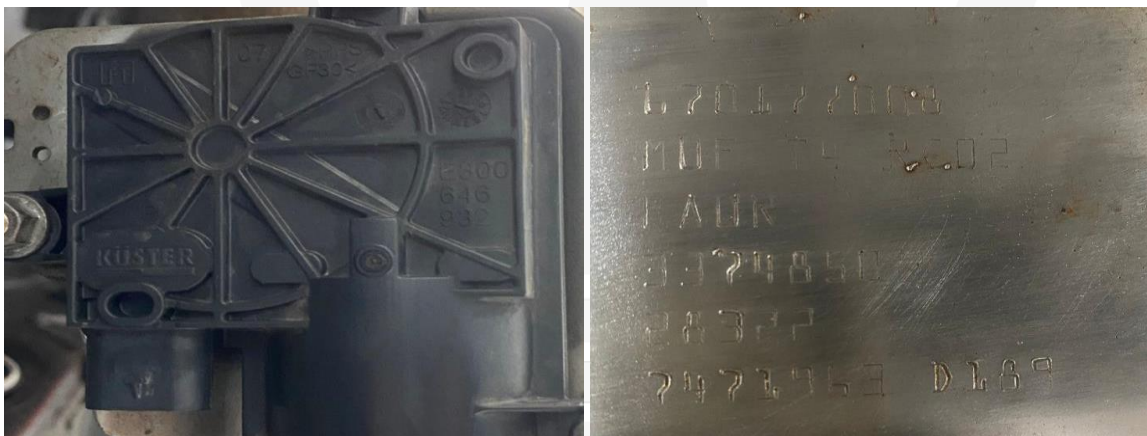
- Open a **Blue On Line Support Request** and attach photos, including silencer identification stamps.

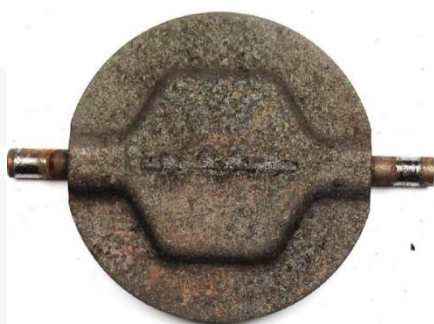
- Disconnect the rear silencer from the center silencer.
- Use an endoscope to inspect the bypass valve.
- Take photos, especially of any corrosion or oxidation.

- Open **Blue On Line Factory Information** request and attach photos.
- Replace the rear silencer.
- **Note:** *Corrosion cases are NOT covered under warranty.*

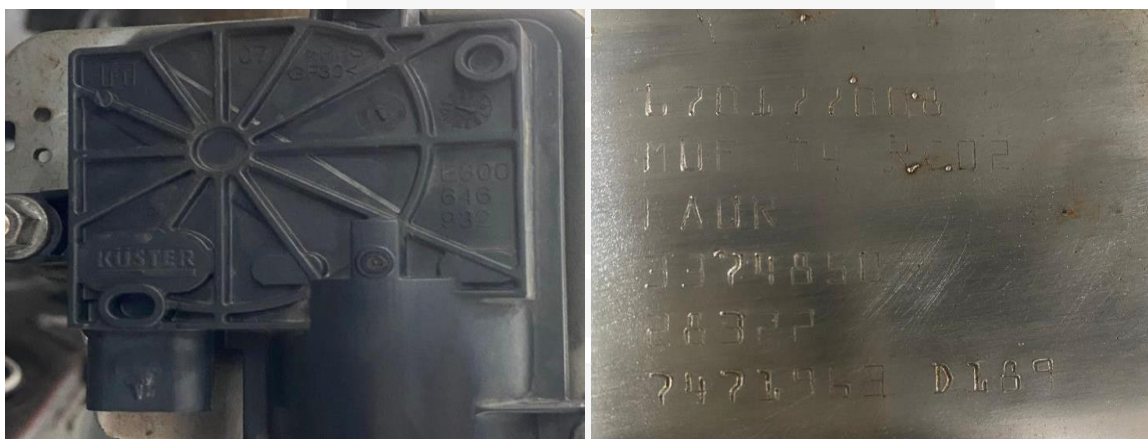
- Open a **Blue On Line Support Request**.
- Attach photos of valve condition and stamped identification data.
