April 21, 2026

Version 2

## Product Update: 2023-25 Accord Hybrid PCU Radiator Guard Inspection

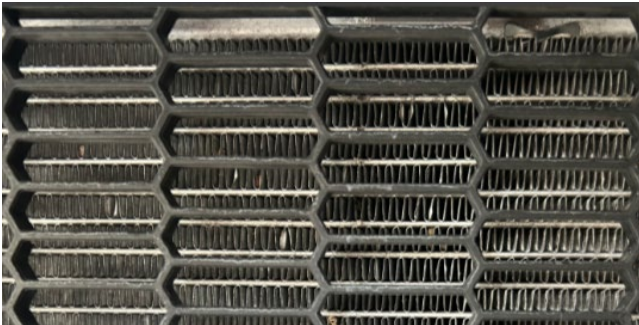
- If the guard has a honeycomb design, proceed to **PCU Radiator Inspection**.

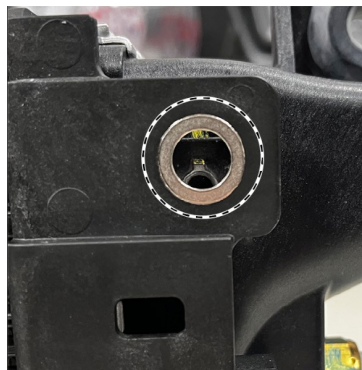
**COUNTERMEASURE PART NOT PROPERLY FITTED ON TOP OF RADIATOR AND BOLT HOLES DO NOT ALIGN.**

There is a gap  
between pieces.

1. [Remove the PCU Radiator Guard.](#)
2. Install new countermeasure PCU Radiator Guard, making sure fitment is correct.

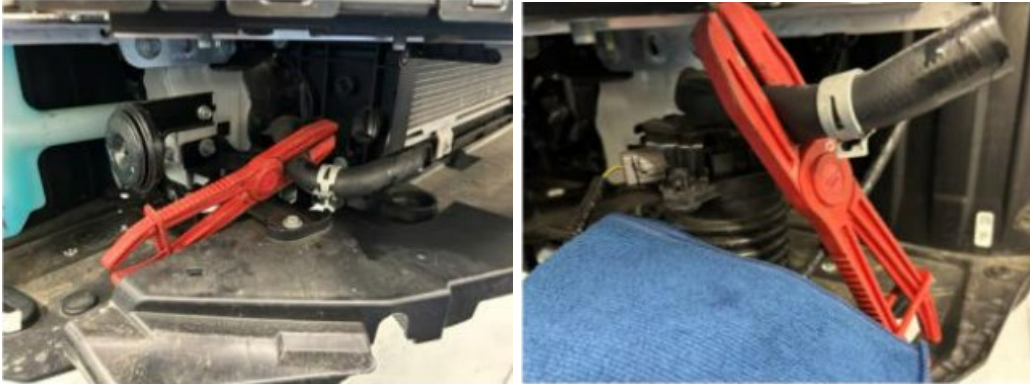
1. Attach coolant hose pliers onto the PCU Radiator coolant hoses.
