TO: Mercedes-Benz Dealer Principals, General Managers, Service Managers, Warranty Administrators and Bookers	FROM: Joe Haller, Department Manager, Warranty Greg Gunther, Department Manager, Vehicle Compliance & Analysis
RE: <b>HVAC Service Warranty Coverage: Various Models and Model Years (see enclosed list)</b>	DATE: October 29, 2020

## HVAC SERVICE WARRANTY COVERAGE

### (Not Effective until December 7, 2020 at the Earliest [see below])

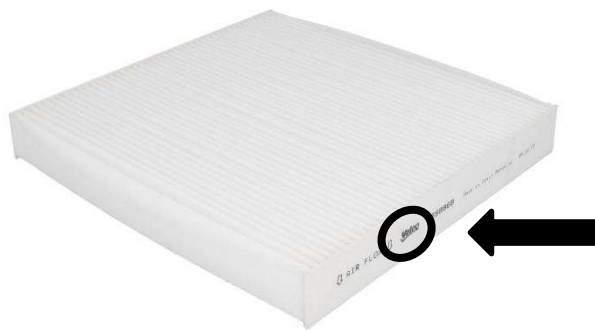
- The customer requesting coverage must provide proof that the Subject Vehicle's currently installed HVAC filter is a Mercedes-Benz brand or **Other Approved Filter**.
- **Other Approved Filters:** Only filters from Behr, Denso, Freudenberg, Mann-Hummel, Valeo will be accepted as **Other Approved Filters**. The supplier name must be verified by checking if the supplier name appears on the side of the filter as shown in the below diagram. No other filter from any other suppliers will be accepted as an approved alternative filter.
