SERVICE PROGRAM BULLETIN

APPLICABILITY: 2026MY Forester **NUMBER:** WRH-25R
SUBJECT: Rear Door Latch & Actuator Assy Replacement **DATE:** 01/15/26
REVISED: 04/02/26

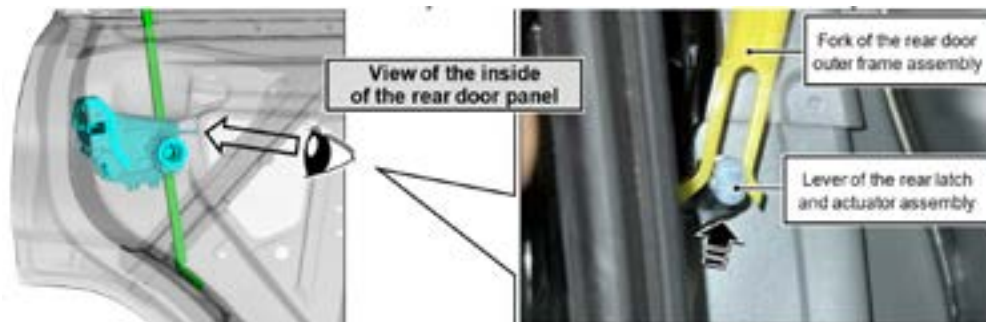
2.2 Insert the door latch and actuator assembly into the fork of the rear door frame assembly.

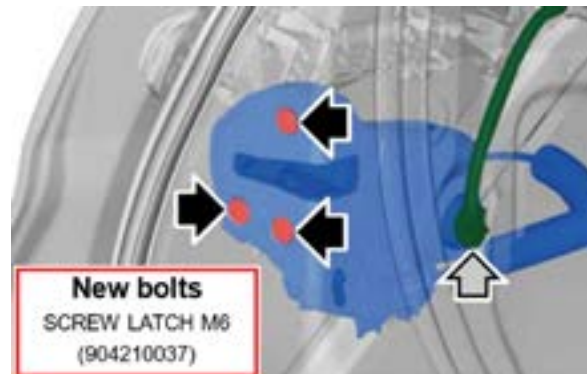
2.3 Install three (3) **NEW** T30 bolts into the door latch and actuator assembly and torque to **6.5 N·m (58 in-lbs)**.

2.4 Connect the electrical connector.

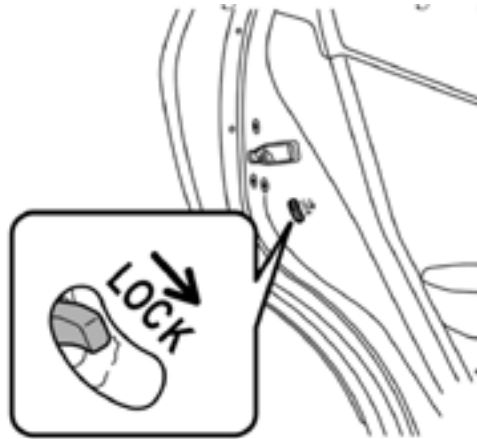
- 3.1 Verify the window glass moves up and down normally.
- 3.2 Check that the inside and outside door handles operate correctly to open the door.
- 3.3 Ensure the lock works from both the key fob and the master window switch.
- 3.4 Confirm the child lock mechanism is functioning and set to its original position.
