Preview Solution CBR-2540-7

Upper Bunk Restraint System – Plastic Gable Retention Field Fix

Mack Chassis - AN (4), PR

Volvo Chassis - VN (4)

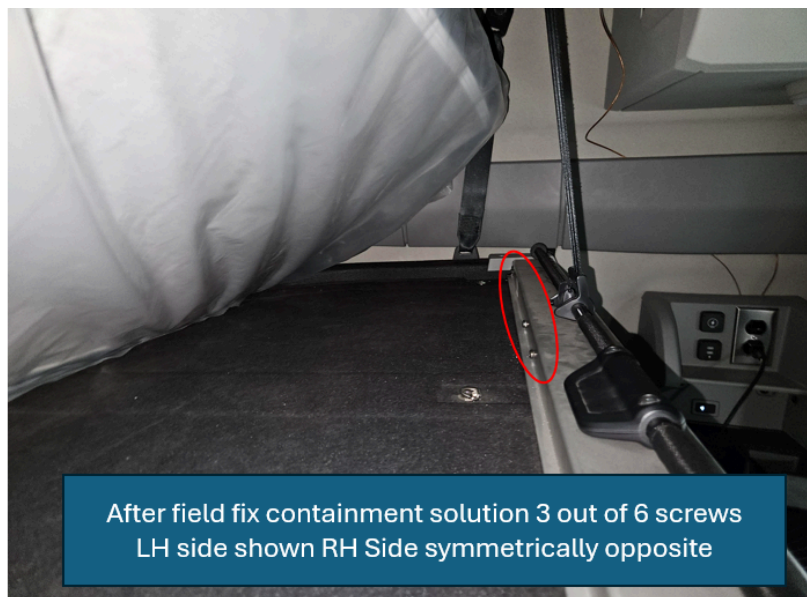
After field fix containment solution 3 out of 6 screws
LH side shown RH Side symmetrically opposite

I webbing does not retract fully down, loosen screw slightly for affected reworked retractor. Loosening the screw will allow the retractor to unbind.
