Preview Solution CBR-2575-1

Mack Chassis - Dash Panel Cracking at Mounting to BIW

Mack Chassis - Anthem, Pinnacle's, Granite's
Model Year 2018 to 2025

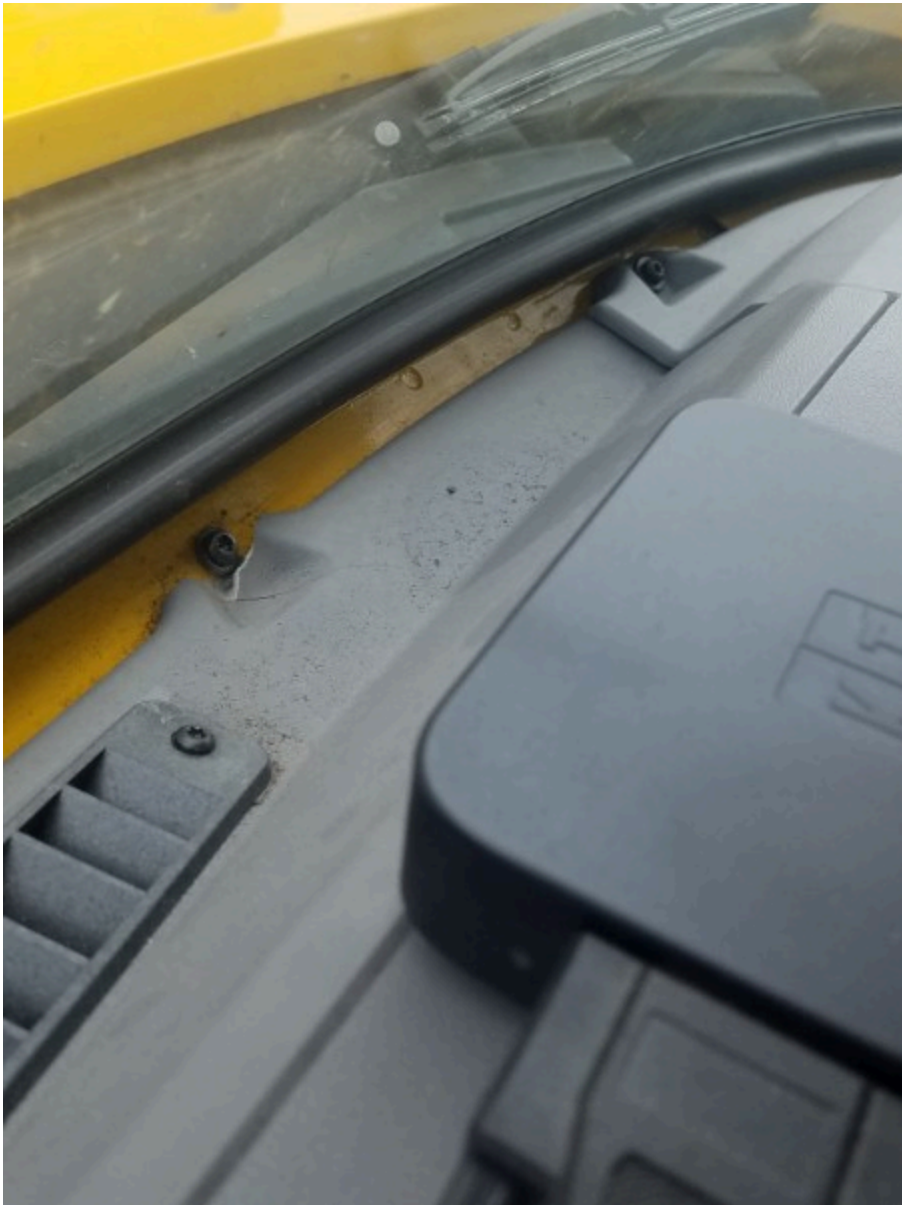
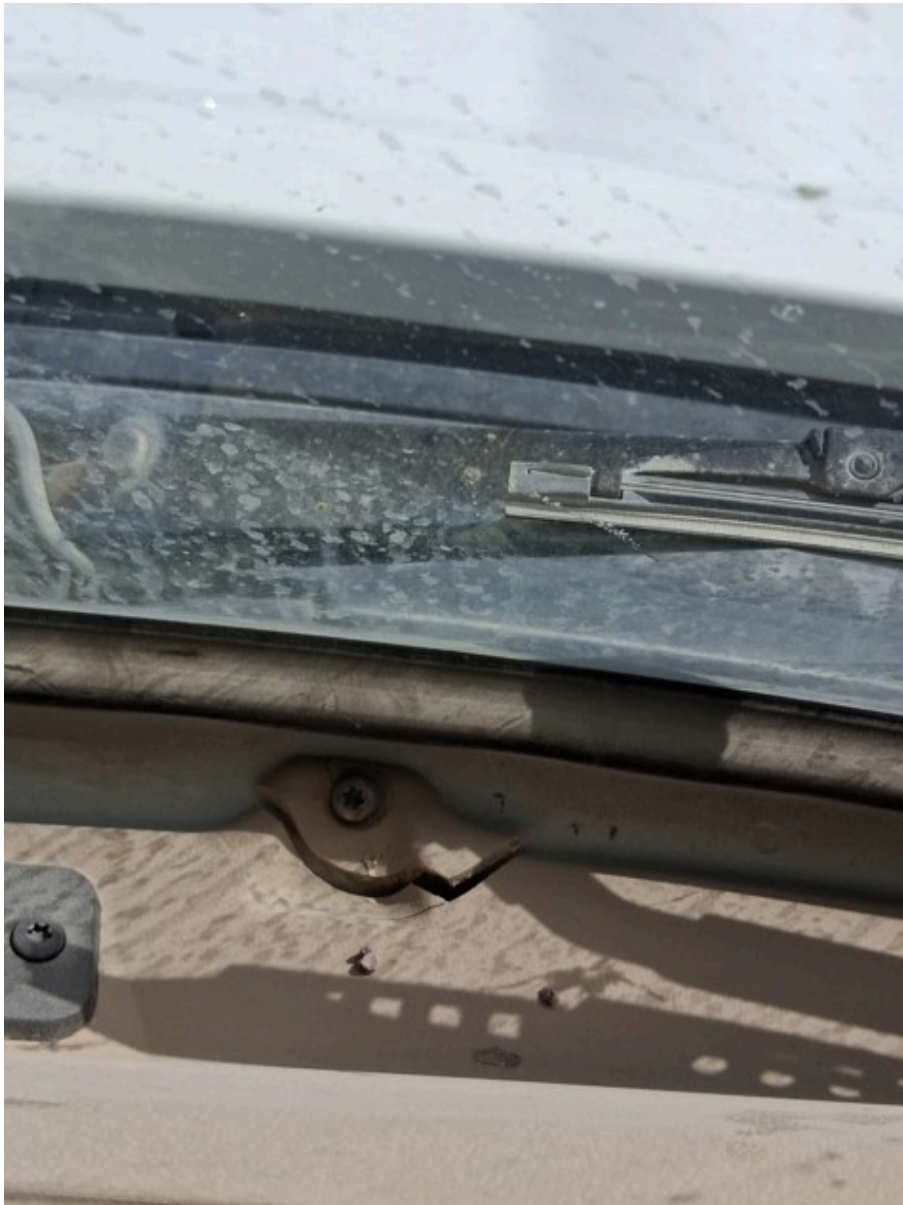
Certain Mack chassis vehicles could experience dash cracking at the mounting points to the Body-In-White.

To alleviate this issue, replace the current dash mounting screw (PN: 25099161) and washer (PN: 25100378) with the new screws with an inbuilt rubber washer (PN:78630681) at the 5 mounting locations around the instrument panel. Replace the dash mounting screw (PN: 25089319) and washer (PN:25100378) with new screw with washer (PN: 994793) at 2 locations of the passenger panel.

New Part Number	Quantity
78630681 - Screw with washer	5
994793 - Screw with washer	2
