Technical Service Bulletin (TSB)
B Pillar Applique Rubber Molding Peeling Off

REFERENCE:	TSB: 23-013-26 GROUP: 23 - Body	Date:	April 29, 2026	REVISION:	—
VEHICLES AFFECTED:	2025 - 2026 (M6) Jeep Compass This bulletin applies to vehicles built on or after February 01, 2026 (MDH 0201XX) and on or before April 06, 2026 (MDH 0406XX).	MARKET APPLICABILITY:			
		<input type="checkbox"/> NA <input type="checkbox"/> CH <input type="checkbox"/> EE <input checked="" type="checkbox"/> IAP <input type="checkbox"/> SA <input type="checkbox"/> MEA NOTE: This bulletin applies to India & Asia Pacific markets.			
CUSTOMER SYMPTOM:	Customers may comment on the following: <ul style="list-style-type: none"> Both rear door B Pillar applique rubber moldings are loose Fig. 1. 				
CAUSE:	Loss of bonding

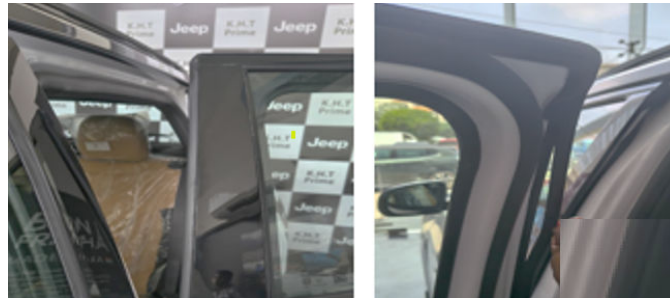
Fig. 1
B Pillar Applique - Rubber Molding Loose

This bulletin involves replacing both rear door B Pillar appliques.

1. Replace both rear door B Pillar appliques. Refer to the detailed service procedures available in DealerCONNECT/Service Library under: Service Info> 23 - Body / Doors - Rear / Channel, Door Glass, Rear / Removal and Installation.
