L636-  
A.05.26

**Campaign code:**  
L636-A.05.26

**Campaign name:**  
Transmission Mechatronics Inspection

**Model:**  
URUS SE

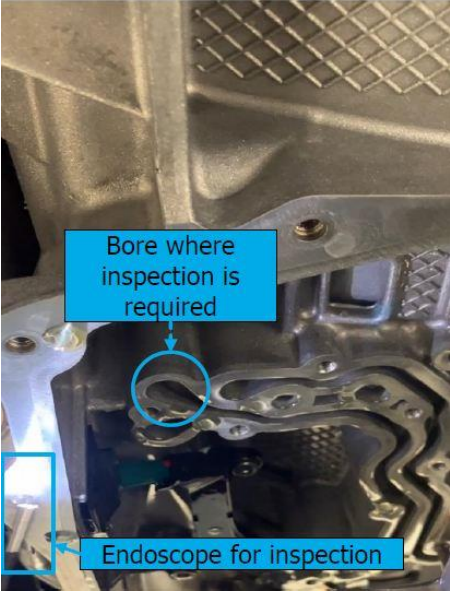
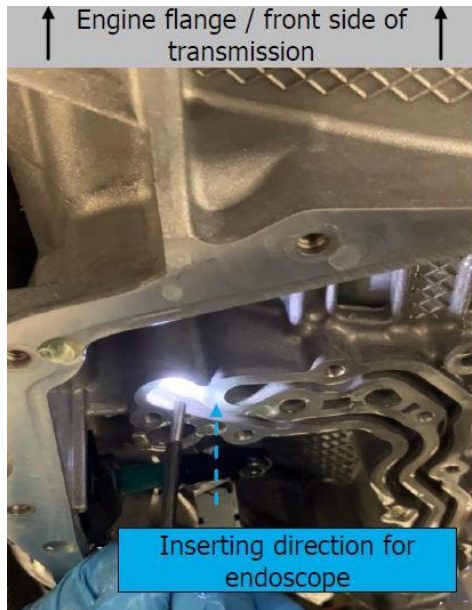
1. Insert the endoscope into the gearbox through the hole shown in the following figures and in the indicated direction.

Disassemble the mechatronics of the gearbox to perform the inspection using an endoscope. Follow the procedure outlined in the workshop manual:

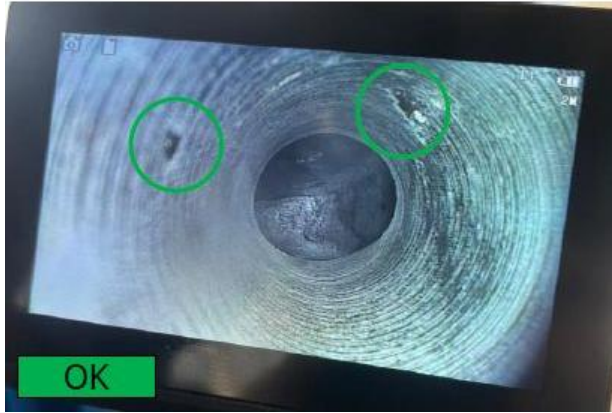
2. During the endoscopic inspection, it is possible to see small holes or cavities as in the following images: In these conditions the channel is OK.

In case of inspection OK, it will not be necessary to perform the 'Mechatronics ECU replacement' diagnosis function.

In case of a OK results of the inspection, reassemble the mechatronics following the procedure outlined in the manual.

**Reuse the previously removed ATF oil.**

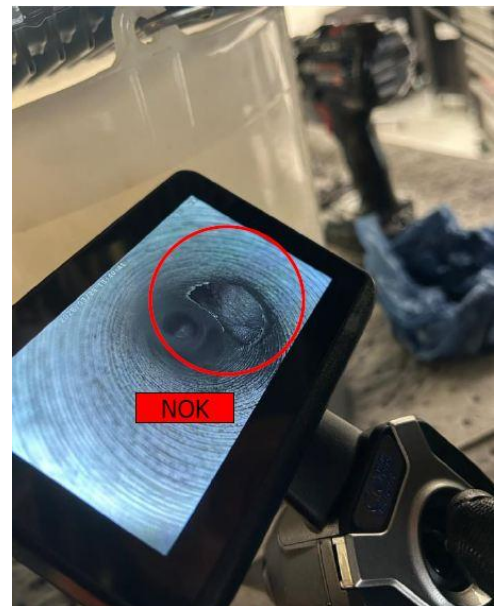
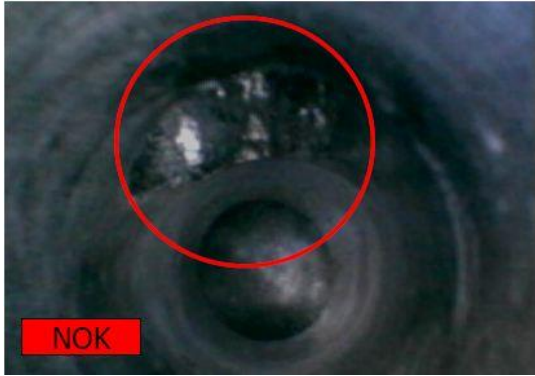
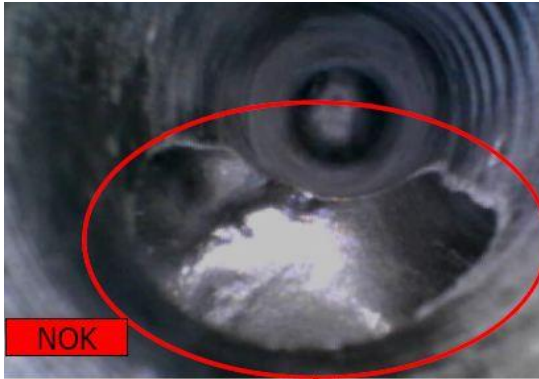
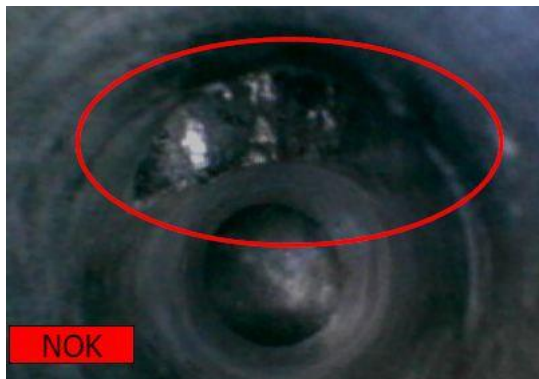
3. In case, during the endoscopic inspection, it is possible to see large cavities as in the images, the channel is KO. It will be necessary to proceed with **operation B**.

**Send the images to technical support for an internal check before proceeding with gearbox replacement.**

In case the inspection gives a negative result, it will be necessary to replace the complete gearbox, the exchanger and the related pipes. Follow the procedures outlined in the workshop manual selecting Urus SE MY26:
