**J1- Measuring the Capacitance of High-Voltage Power Electronics**

**Vehicles Affected**

Models	Model Year	Model Type	VIN Range	Vehicle-Specific Equipment
Taycan	As of 2020 up to 2024	Y1A, Y1B, Y1C	N/A	Power Electronics

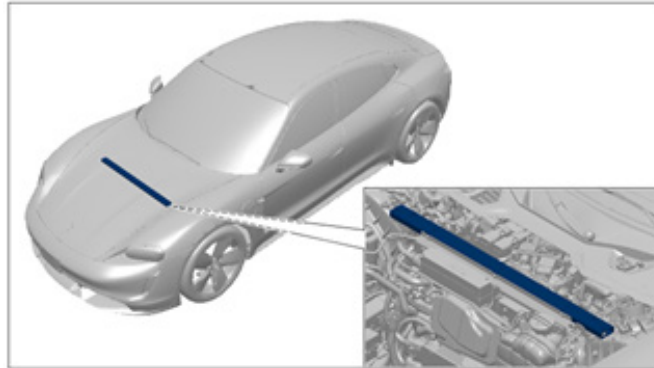
- c. Remove the dome strut in the front trunk area (Reference: WM, 408619A2 Removing and installing strut (dome strut)) (Figure 2).

**Figure 2 - Dome Strut**

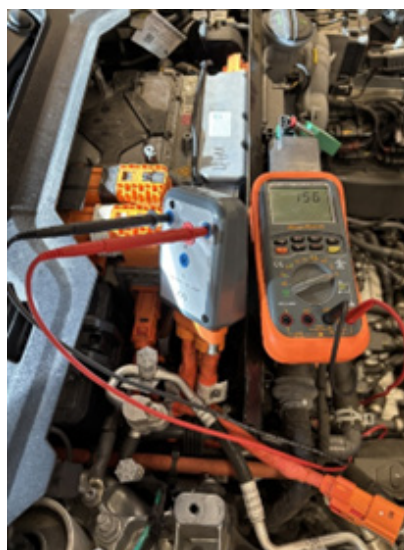
- d. Disconnect front HV PE traction cable connector (high-voltage connector).
- e. Install special tool VAS 6558A/38A-2 to front HV PE traction cable connector.
- f. Set multimeter to the capacitance measurement setting. Insert the red and black probes of the multimeter to the special tool leads labeled 1 and 2, respectively (Figure 3).
- g. Wait at least 10 seconds for the measurement to stabilize. Record the capacitance value once stabilized.
- h. Reinstall all components in reverse order.

**Figure 3 - Measuring Capacitance on Front PE**

- 3. Compare measurements to the chart below (Table 1). Replace any PE with a capacitance measurement that does not meet or exceed the lower tolerance limit. Please document the capacitance measurements in the PCSS job.

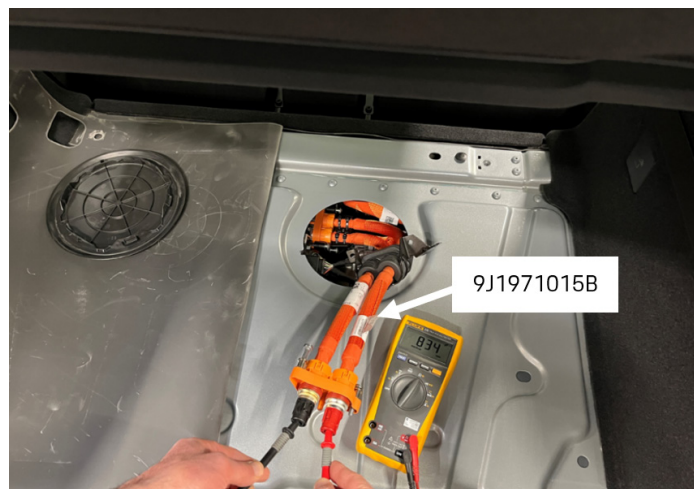
- a. Observe general warning notes for working on the high-voltage vehicle electrical system.
- b. Remove rear cargo anchoring system eyelets.
- c. Remove rear luggage compartment cover and insulating mat underneath.
- d. Open access port lid (body cover) to access rear PE.
- e. Disconnect HV PE traction cable connector (high-voltage connector) and install HV cable 9J1971015B.
- f. Set multimeter to capacitance measurement setting. Insert the red and black probes of the multimeter to the red and black leads of the HV cable (9J1971015B), respectively.
- g. Wait at least 10 seconds for the measurement to stabilize. Record the capacitance value once stabilized.
- h. Reinstall all components in reverse order.

Figure 4 - Measuring Capacitance on Rear PE
