Document ID: IK1201514
Revision: 0
Created: 5/29/2025
Last Modified: 4/30/2026
Author: Greg Scheff

Title: Sealing Oil from the Crankshaft Gear on S13 Engines

Applies To: MY2023, MY2024, MY2025, MY2026 All S13 Engines

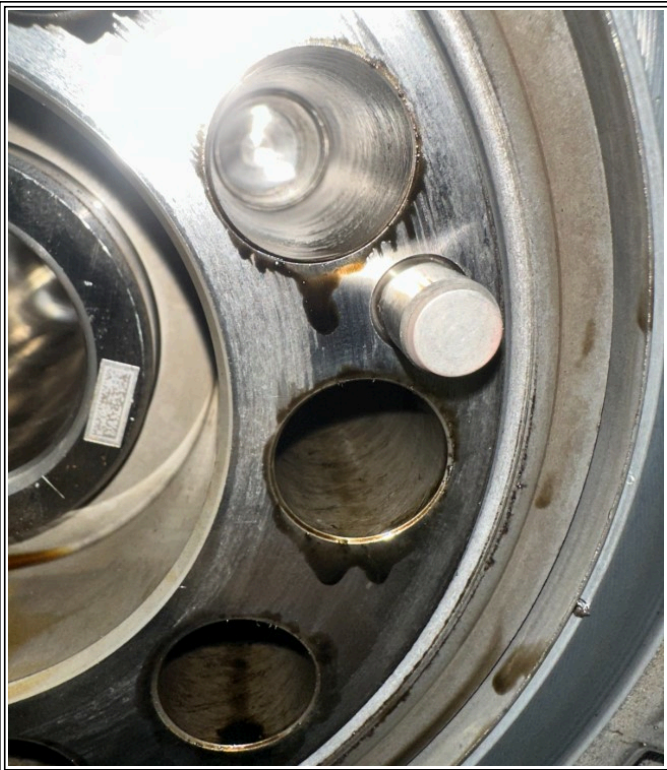
This document provides instructions for sealing oil leakage past the flywheel bolt holes on S13 engines. Oil leaking from behind the crankshaft gear may exit through the flywheel bolt holes and is often misdiagnosed as a rear crankshaft seal leak. This condition is confirmed by oil-saturated flywheel bolts and visible oil pooling in the flywheel bolt holes behind the gear.

Figure #1: Excess Oil in the flywheel bolt holes

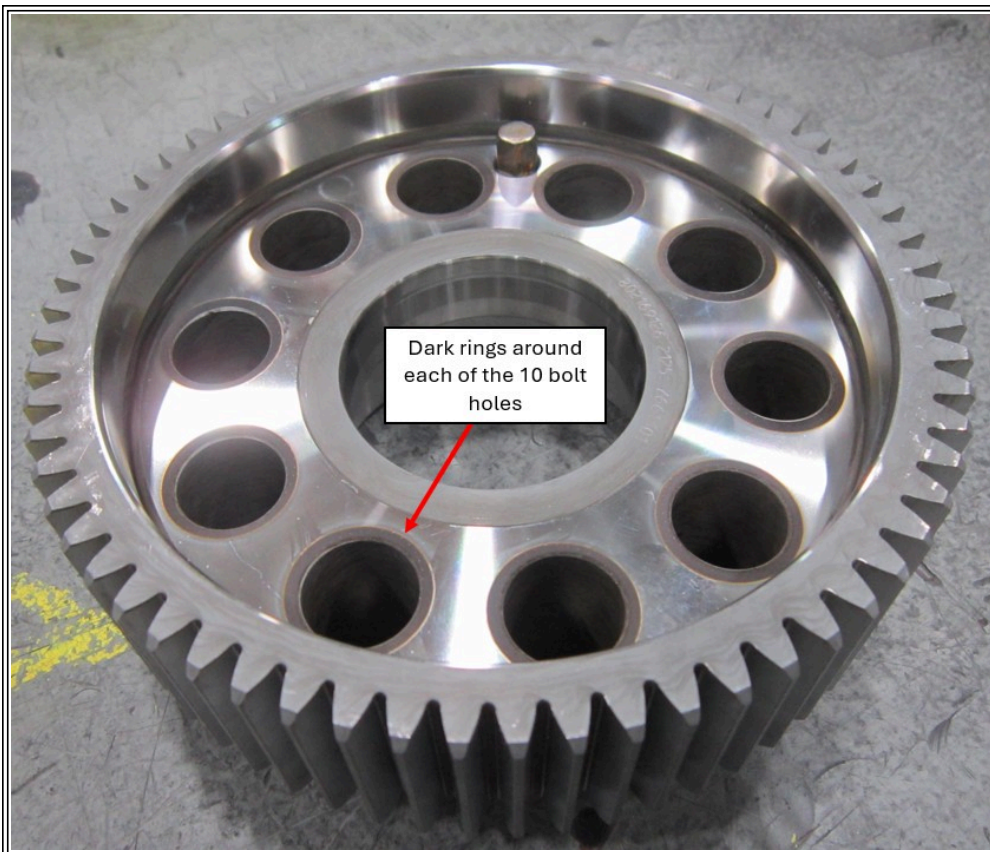
Figure #2: New 121691N91 Crankshaft Gear ID

The new "laser-structured" crankshaft gear can be identified by dark rings around each of the 10 flywheel bolt holes on the backside of the gear (**Figure #2**). The instructions below must be followed exactly to install the new gear.

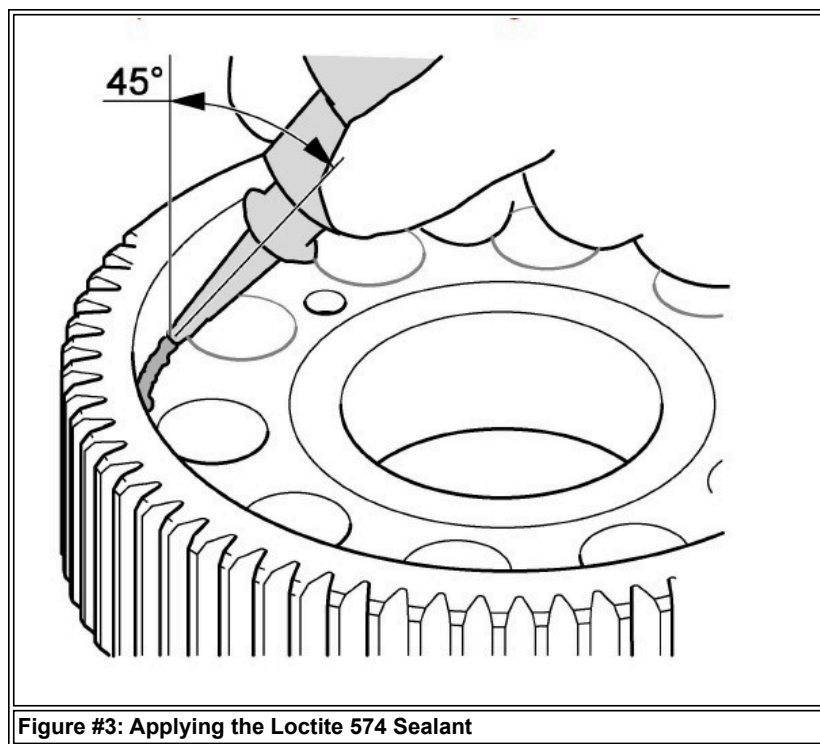
Figure #3: Applying the Loctite 574 Sealant

13. Apply a smooth 1.5mm bead of Loctite 574 at the inner radius of the new gear (**Figure #3**), holding the tube at a 45° angle; do not cut the tip of the sealant tube.

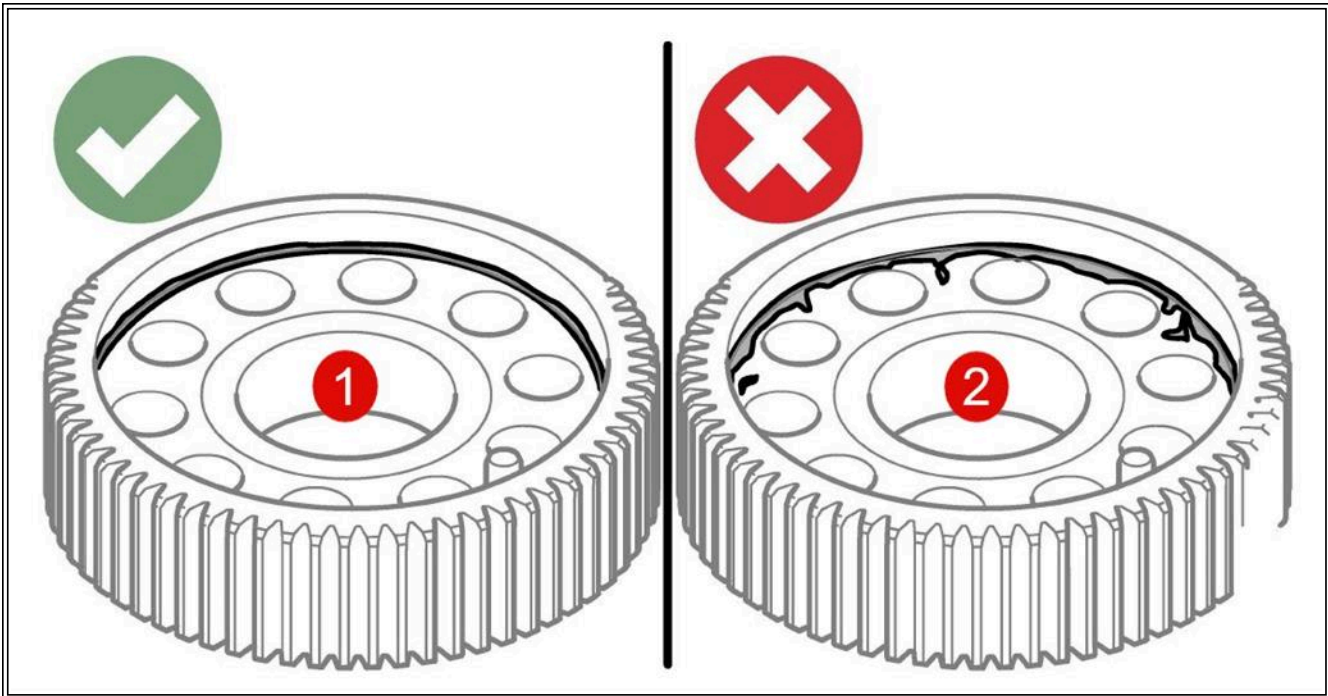
Figure #4: Examples of Sealant Quantity and Position

Item 1: **OK**, sealant bead is evenly applied only in the inner radius of the gear

Item 2: **NOT OK**, excess sealant applied unevenly. Requires sealant to be removed and reapplied properly

- See **figure #4** below for examples of the correct and incorrect amount of sealant used

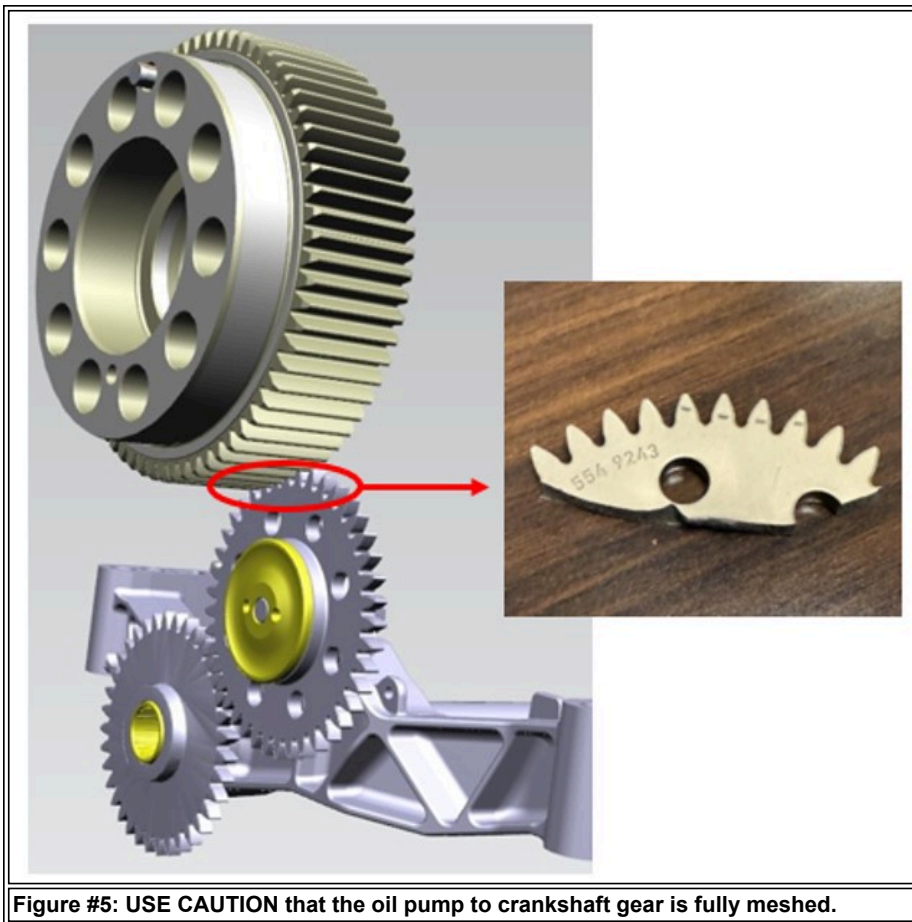
Make certain the lower oil pump gear is properly meshed with the new crankshaft gear. See figure #5, if the oil pump gear is NOT meshed, it will snap when the flywheel bolts are torqued, resulting in NO oil pressure on startup.

Figure #5: USE CAUTION that the oil pump to crankshaft gear is fully meshed.

14. Thread the two M20 guide pins into the crankshaft. Carefully position the new gear over the studs so that the alignment pin (dowel) in the gear aligns with the hole in the rear of the crankshaft. Make sure the gear fully bottoms out against the crankshaft and that **BOTH** the lower oil pump drive gear and upper idler gear are properly meshed. A clean plastic or rubber mallet may be needed to gently tap the gear side to side evenly to get it to fully seat.
