Special Processing Of Rear Axle Carriers

Topic number	LI35.10-P-078931
Version	2
Function group	35.10 - Complete rear axle
Date	5/12/26
Validity	Model 204, 212, 171, 172
Reason for change	GLK addition

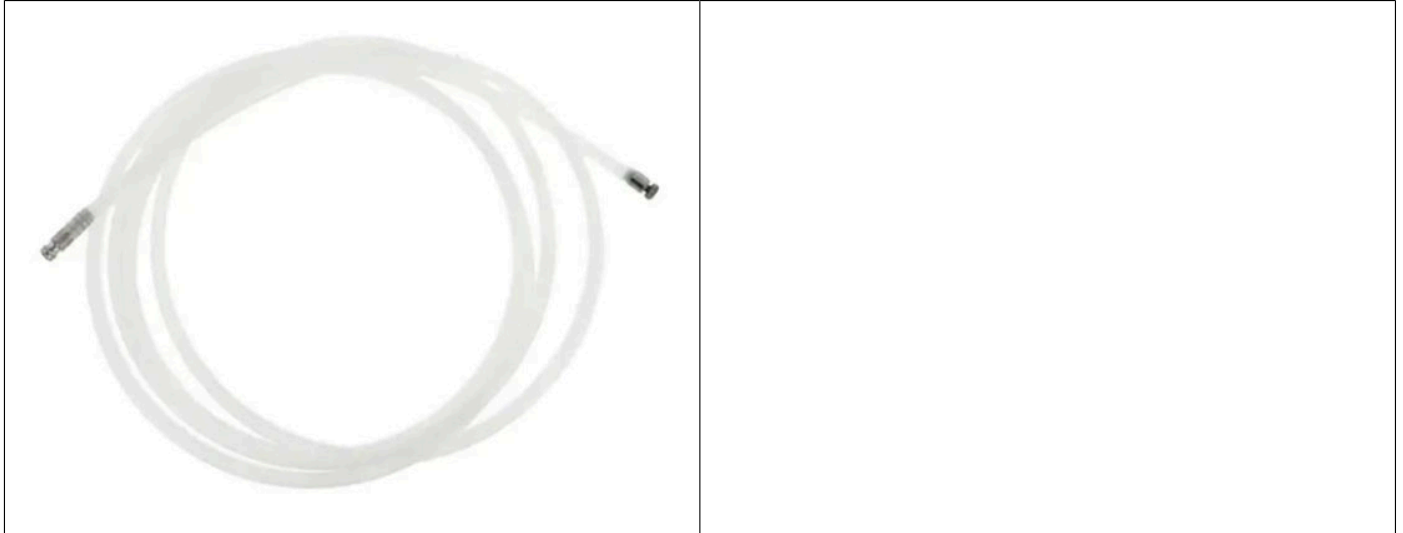
Note: Please utilize flexible wand (319-SAT1058826) along with the Cavity Preservation Gun (W 000 588 03 72 00) for cavity wax application to improve coverage and reduces labor efforts. The flexible wand may be obtained through the [Mercedes-Benz Standard Service Equipment Program](#) website.
