OEM Antenna Connections - Mercedes

Bulletin Type:	SRP	Publication Date:	May 2026
Bulletin #(s):	26-014	Make(s):	Jayco & Entegra Coach
Job Code(s):	<i>**If affected unit has a warranty remaining, submit your claim following the normal process.</i>	Model(s):	Melbourne, Melbourne Prestige, Granite Ridge, Condor, Qwest, Qwest SE,
Flat Rate(s):		Model Year(s):	2025-2026

Incident:	OEM Antenna Connections may not be fully made.
Affected Units:	2025 – 2026 Jayco Granite Ridge, Melbourne, Melbourne Prestige & 2025 – 2026 Entegra Coach Condor, Qwest, Qwest SE
Parts List: N/A	Parts List: N/A N/A
Misc. Tools & Supplies:	Screw Gun with Square Head & Phillips Bit Putty Knife/Flat Edge/Trim Tool Caulk Gun with Self Level Ratchet with T30 Torx Bit Heat Shrink/Electrical Tape SCREW,RTNR MIRGR .22" + (Contact Jayco Customer Service) SCREW,RTNR CAP MIRGR + (Contact Jayco Customer Service)
Parts Return Information:	N/A

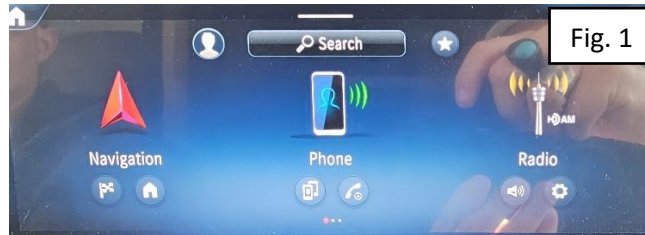
1. With the vehicle on and outside, activate the MBUX Mercedes interface on the touchscreen.
 - a. **Note: It is critical the unit is outside to test the antenna functionality as being indoors could prohibit the antenna from receiving a strong signal even if all of the appropriate connections are made to the OEM antenna.** (Figure 1)

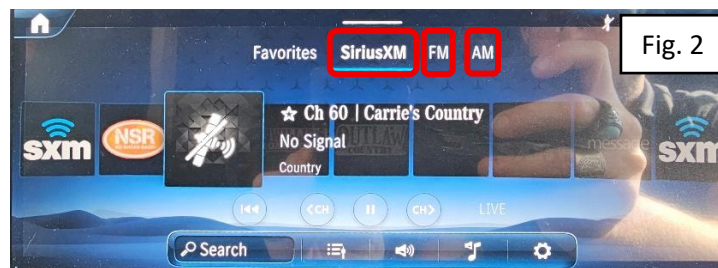
2. From the Home screen, Select "Radio". (Figure 2)
 - A. Select "SiriusXM" and test for functionality. You will want to see the station cards pull up and receive clear audio.
 - B. Select "FM" repeat the process to ensure the station cards appear and receive clear audio.
 - C. Select "AM" repeat the process to ensure the station cards appear and receive clear audio.

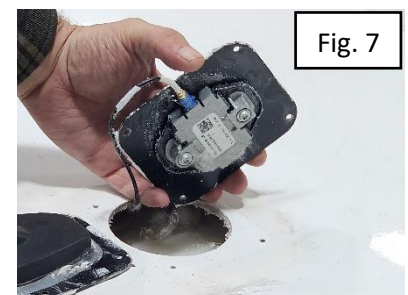
8. Verify the connection is made between the harness and the SiriusXM antenna and that the connection is secure in the antenna. Replace the antenna on the roof and re-secure using the original 4 fasteners removed from the antenna. (Figure 7)

9. Use a screw gun with square head bit to remove the second OEM antenna.

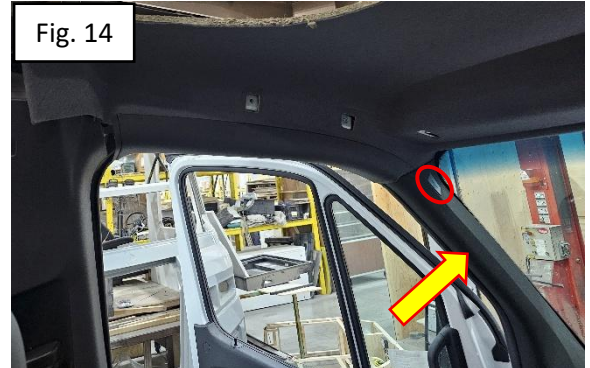
- Use a flat head or trim tool to remove the small rectangular cover on the driver side A pillar. Then use a screw gun with square head bit to remove the fastener from under the cover. (Figure 14)
- Remove the front ABS driver side A pillar cover. (Figure 14)

- Re-install the OEM front driver side pillar cover using the same fasteners originally removed, then re-install the rectangular cover. (Figure 14)
- Re-install the metal clip for the OEM hook, then re-install the ABS hook cover. (Figure 13)
- Re-install the driver side sun visor and grab handle using the original X4 bolts removed. (Figure 12)
- Re-secure the wing wall to the cab over area. (Figure 11)
- Re-install the x3 ABS U-channels to cap off the cab over area using the original fasteners that were removed. (Figure 10)

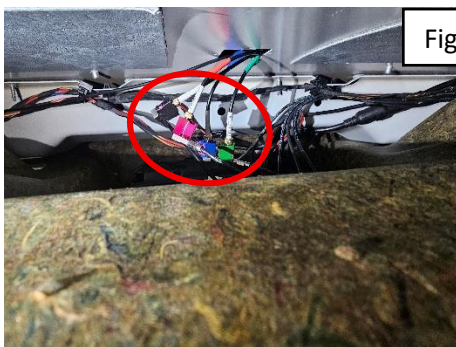
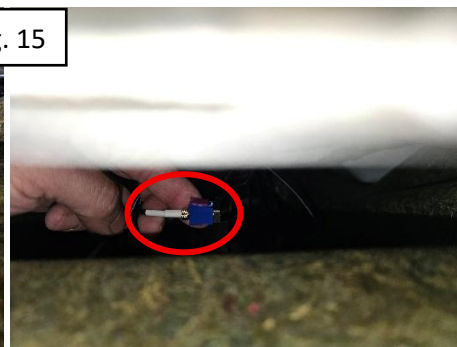
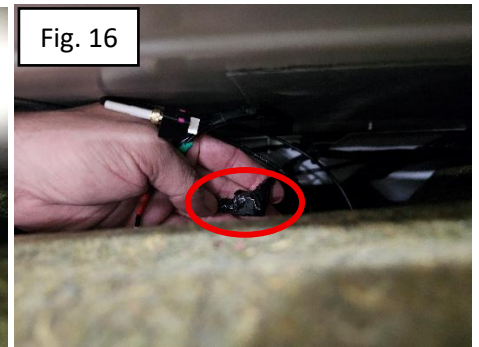
- You should now be able to access and view the connections for the OEM antenna. There will be 4 connections under the center overhead console and one on the drive side.
 - Note: The connection on the driver's side may fluctuate in location. Typically, it is towards the front of the cab but can be towards the rear of the cab.** (Figure 15)
- Confirm all the connections are properly made. Use heat shrink or electrical tape to reinforce all the connections. (Figure 16)

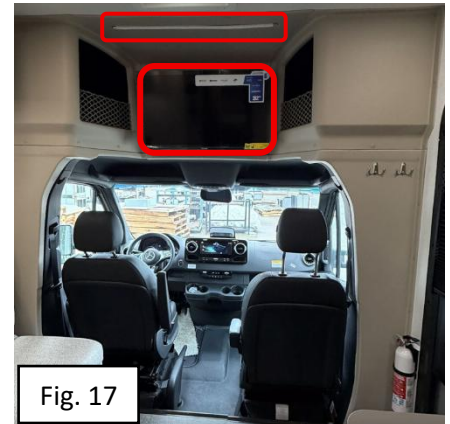
1. Remove any accessories mounted to the front cab over plastics or preventing them from being removed. (Figure 17)
 - A. Remove the Front TV (If floorplan has cab over tv option)
 - B. Remove the TV Bracket (If floorplan has cab over tv option)
 - C. Remove the upper "Luna" light
2. Use a flat head or trim tool to remove the inserts in the retainers for all the cab over plastics.
 - a. **Note: This will grant you access to the fasteners securing the ABS cab over walls.** (Figure 18)
3. Remove the Cab over plastics in the following order: (Figure 18)
 1. Front Center Cab Over (with TV if option Selected)
 2. D/S Upper Corner
 3. P/S Upper Corner
 4. D/S Wing

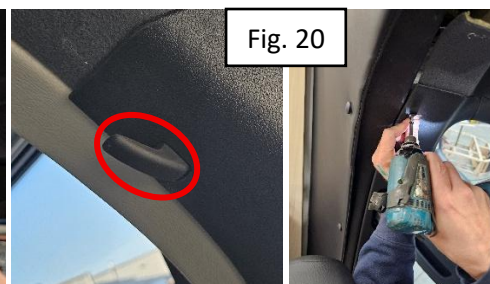
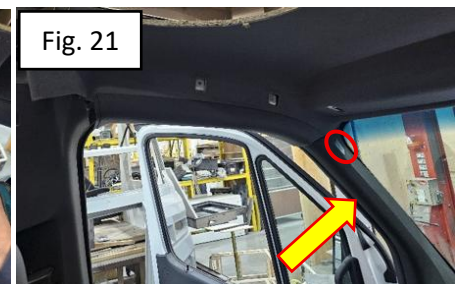
4. With the plastics removed, use a ratchet with T30 Torx bit to remove the X4 OEM bolts for the Driver side sun visor and grab handle. (Figure 19)
5. Use a flat head or trim tool to remove the drive side abs hook. With the metal clip visible, use a screw gun with Phillips bit to remove the clip. (Figure 20)
6. Use a flat head or trim tool to remove the small rectangular cover on the driver side front A pillar. Then use a screw gun with square head bit to remove the fastener from under the cover. (Figure 21)

10. Re-install the OEM driver side A pillar cover using the same fasteners originally removed, then re-install the rectangular cover. (Figure 21)

11. Re-install the metal clip for the OEM hook, then re-install the ABS hook cover. (Figure 20)

12. Re-install the driver side sun visor and grab handle using the original X4 bolts removed. (Figure 19)

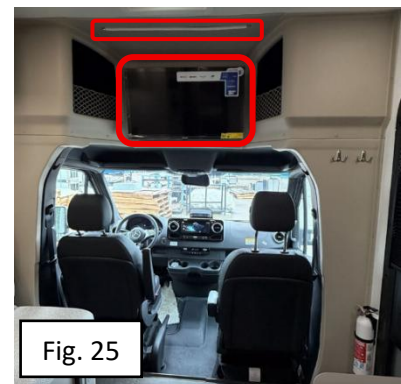
14. Re-install any components removed from the ABS. (Figure 25)

- A. Upper "Luna" Light
- B. TV Bracket (If floorplan has cab over tv option)
- C. TV (If floorplan has cab over tv option)
