SIB 64 03 20

CENTER CONSOLE / CUP HOLDER GETS HOT WHEN THE HEAT IS ON

2026-05-04

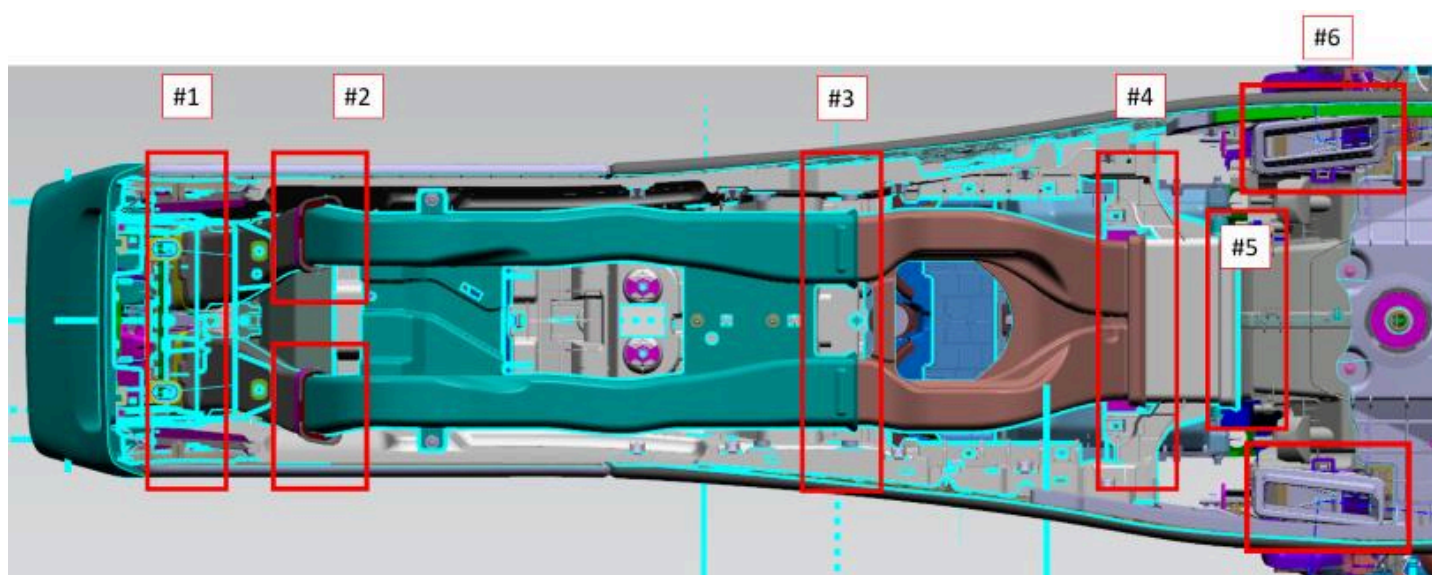
The air ducts may not be properly connected, this allows heated air to leak out in this area.

The foam material that seals between the ducts may be out of position, not held by the mounting adhesive and squashed allowing for an air leak. This leak can occur at any of these 6 junction locations:

1-Check foam seal material at duct connections and replace foam as needed. Ensure ducts are properly overlapped on installation.

2-Replace rear air ducts.

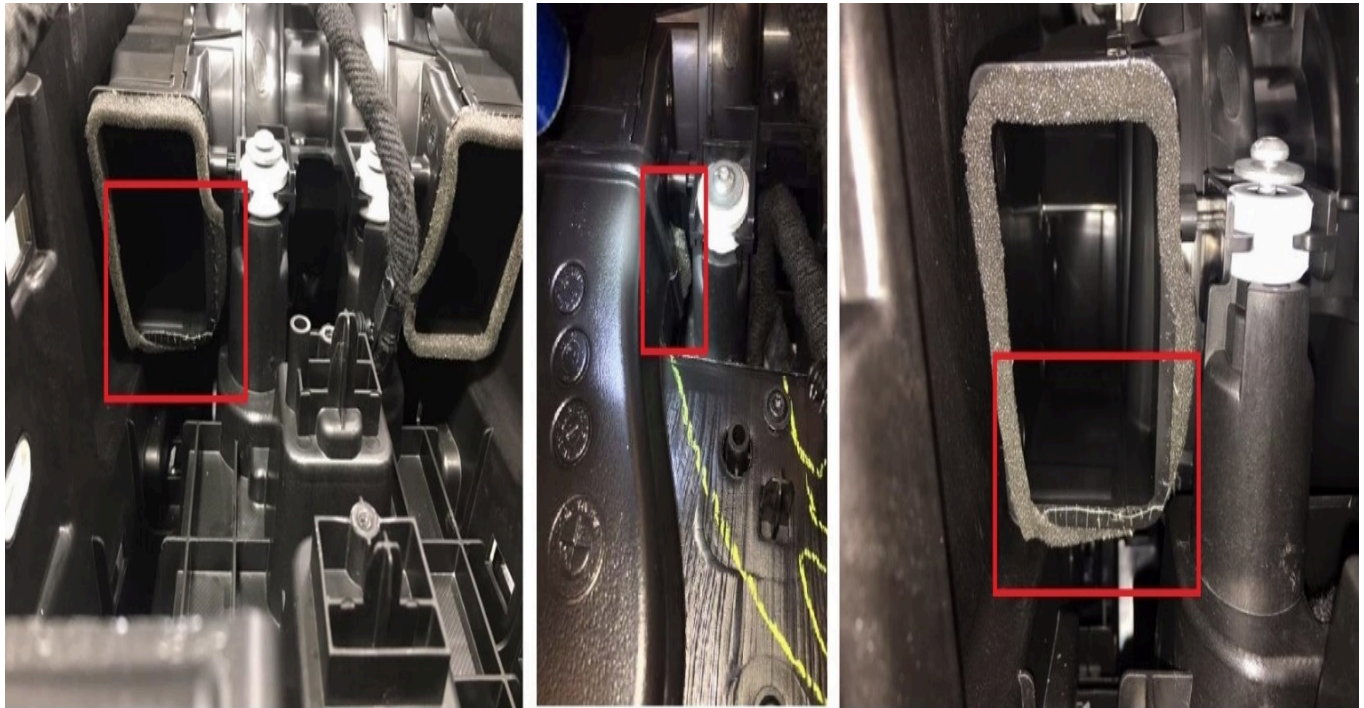
Not OK: Blower Assembly foam insulation found rolled, not positioned in correct, location allowing air to leak.

1. Check whether the air ducts beneath the center console are properly assembled. They should overlap when installed.

If one or more air ducts are not properly mounted or connected, disassemble these and install them correctly. Observe point 2 when installing!

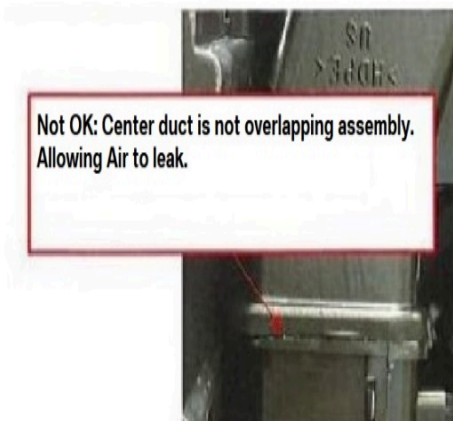
Not OK: Center duct is not overlapping assembly. Allowing Air to leak.

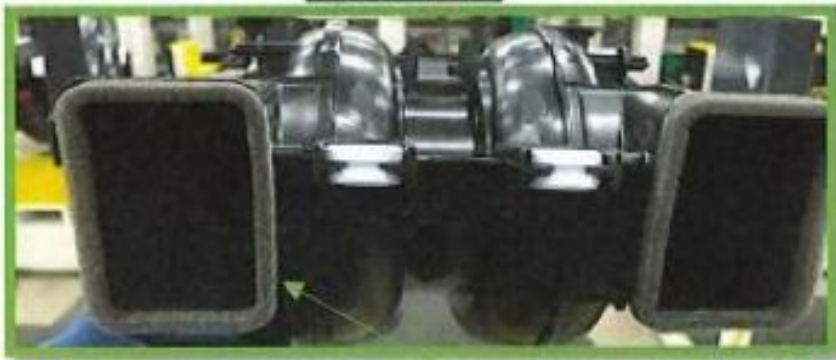
OK: Blower Assy. foam insulation in right position.

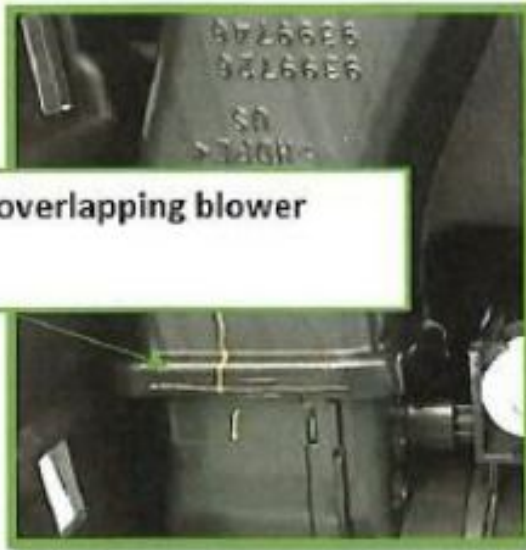
OK: Center duct is overlapping blower assy.

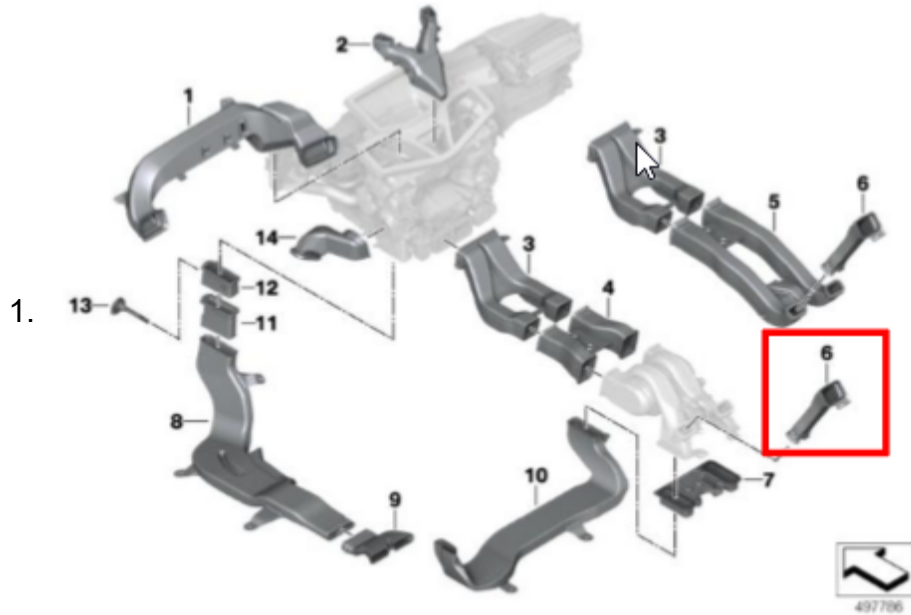
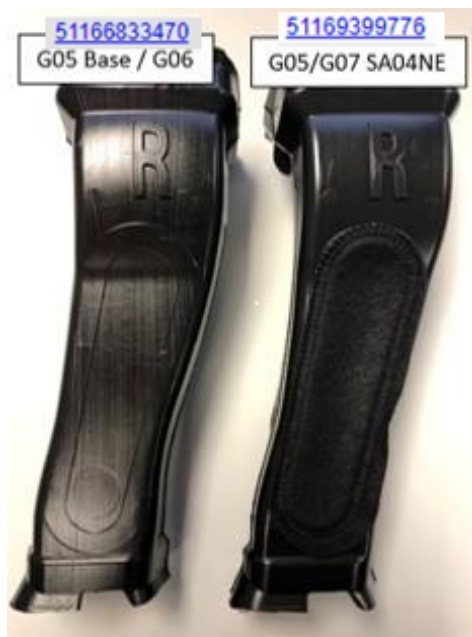
Vehicles that utilize these fleece material lined ducts can be visually identified by their having a second blower motor located in the center console, and the addition of B pillar vents.

To improve interior acoustic levels and circulate some air into the console, the rear air ducts with part number 51 16 9 399 775 (left side) and 51 16 9 399 776 (right side) are utilized on the G07 and optionally on the G05. These ducts have a hole that is covered in fleece material.

To maximize heat reduction within in the center console, the rear air ducts with part number 51 16 9 399 775 (left) and 51 16 9 399 776 (right) **must be replaced in all cases** with base model rear air ducts with part number 51 16 6 833 469 (left) and 51 16 6 833 470 (right).

NOTE: By installing the base model rear air ducts with part number 51 16 6 833 469 (left side) and 51 19 6 833 470 (right side) these fleece cutouts are removed maximizing the heat reduction in the center console. **The base ducts may impact acoustics of rear HVAC.**
