## Play or Noise on the Height Adjuster or in the Seat Rail of the Front Seats

Topic number	LI91.10-P-076097
Version	5
Function group	91.10 - Front seats
Date	5/19/26
Validity	BR 206 / 214 / 294 / 295 / 296 / 297 / 254 up to cleanpoint: Production status higher than or equal to E108
Reason for change	Addition of Damage Code

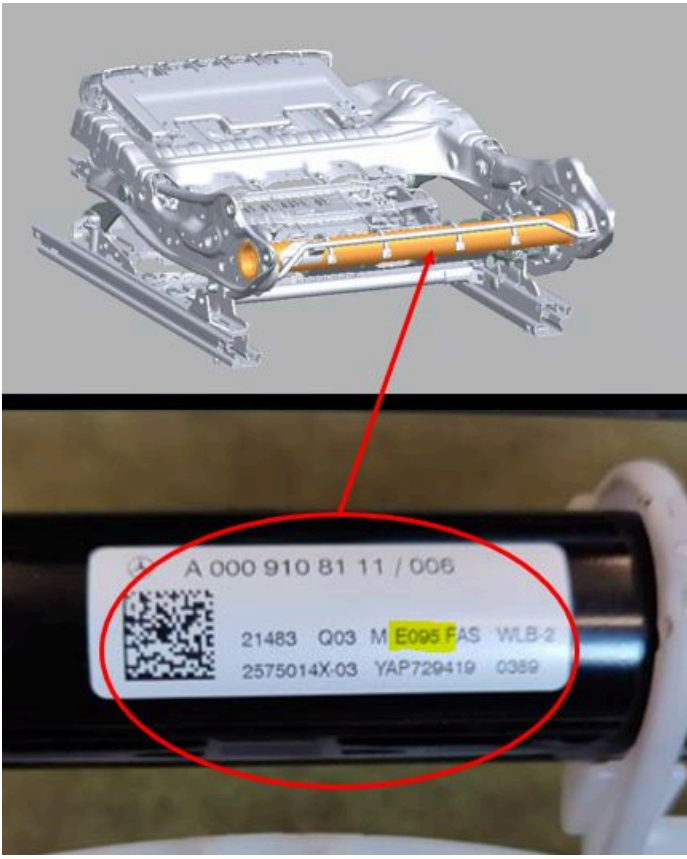
File	Description
<p data-bbox="116 271 318 300"><a href="#">Pic.1 seat label.jpg</a></p>

#### 1. Inspect Seat Height Adjuster Barcode Label (See Pic.1)

- Locate the barcode label on the cross tube of the seat height adjuster.
- In isolated cases, the barcode label may be located on the front side of the cross tube. If not visible, remove the seat cushion to access the label.

<p data-bbox="805 271 1224 300">Example of barcode label on cross tube</p>

**If Production Status is LOWER than E108 #** Replace the seat frame base with the height adjuster motor.

**If Production Status is E108 or HIGHER #** Do NOT replace parts. Please submit a TIPS case to the Body/Chassis/Entertainment inbox and attach:
