REFERENCE:	TSB: 23-018-26 GROUP: 23 - Body	Date:	May 21, 2026	REVISION:	—
VEHICLES AFFECTED:	2025 - 2026 (DT) RAM 1500 Pickup This bulletin applies to vehicles built on or after May 26, 2025 (MDH 0526XX) and on or before February 11, 2026 (MDH 0211XX) equipped with Blind Spot And Cross Path Detection (Sales Code XAN) and one of the following: <ul style="list-style-type: none"> • Accent Color Premium Power Mirrors (Sales Code GT4). • Black Base Power Mirrors (Sales Code GT6). • Chrome Premium Power Mirrors (Sales Code GU4). • Black Premium Power Mirrors (Sales Code GUK). 			MARKET APPLICABILITY: <input checked="" type="checkbox"/> NA <input type="checkbox"/> MEA <input type="checkbox"/> SA <input type="checkbox"/> IAP <input type="checkbox"/> EE <input type="checkbox"/> CH NOTE: This bulletin applies to the North America markets.	
CUSTOMER SYMPTOM:	Customers may comment on the following: <ul style="list-style-type: none"> • Wind noise or whistle noise heard from the driver door mirror area while driving.

CAUSE:	Mirror access cover deformation

This bulletin involves replacing the left-hand door mirror access cover.

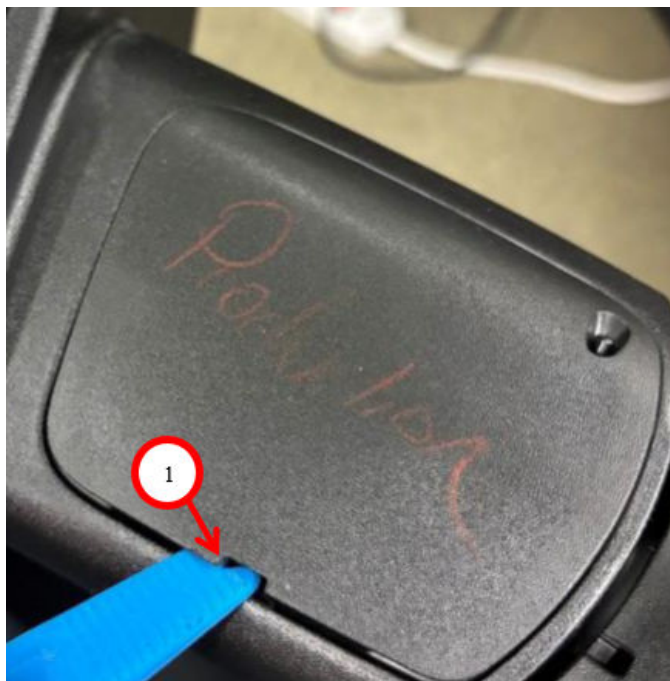
Fig. 2
Loosen Access Cover

- Using a trim stick, loosen the mirror access cover from the mirror assembly [Fig. 2](#).

1 - Use Trim Stick To Loosen Cover At Insert Slot

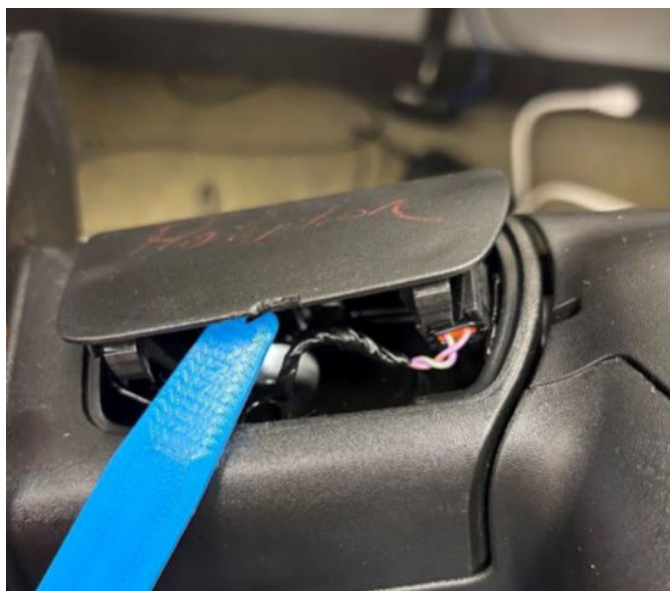
Fig. 3
Access Cover

- Pull the mirror access cover away from the mirror to gain access to the outside ambient temperature sensor [Fig. 3](#).

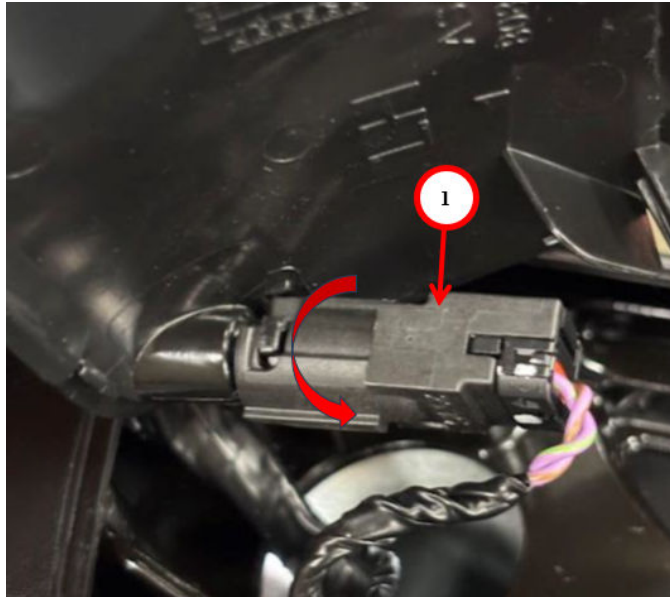
**Fig. 4**

4. Flip the mirror access cover and grab the outside ambient temperature sensor, twist counter-clockwise and pull to remove [Fig. 4](#).

Remove Outside Ambient Temperature Sensor

1 - Outside Ambient Temperature Sensor

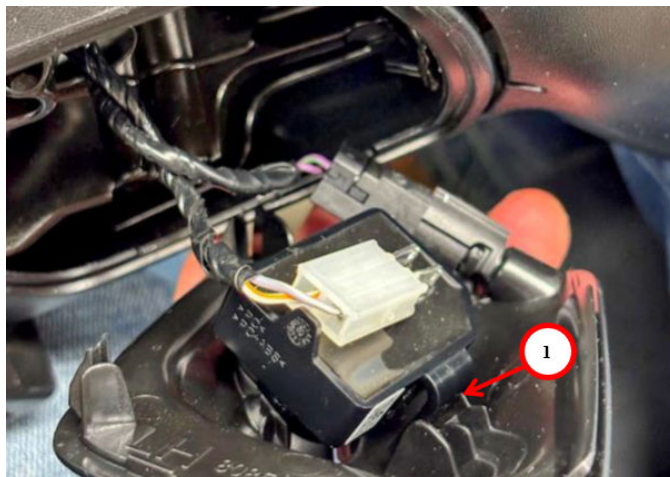
**Fig. 5**

5. If equipped, push in the tab on the logo lamp to remove it from the access cover [Fig. 5](#).

Removed LOGO Lamp From Access Cover

1 - Logo Lamp Tab

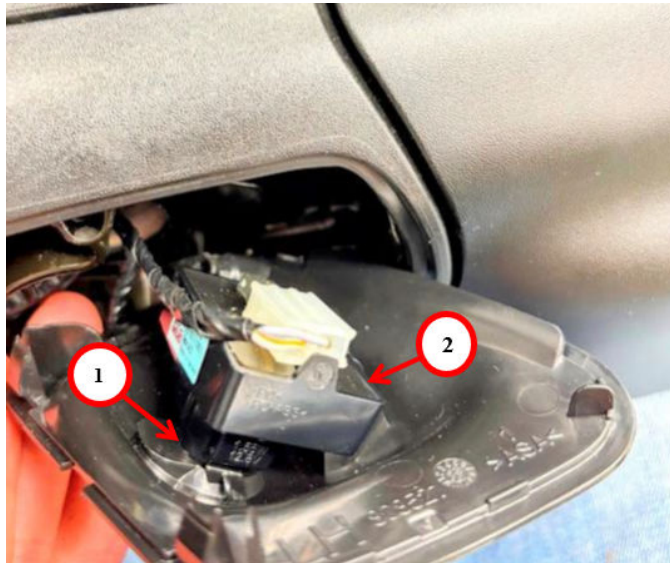
Fig. 6
Install Logo Lamp

8. If equipped, place the logo lamp into the access tab. Depress the lamp until an audible click is heard [Fig. 6](#).

1 - Position Logo Lamp To Mirror Access Cover Tab
2 - Logo Lamp

NOTE: Ensure that the lip goes under the A-surface hole before snapping into place.

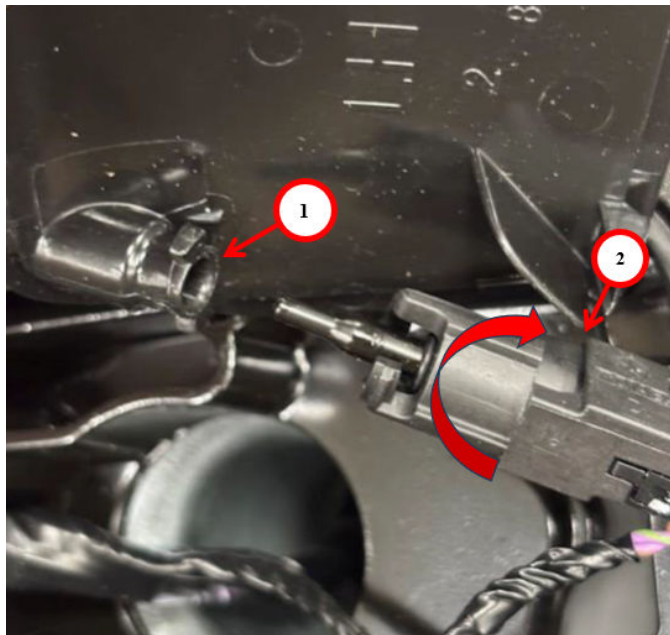
Fig. 7
Install Outside Ambient Temperature Sensor

9. Install the outside ambient temperature sensor to the mirror access cover. Twist clockwise to lock into place [Fig. 7](#).

1 - Outside Ambient Temperature Sensor Installation Port
2 - Outside Ambient Temperature Sensor

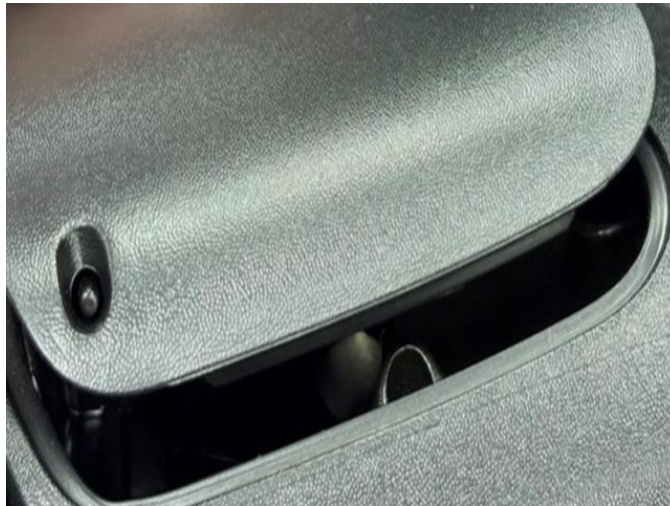
Fig. 8

10. Line up the mirror access cover lip to the bottom edge of the outer base of the mirror assembly [Fig. 8](#).

Mirror Access Cover To Mirror Alignment

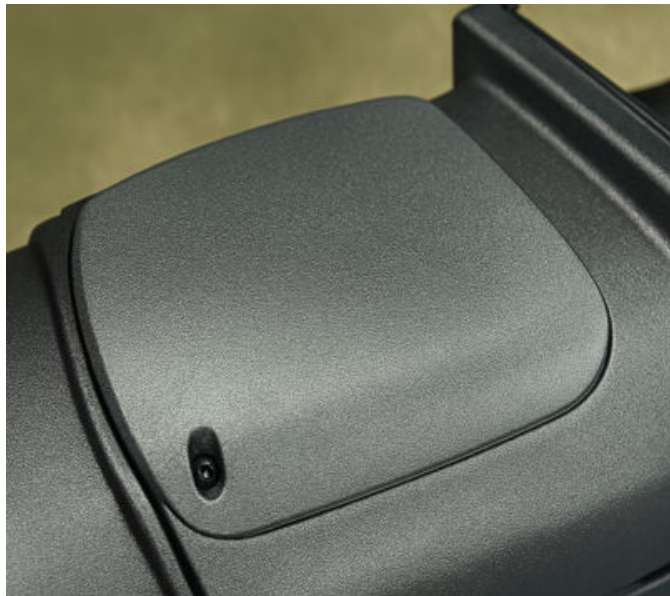
Fig. 9

11. After the ribs align, push down and slide towards the insert hole side [Fig. 9](#).

Mirror Access Cover Installation

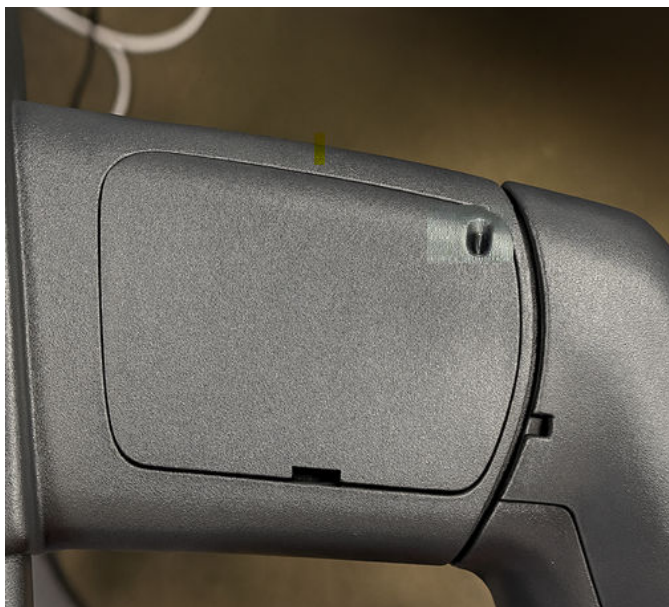
Fig. 10
Properly Installed Mirror Access Cover

12. Push down on the insert clip side of access cover until you hear an audible pop Fig. 10.

NOTE: Ensure the front lip is under the base cover before pushing down.

13. Inspect the mirror access cover installation. Confirm the access cover is properly seated, flush, and not loose. Verify that the outside ambient temperature sensor tip is visible through the sensor hole in the access cover.
