## Detachment of the Maybach Emblem at the C-pillar

Topic number	LI88.85-P-080644
Version	1
Function group	88.85 - Trim strips
Date	5/26/26
Validity	Model series 223.9 with code 5B2, without code PMA, up to production date July 28, 2025
Reason for change

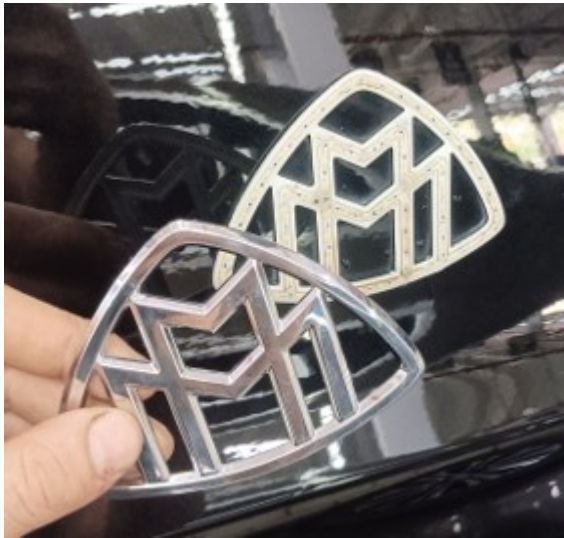
The Maybach emblem at the C-pillar is detached from the vehicle

Attachments	
File	Description
Bild1.jpg	Detachment of the Maybach emblem at the C-pillar

The adhesive bond has failed

The adhesive has been optimized.

Perform replacement of the Maybach emblem on both sides of the vehicle.

The old part numbers include the updated adhesive and may be used if the newer parts are not available.

WIS-References		
Document number	Title	Note
AR88.40-P-4051S	Remove/install the Maybach emblem	Replace on both sides
