Transmission Oil Cooler Lines Rubbing APU Coolant Lines

FIELD SOLUTION: Fix as Fail

- Gen 5 Cascadia WST 47x 49x

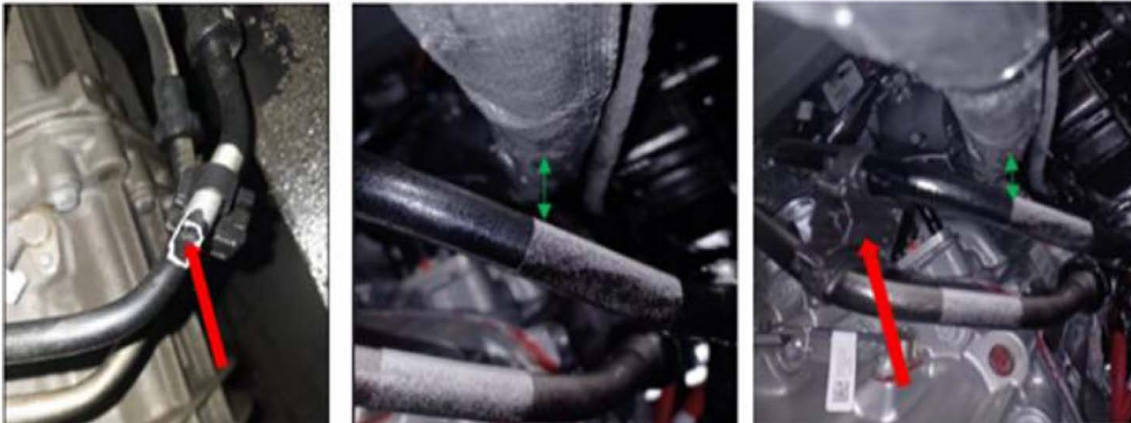
VISUALIZATION:

- Nylon Transmission oil cooler lines if not fastened correct can rub & chafe & eventually leak at low mileage. If caught early, lines are replaced. If not caught quickly the entire transmission often must be replaced.

- Plant Work instruction was updated to address the routing requirements, Stating not to deviate or add any extra ties or clamps.
- Re-Training at the plants per the updated work instruction implemented & ongoing.

- LTCA Production – Plant Updates – Add Transmission Cooler lines to Standard Routing and Clipping Guidelines.
- Verification 30/60/90 Day process audits to be complete by 7/30/26
