| <b>Subject:</b><br><br><b>RATTLING NOISE FROM SECOND SEAT UNDER VARIOUS VEHICLE SPEEDS AND ROAD CONDITIONS</b> | <b>Bulletin No.:</b> 09-017/26 |
| | <b>Last Issued :</b> 05/20/2026 |

2024-2026 CX-90 with VINS lower than JM3KK\*\*\*\*\*390346 (produced before March 17, 2026)

2025-2026 CX-70 with VINS lower than JM3KJ\*\*\*\*\*352226 (produced before March 17, 2026)

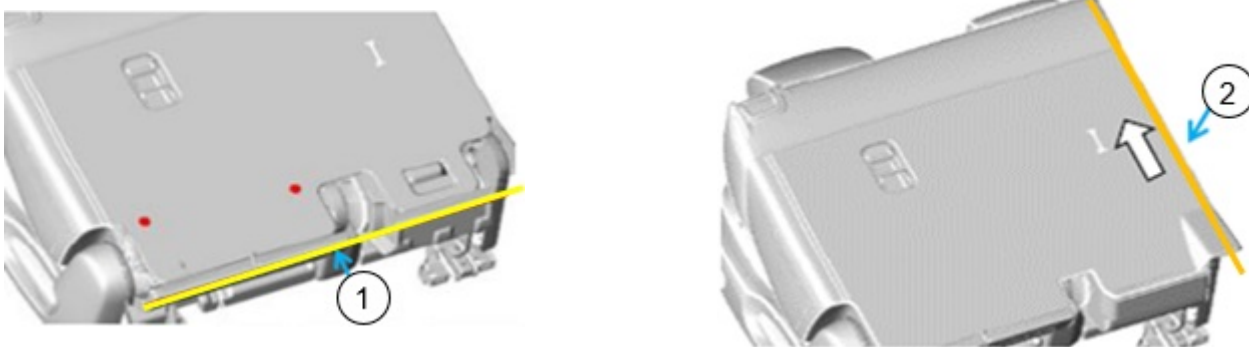
1. Verify the customer concern.
2. Replace the armrest hinge cover with the improved part according to the procedure below.
  - a. Remove the back panel trim.
    - (1) Remove the rear back panel lower finisher.
    - (2) Lift the inner side fastener (clip).

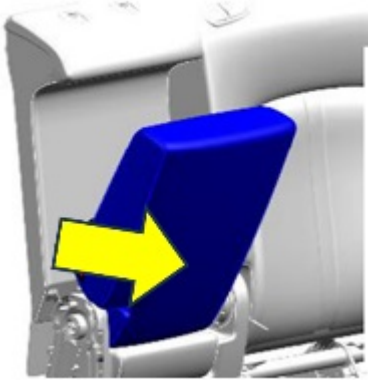
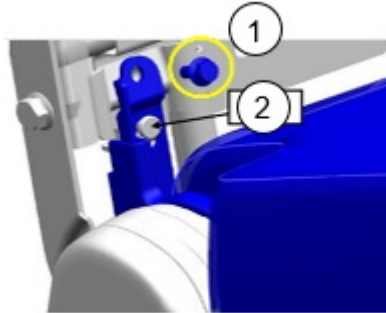
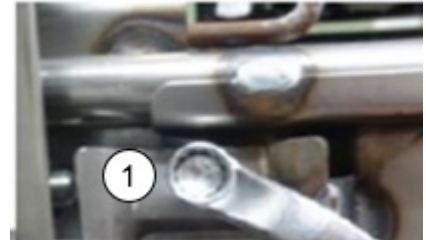
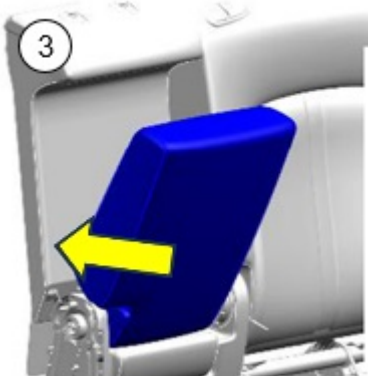
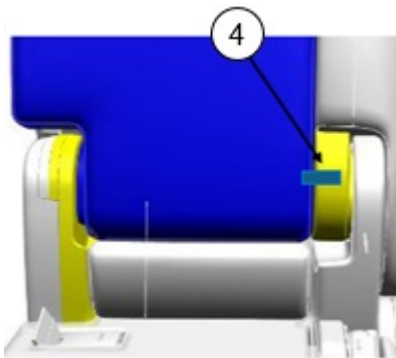
- b. Remove the armrest. (1) Remove the bolt that secures the armrest by inserting a socket wrench into the slit in the urethane. (Socket size: 10 mm)  
(2) Lift the armrest upward to disengage the shaft from the bracket.  
(3) Pull the armrest diagonally to remove it from the vehicle.  
(4) At this time, the armrest rotation shaft will come off.

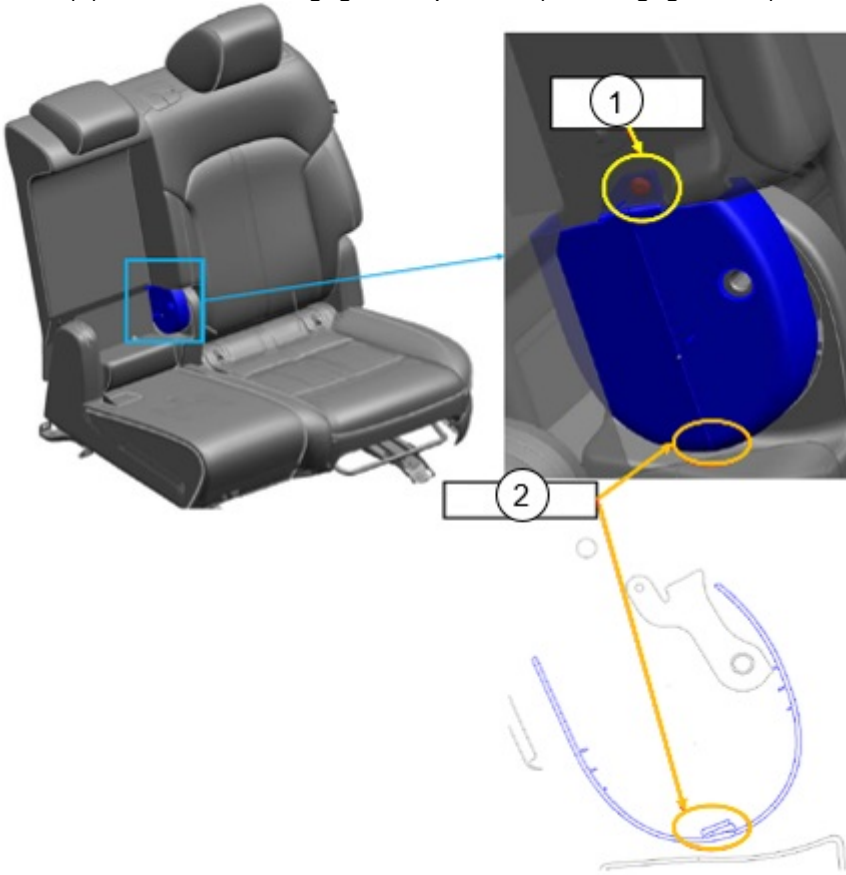
- c. Replace the armrest hinge cover. (1) Peel back the back trim and remove the screw.  
 (2) Release the engagement portions (claw engagements).
