RSB-26-26-001-1: HVAC Sealant Application

Document Type	Technical Service Bulletin
Date	May 14, 2026
Affected Region(s)	USA
Affected Model(s)	R1T, R1S
Model Year(s)	2022-2024
Approximate Build Dates	September 2021-April 2024

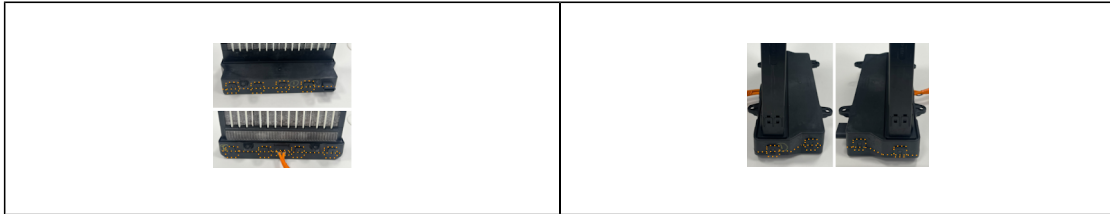
1. Apply a bead of Lexel sealant around the entire case joint.

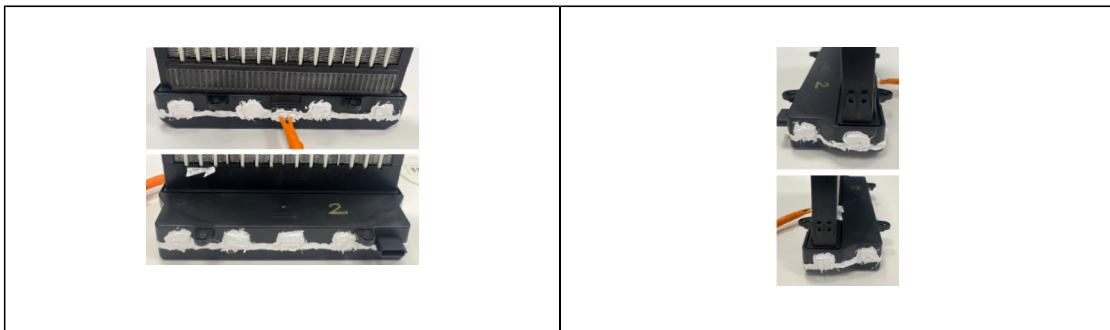
2. Spread the Lexel sealant, ensuring coverage on all clipping features, around the orange wire harness, and under the low voltage connector.

3. Allow 15 minutes for the sealant material to dry.
4. Reinstall: Heater, HVAC, Cabin (refer to service manual procedure 266420010).
5. Continue to the next section.

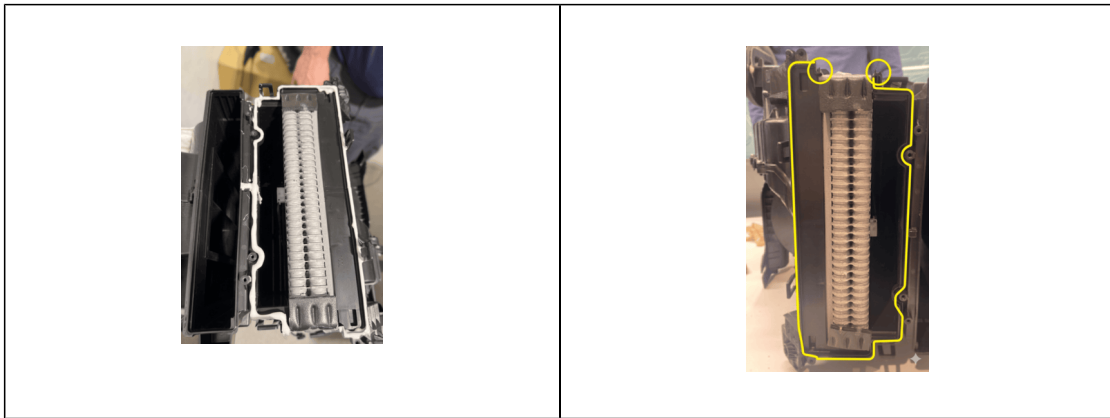
2. Seal the HVAC drip pan using Lexel sealant.

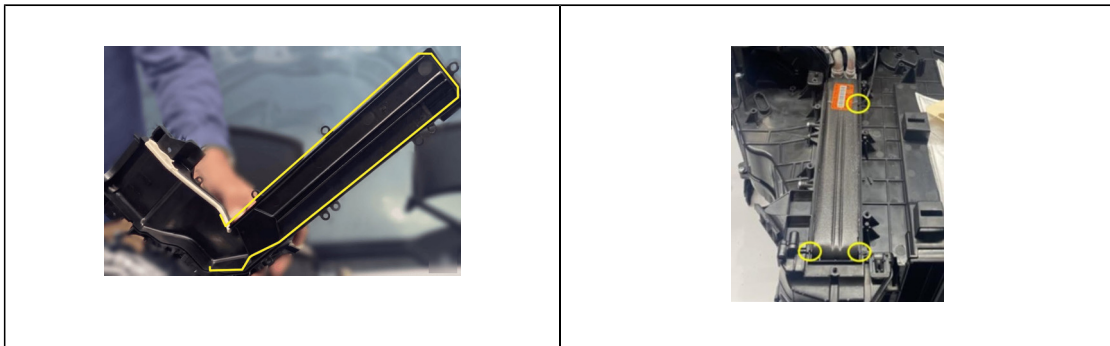
3. Seal the HVAC side cover using Lexel sealant.

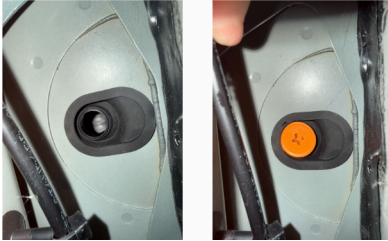
7. Install the R1 Body HVAC Drain Gasket.

8. Replace: Drain Valve, Front HVAC Assembly (refer to service manual procedure 266468010). The drain plug should still be able to move up and down after installation, not fixed in place.
