Applicable Vehicles					
Model(s)	Year	Eng. Code	Trans. Code	VIN Range From	VIN Range To
All	2018 - 2026	All	All	All	All

Revision Table			
Instance Number	Published Date	Version Number	Reason For Update
2081638/1	05/19/26	00-26-01	Original publication.

Determining fluid leakage versus seepage.

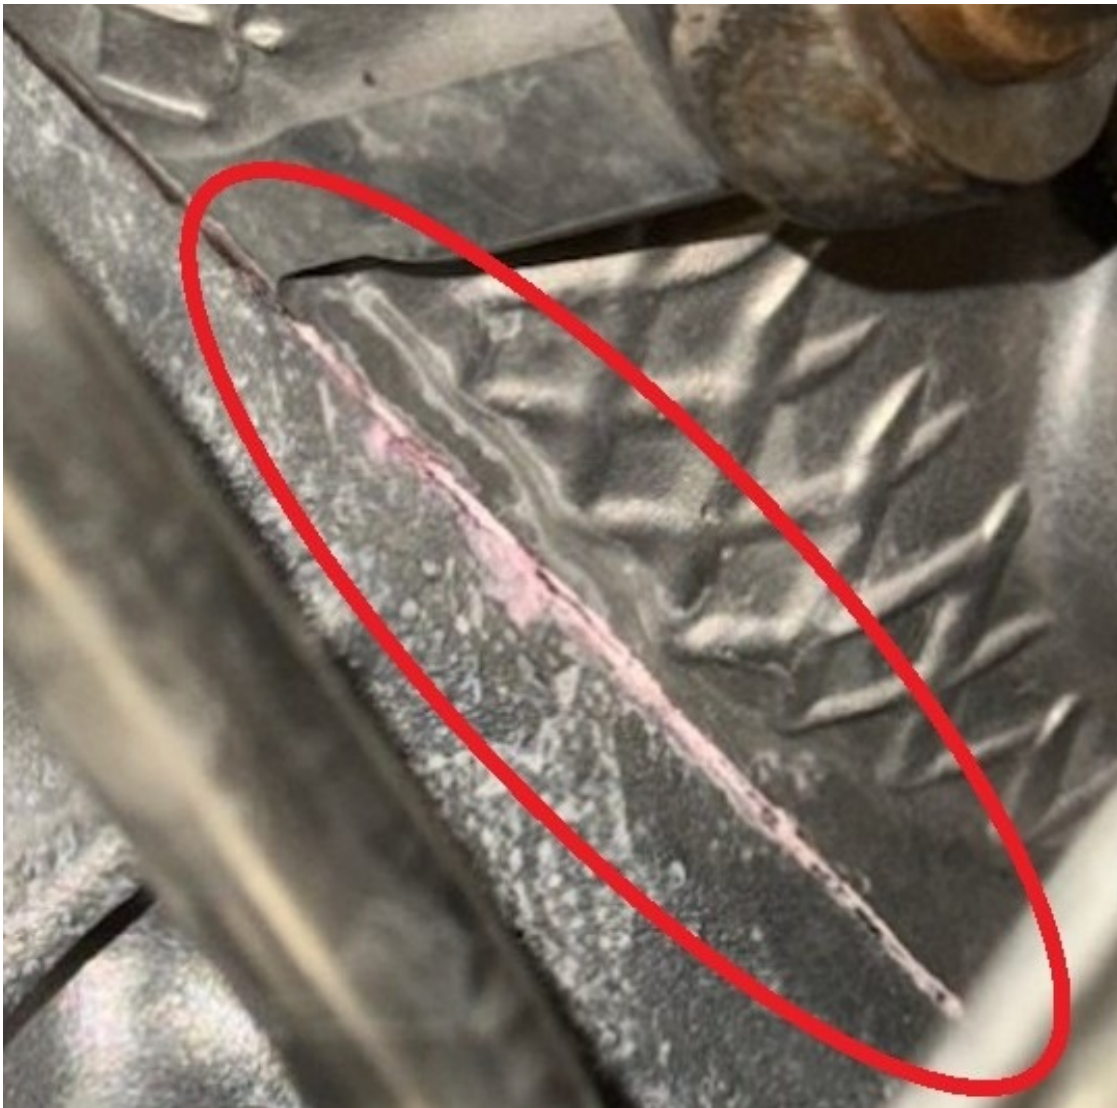
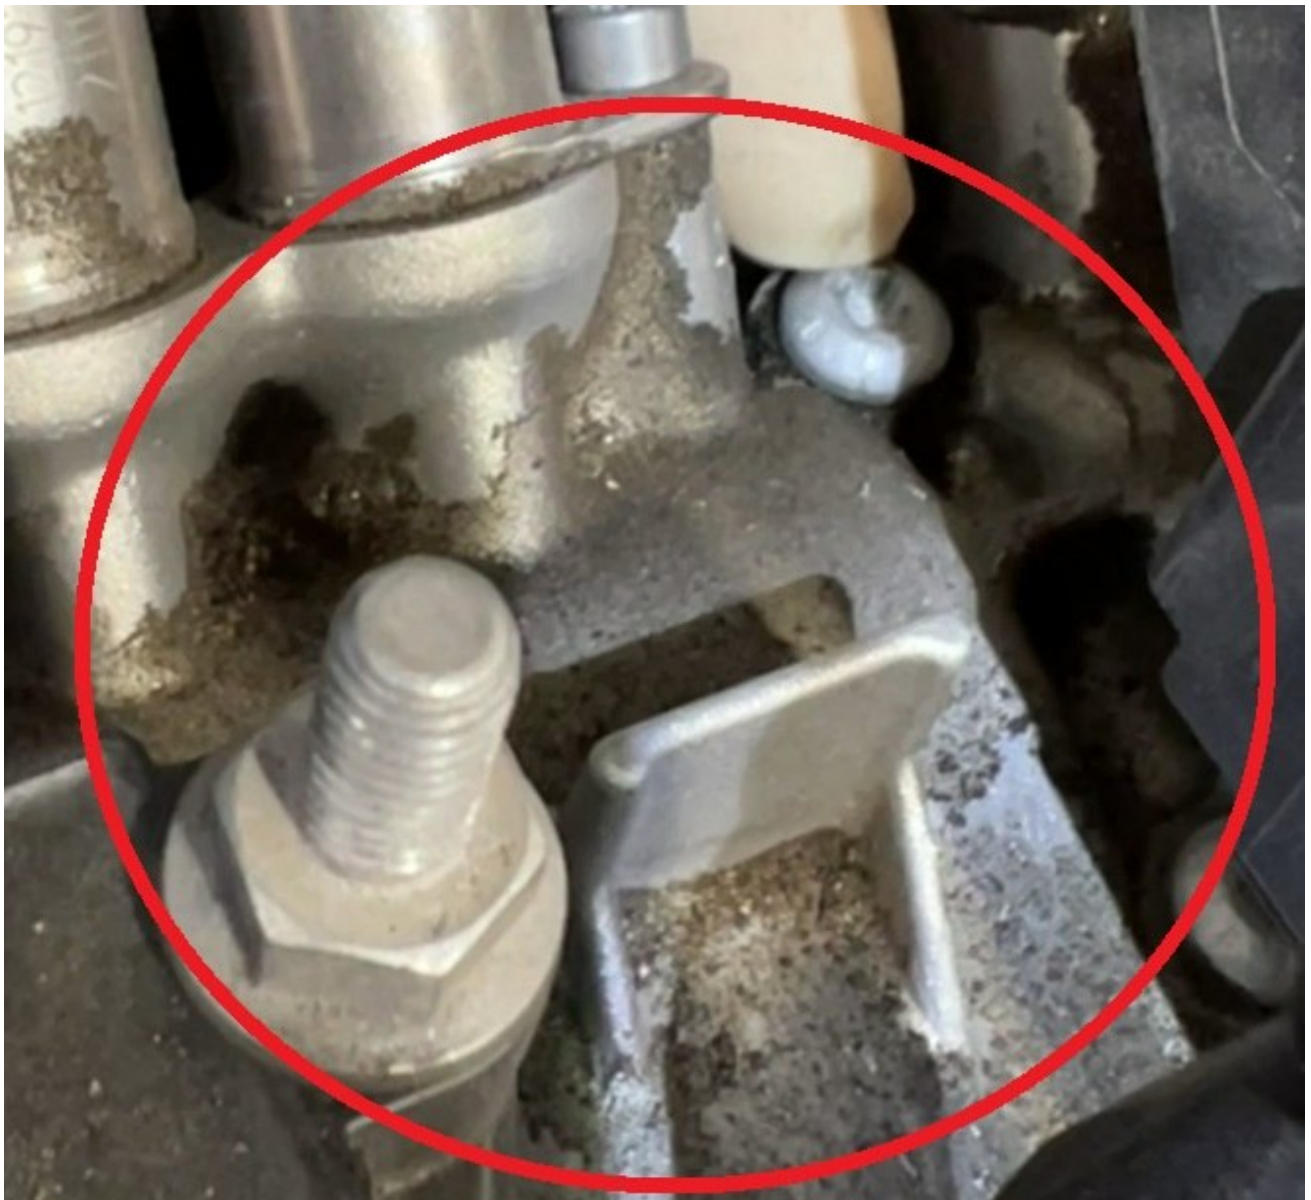
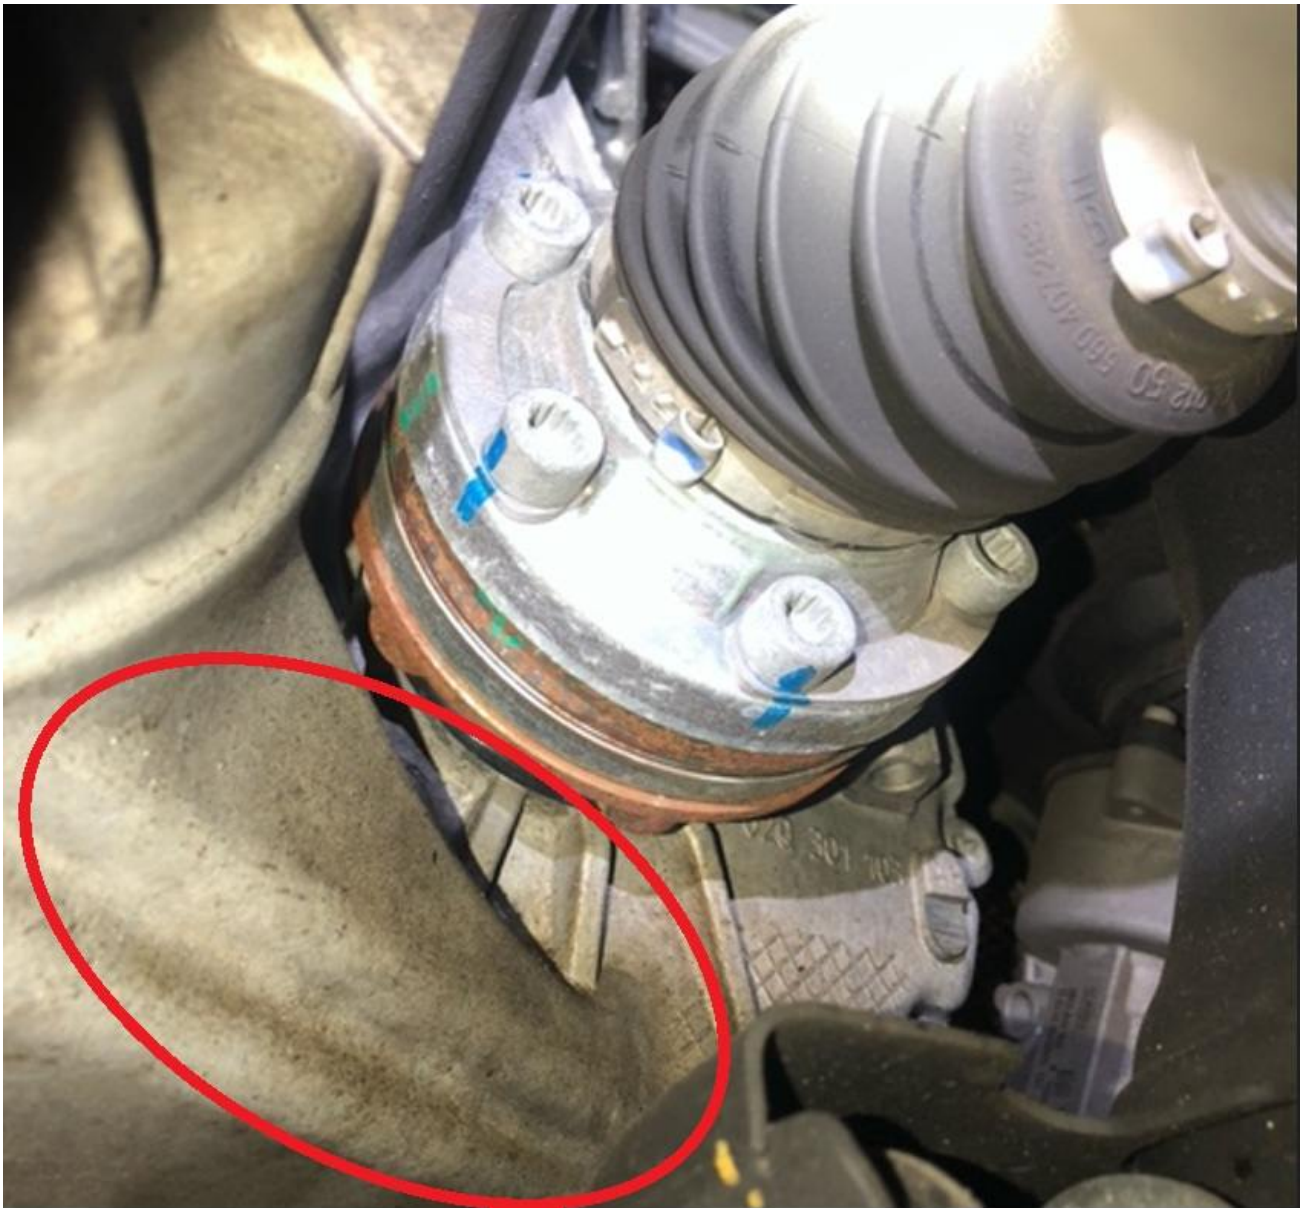
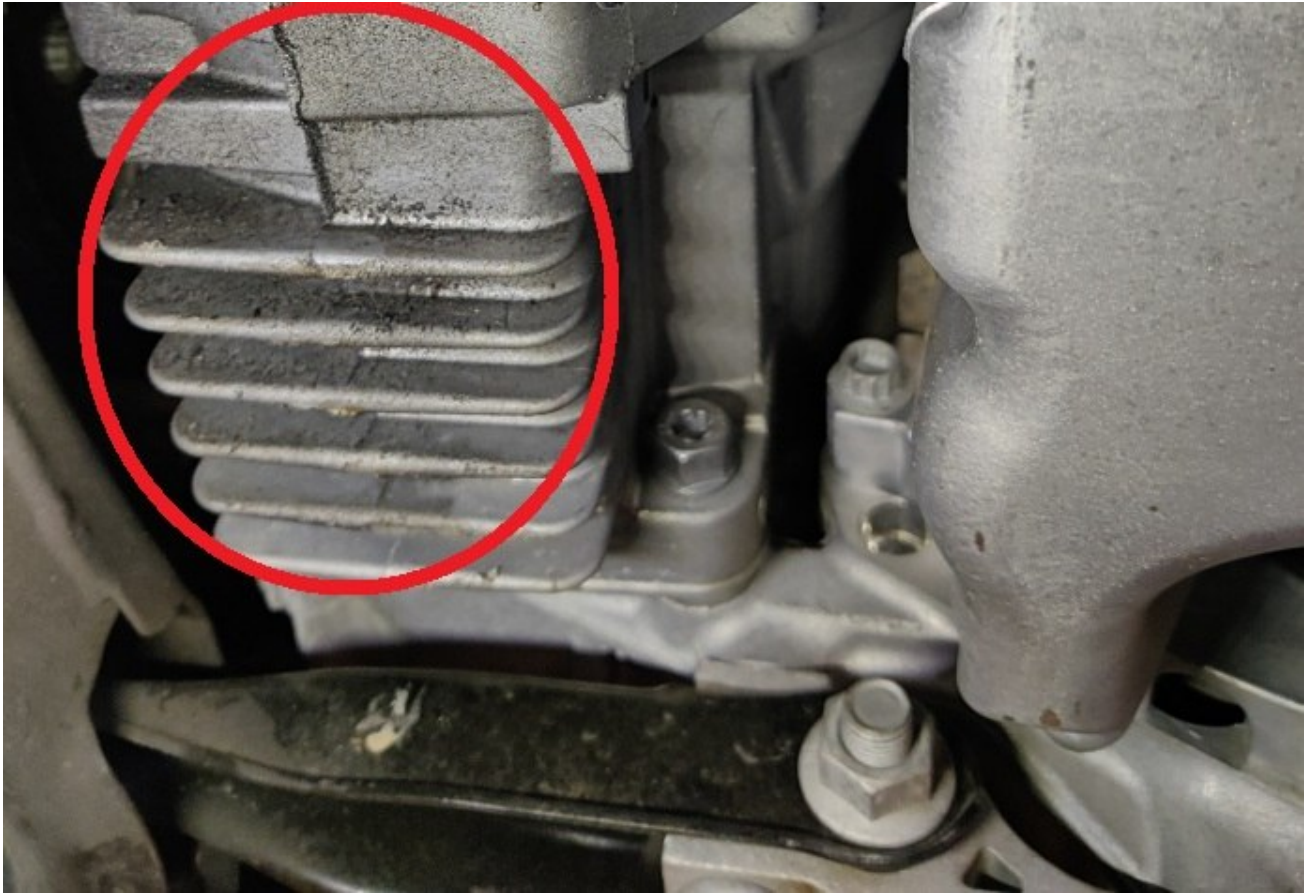
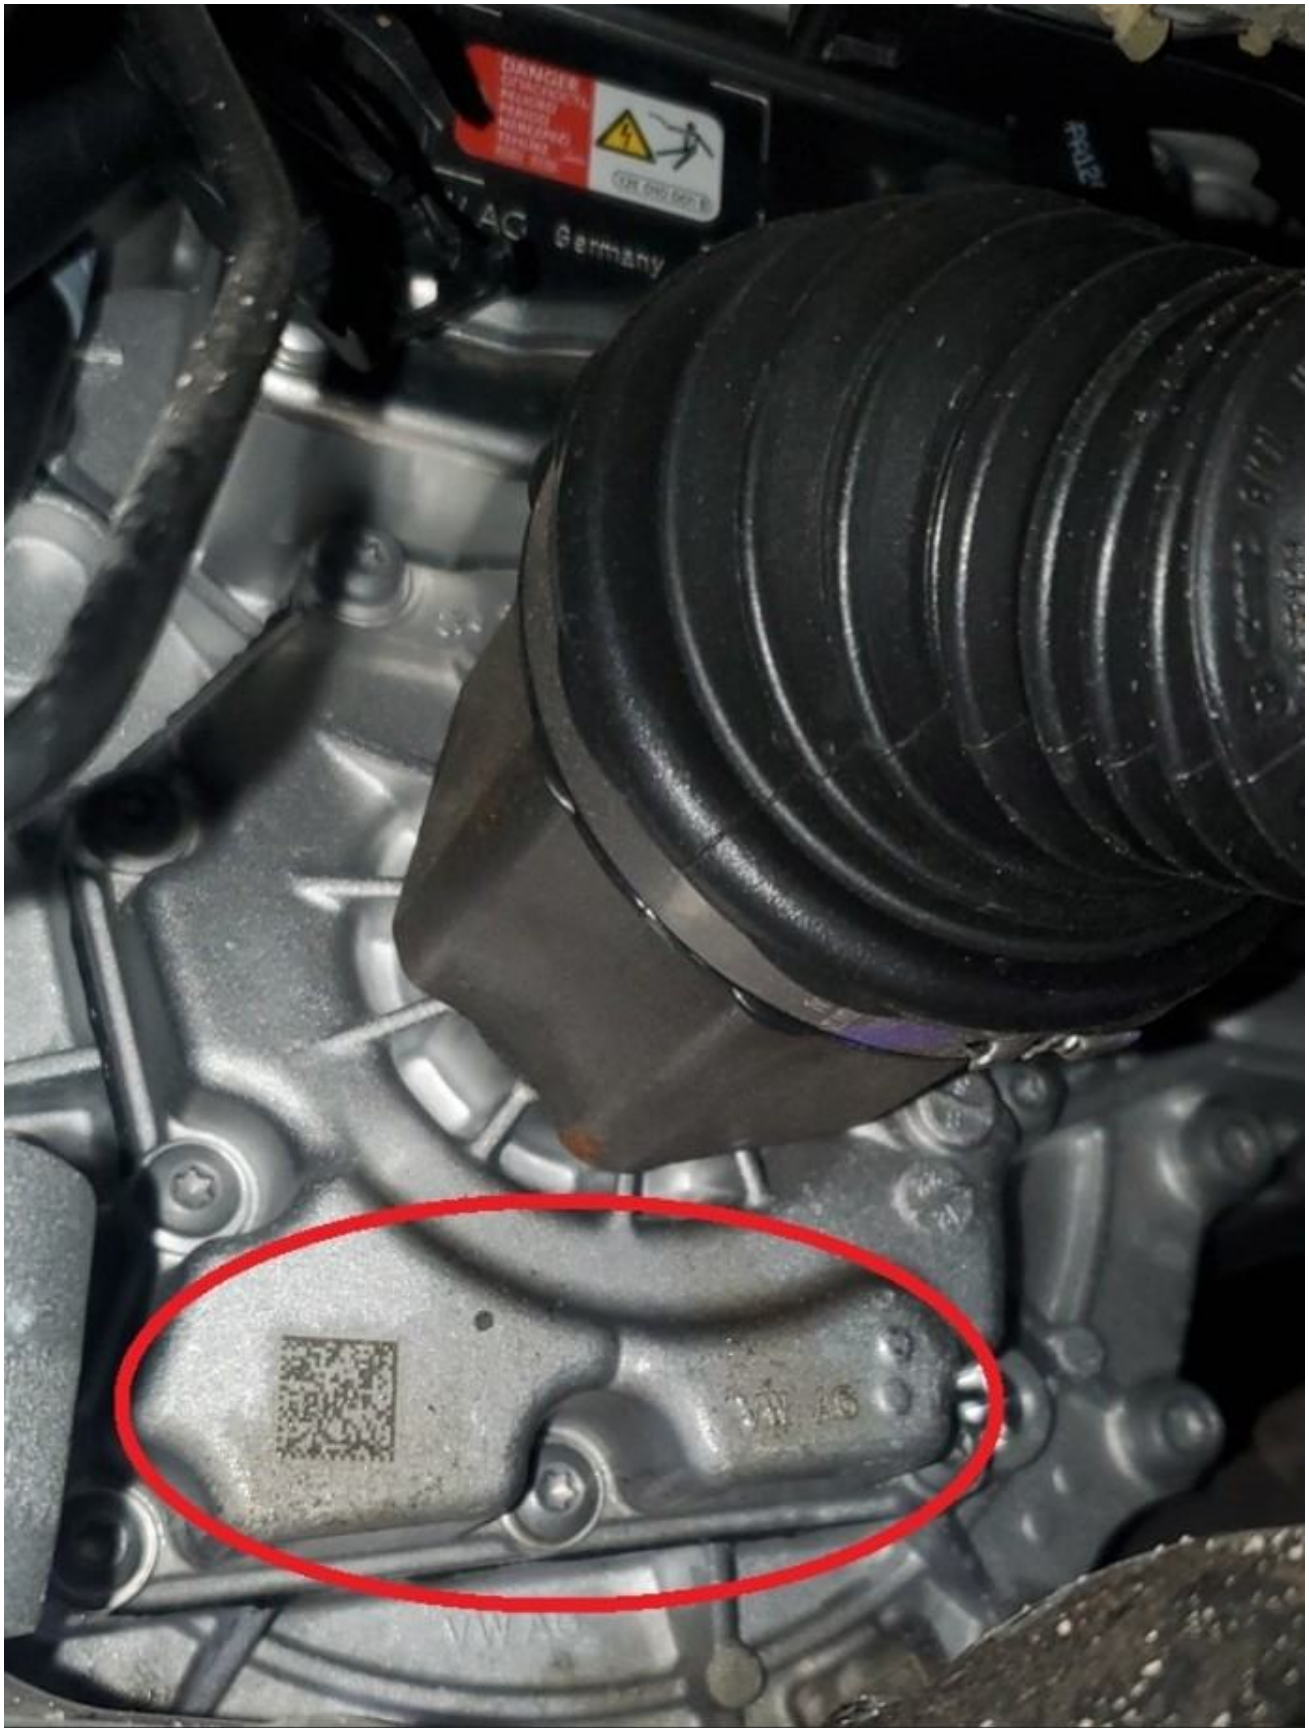
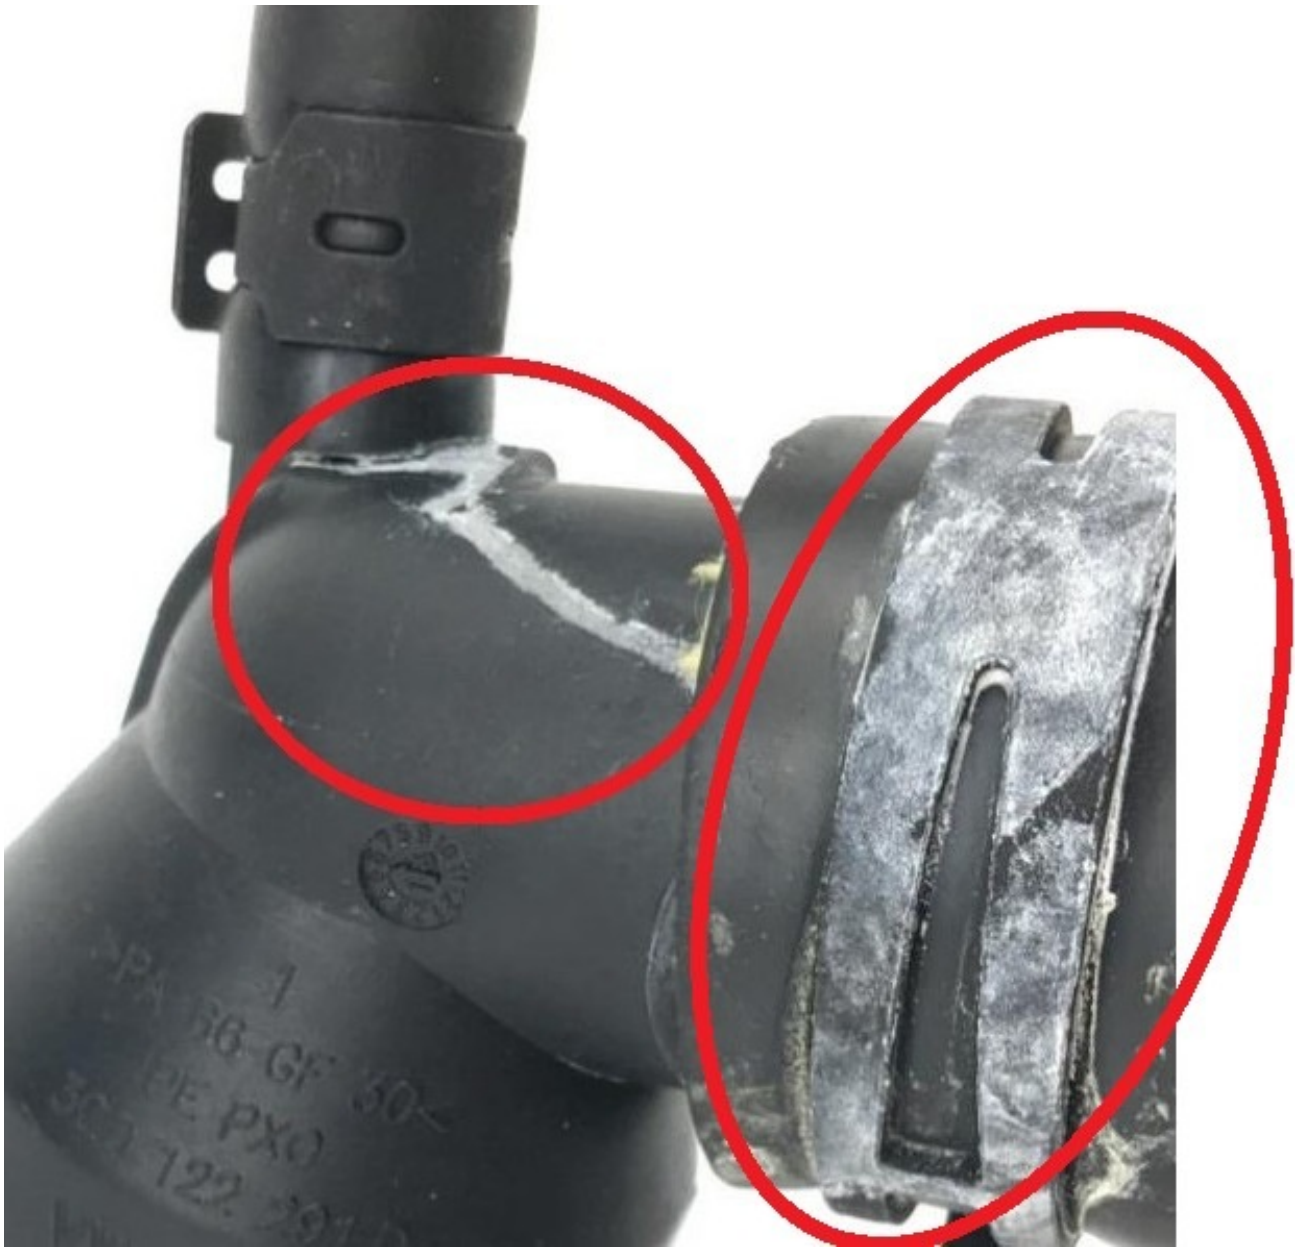
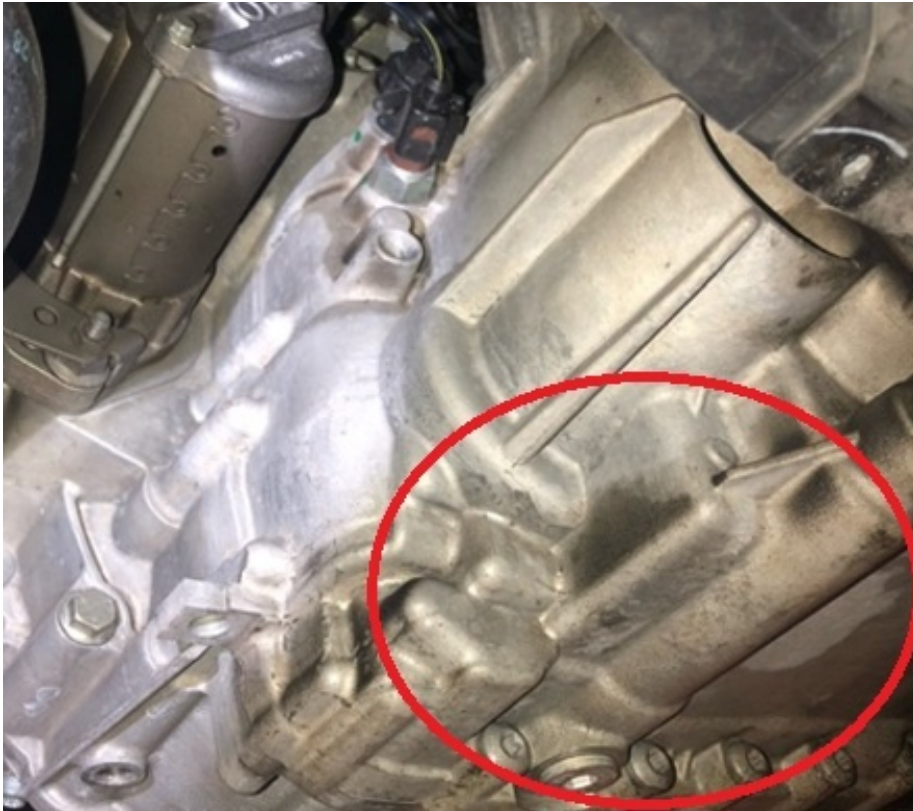
Seepage - Figures 1-7:

Seepage is the minor migration of fluid through assembled components or sealing interfaces that results in surface wetness or light discoloration, but does not produce fluid droplets, does not drip, and does not lead to measurable fluid loss over time. The area often has a darker or damp appearance compared to the rest of the part and may attract dust or dirt over time.

- Refer to Figures 1–7 below for visual examples of fluid seepage.
- Refer to Figures 8–12 below for visual examples of fluid leakage.

- If fluid seepage is observed, document the condition and reinspect at the next scheduled service interval. Seepage is a normal condition, and no repair is required unless active leakage is present.

Conditions identified as seepage are considered normal and are not covered under warranty. Seepage is considered a cosmetic or non-functional condition and is typically acceptable within design tolerances. Seepage alone does not indicate seal failure or warrant component replacement unless specifically stated otherwise by the repair manual or TSB.

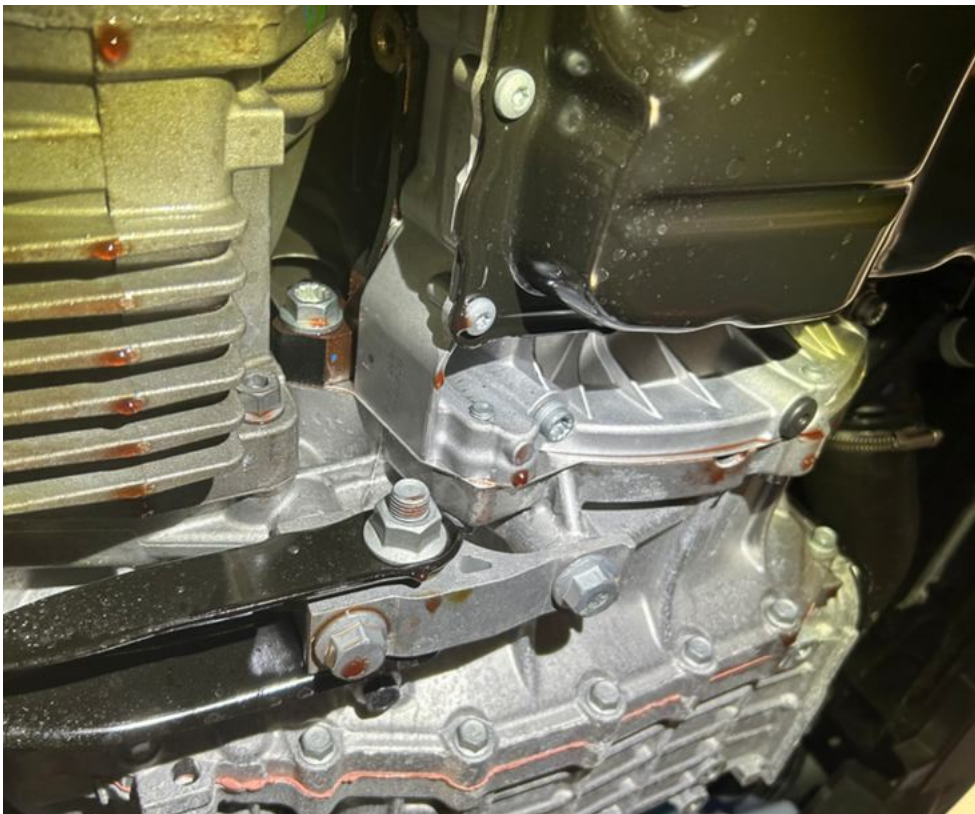
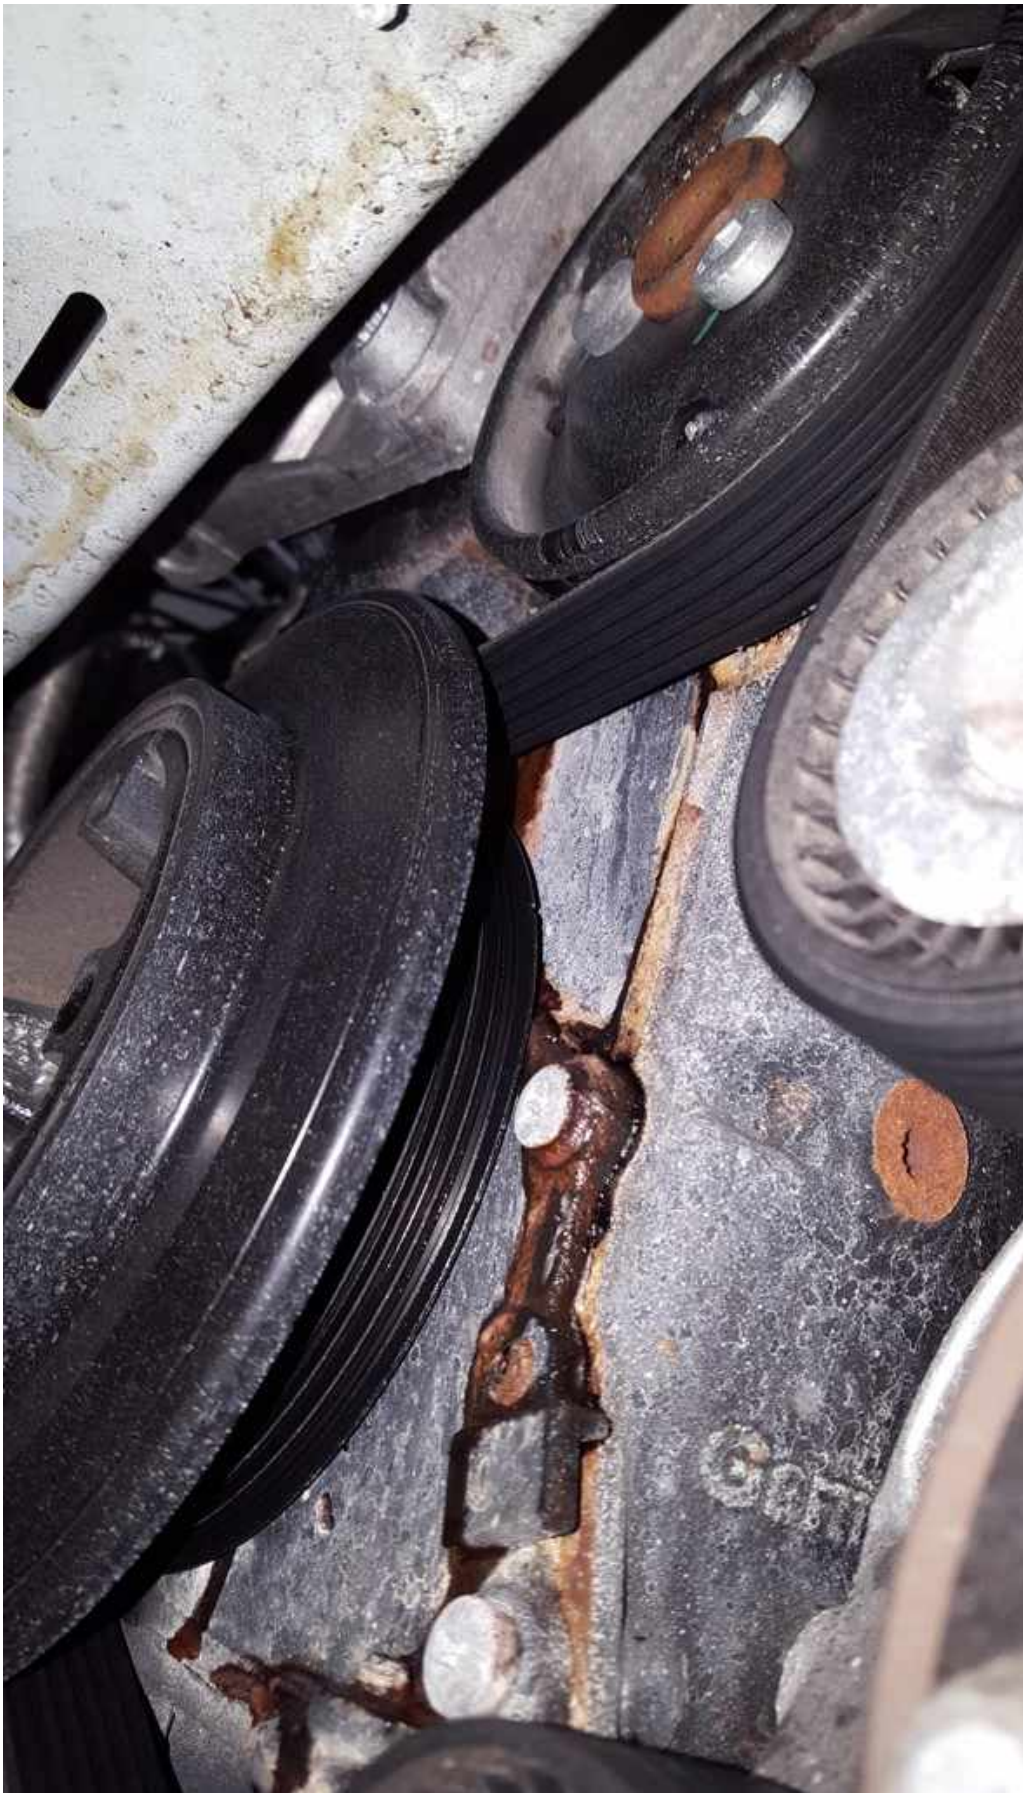
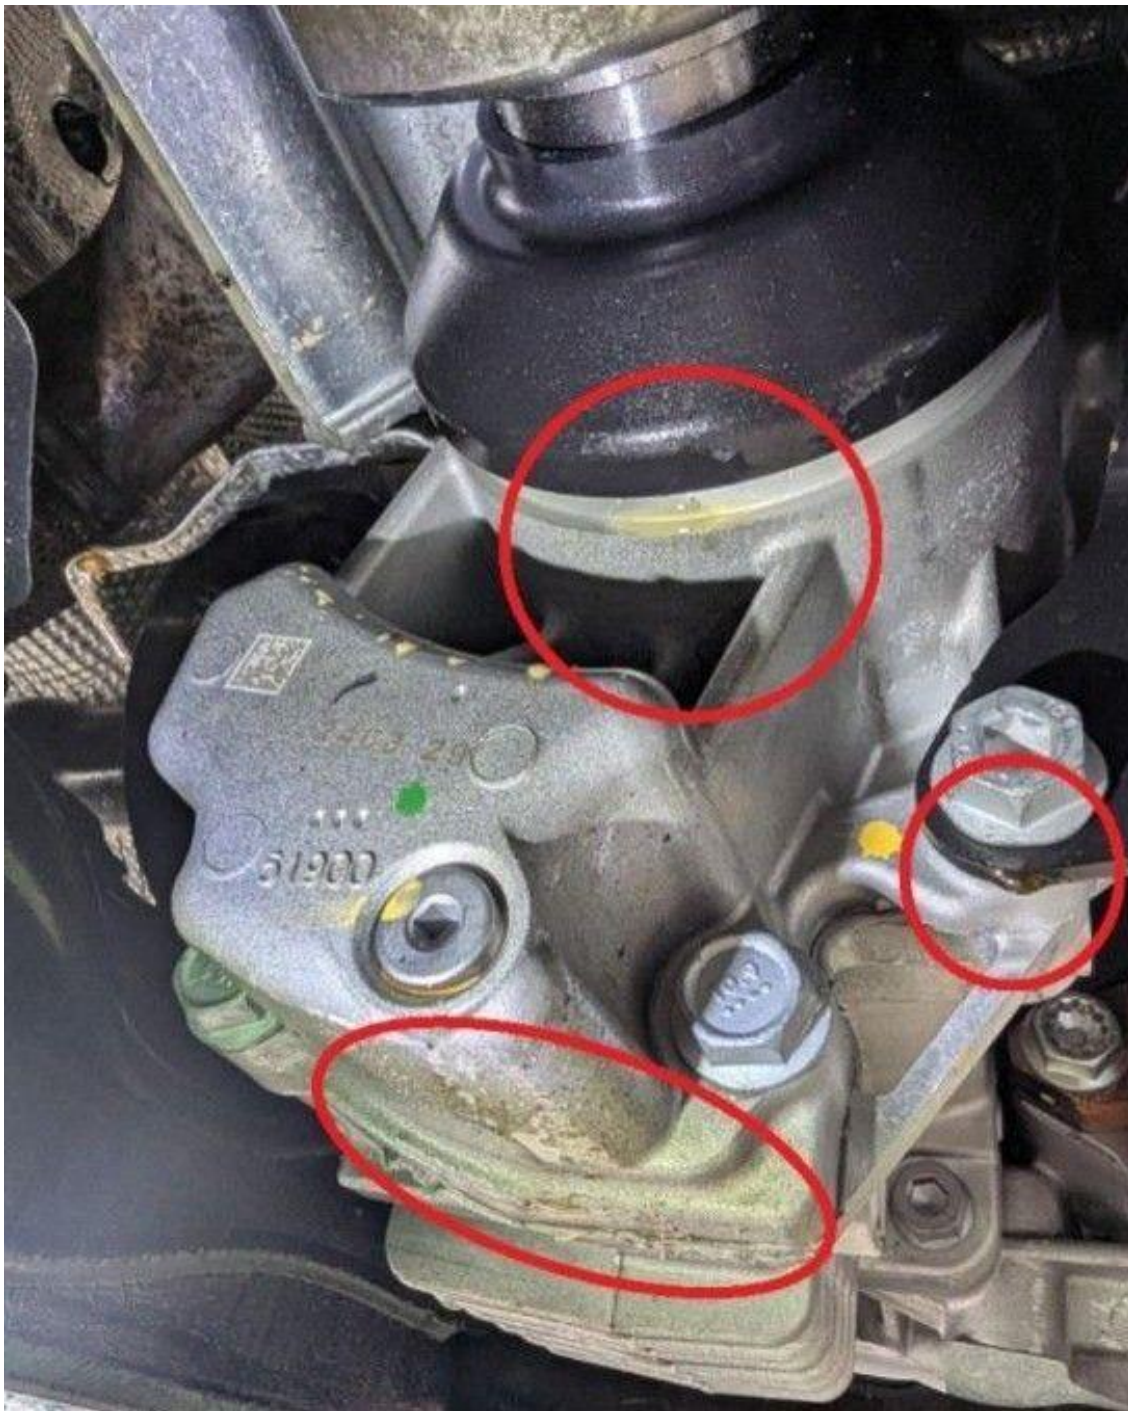
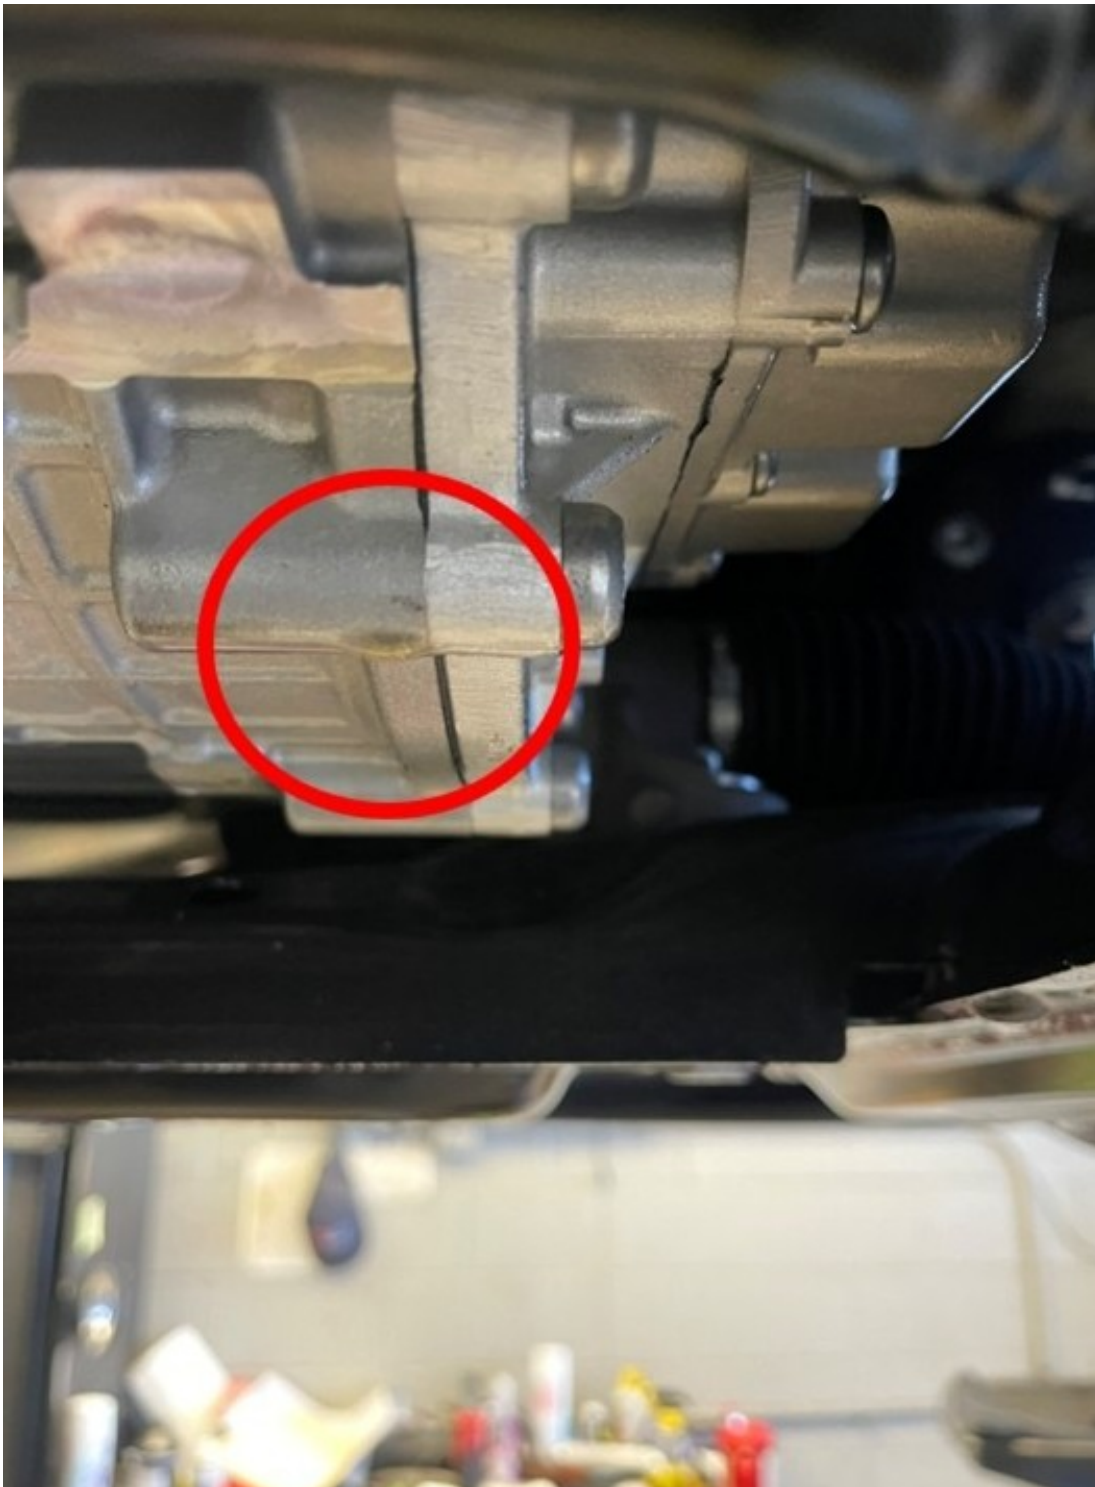
Leakage - Figures 8-12:

Leakage is the unintended release of fluid from a component or system that results in droplet formation, dripping, or active fluid flow, and may cause measurable fluid loss, contamination of adjacent components, or functional concerns.

- If fluid leakage is observed (active dripping, droplet formation, or puddling), diagnose the source and perform the necessary repair according to repair manual procedures. Verify repair effectiveness after completion.

If a leak is confirmed and repair is required, the repair must comply with Warranty Policy “VWP-26-06”. Photo documentation is required for warranty eligibility and must be uploaded to Doc-IT upon claim submission. Images must be of the leaking component while installed in the vehicle.
