Technical product information

Topic	Flying B mascot clear wings replacement procedure
Market area	Bentley: worldwide (2WBE),China 796 VW Import Comp. Ltd (Vico), Beijing (6796)
Brand	Bentley
Transaction No.	2074992/3
Level	EH
Status	Released for publishing
Release date	May 19 2026

New Flying Spur

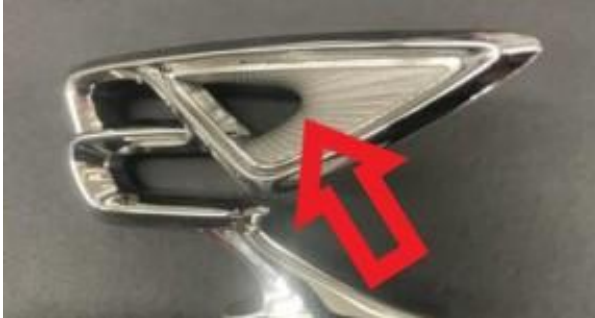
Figure 1

One or both of the Flying B mascot clear wings are missing (Figure 1)

In the event that one Flying B wing is missing the operative must replace both wings to eliminate a repeat repair

VERY IMPORTANT: It is no longer a requirement to replace the complete Flying B mascot assembly if the clear wings are missing, the process within the Measure section details how to fit new replacement clear wings

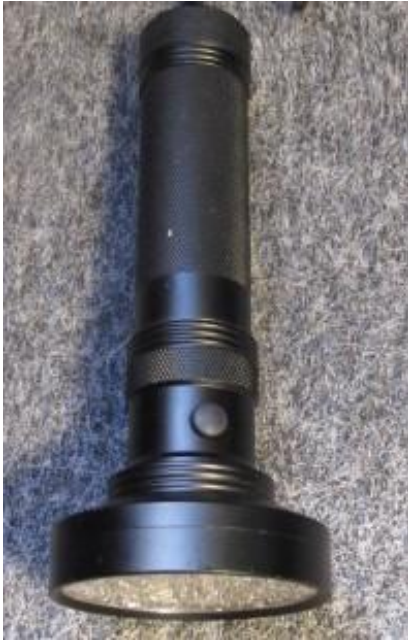
Figure 2

UV light (Figure 2) the specification must be as follows:

- Minimum power output must be 5W

The UV Wavelength must be as follows:

- Minimum wavelength of 395nm (nanometres)
- Grey or dark brown UV safety glasses must be worn when conducting the adhesive bonding procedure
- Standard safety glasses must be worn whilst conducting all other steps other than the UV adhesive bonding procedure
- Dymax Ultra light weld 3094-GEL-REV- A - 30 ML (Figure 3)
- 3M surface cleaner or same specification

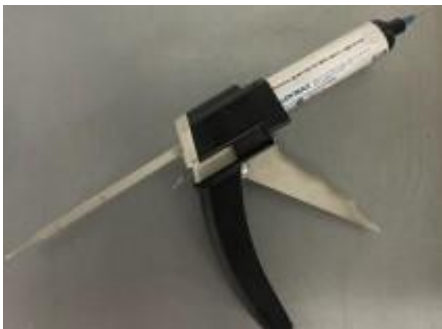
Figure 4

- Adhesive application gun (Figure 4)

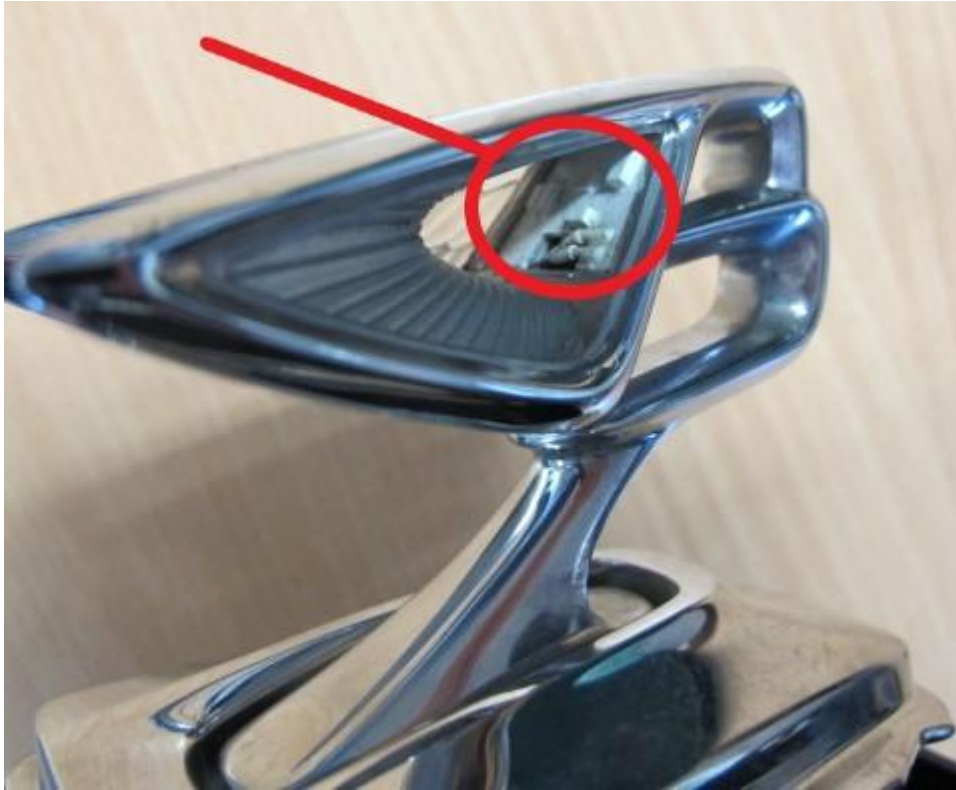
Figure 5

1) Due to the location of the LED light (Figure 5) damage can be caused to the Flying B mascot therefore it is imperative the wings are drilled at the exact location shown within Figure 6

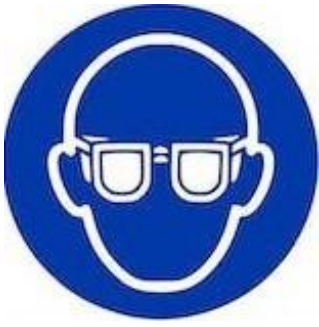
Figure 7

- Safety glasses and gloves must be worn for the duration of this repair process (Figure 7) UV safety glasses are also required to be used when advised within the TPI

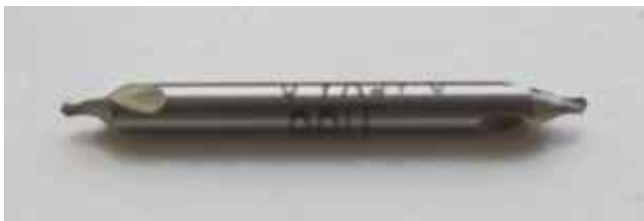
Figure 8

Once removed from the vehicle the operative must ensure the Flying B assembly is placed on a clean protective surface - The use of a suitable countersink drill (3mmx1.6mm) is recommended (Figure 8) the countersink drill must be capable of a making a hole with a maximum width of 3mm, the tool Must Not contact the mascot or LED

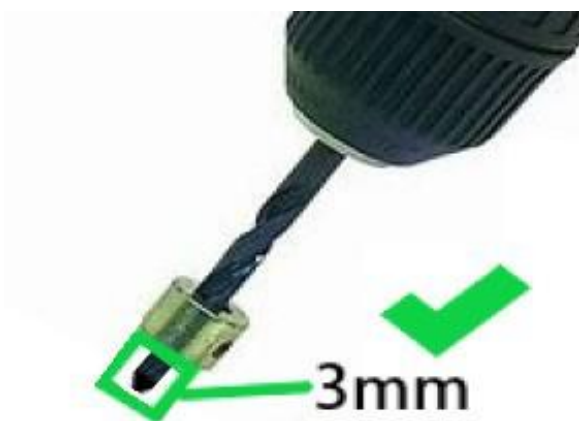
Figure 9

Hint: A standard 3mm drill bit can be used however the drill must be used in conjunction with a drill stop tool to ensure a depth of 3mm is not exceeded (Figure 9)

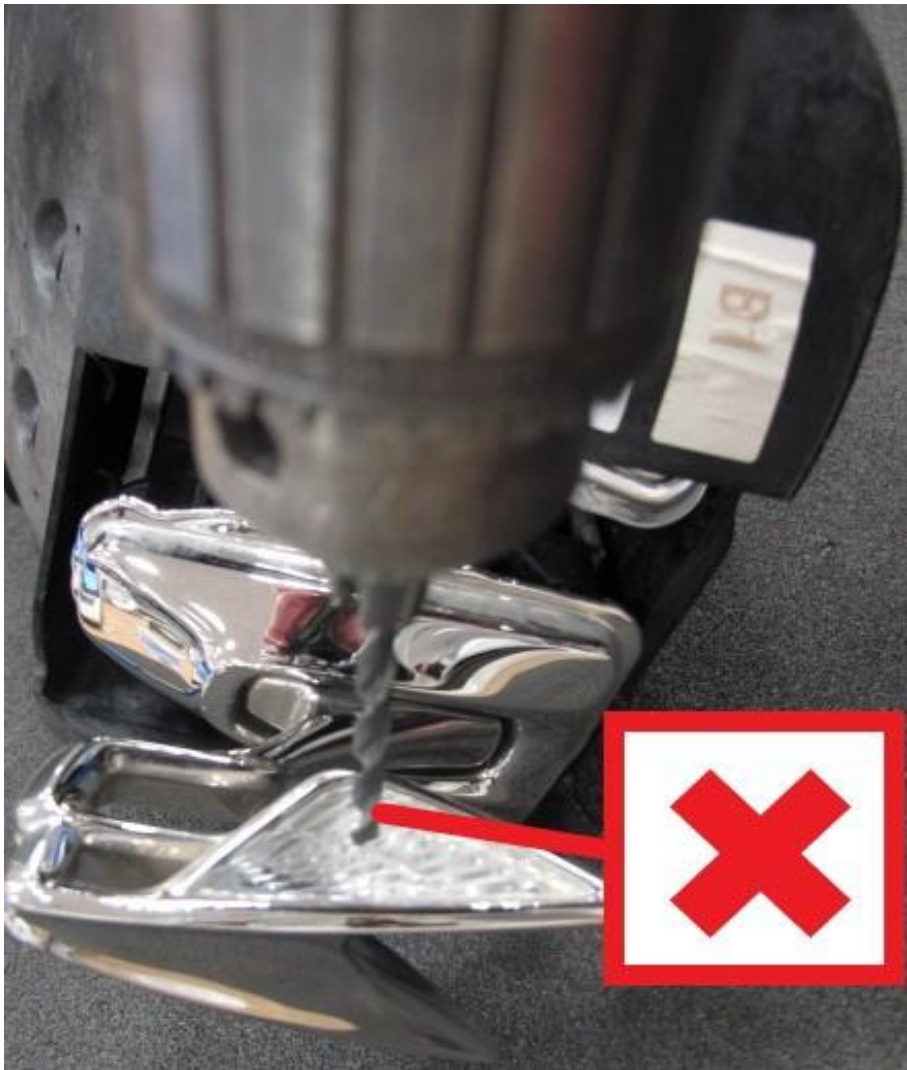
Figure 10

- Do not use a standard drill without using a drill stop as damage can easily be caused to the mascot or LED (Figure 10)

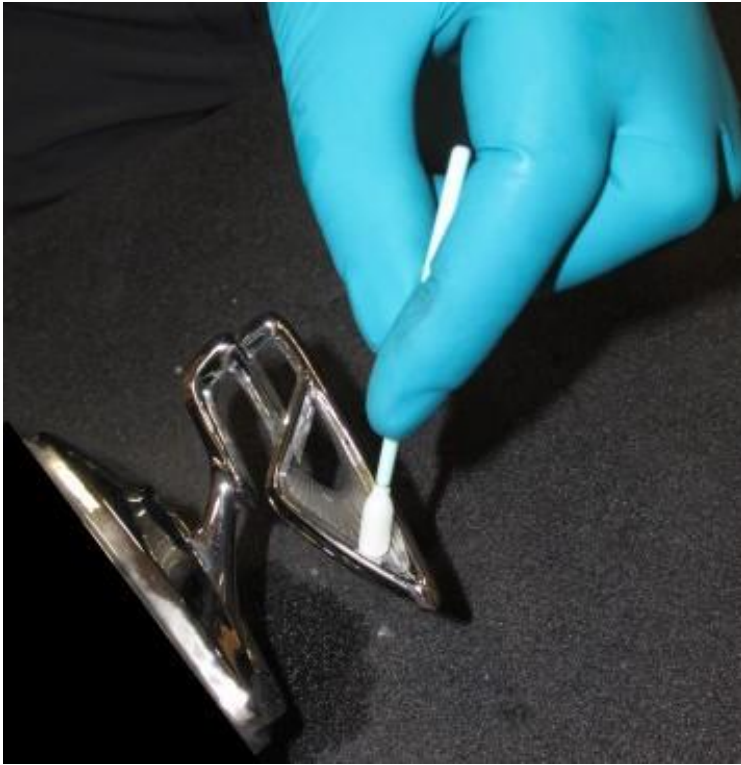
2) Referring to Figure 11 - Using foam cleaning tips in conjunction with 3M surface cleaner thoroughly clean the Flying B aperture

Once the adhesive has been removed using the 3M cleaner the operative should wait 60 seconds to allow the liquid to evaporate

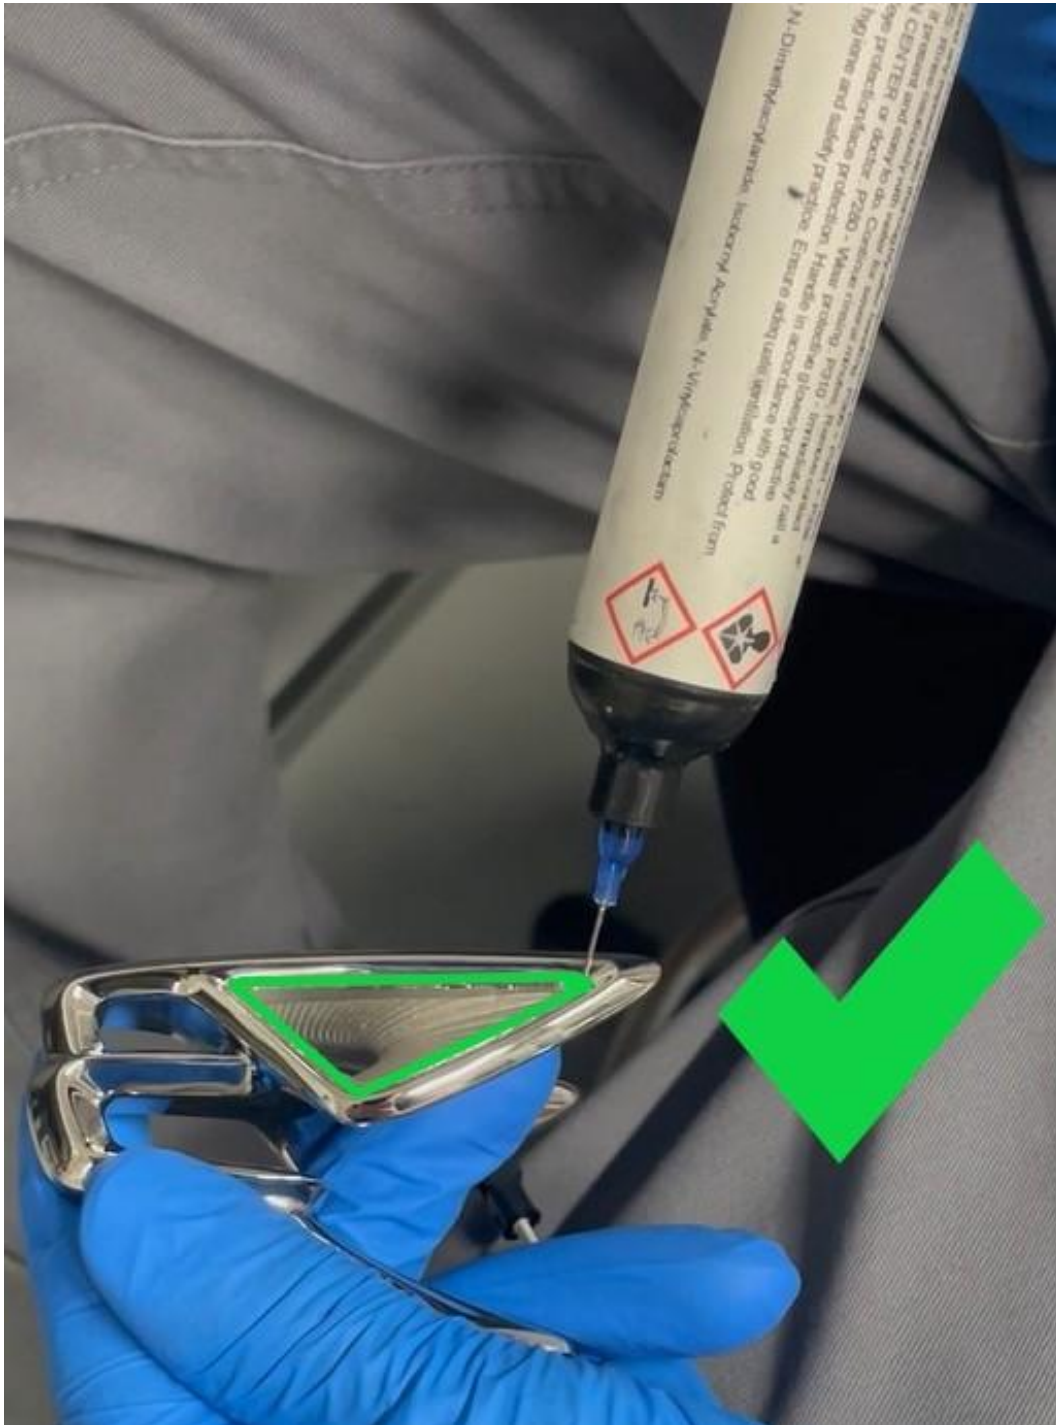
4) Referring to Figure 12 - Apply the adhesive as shown ensuring the adhesive is applied in a consistent manner noting the following:

- Poor Cleaning of the Flying B mascot can lead to debris inside the mascot
- Should too much adhesive be applied the excess will be visible and would be seen through the clear wings

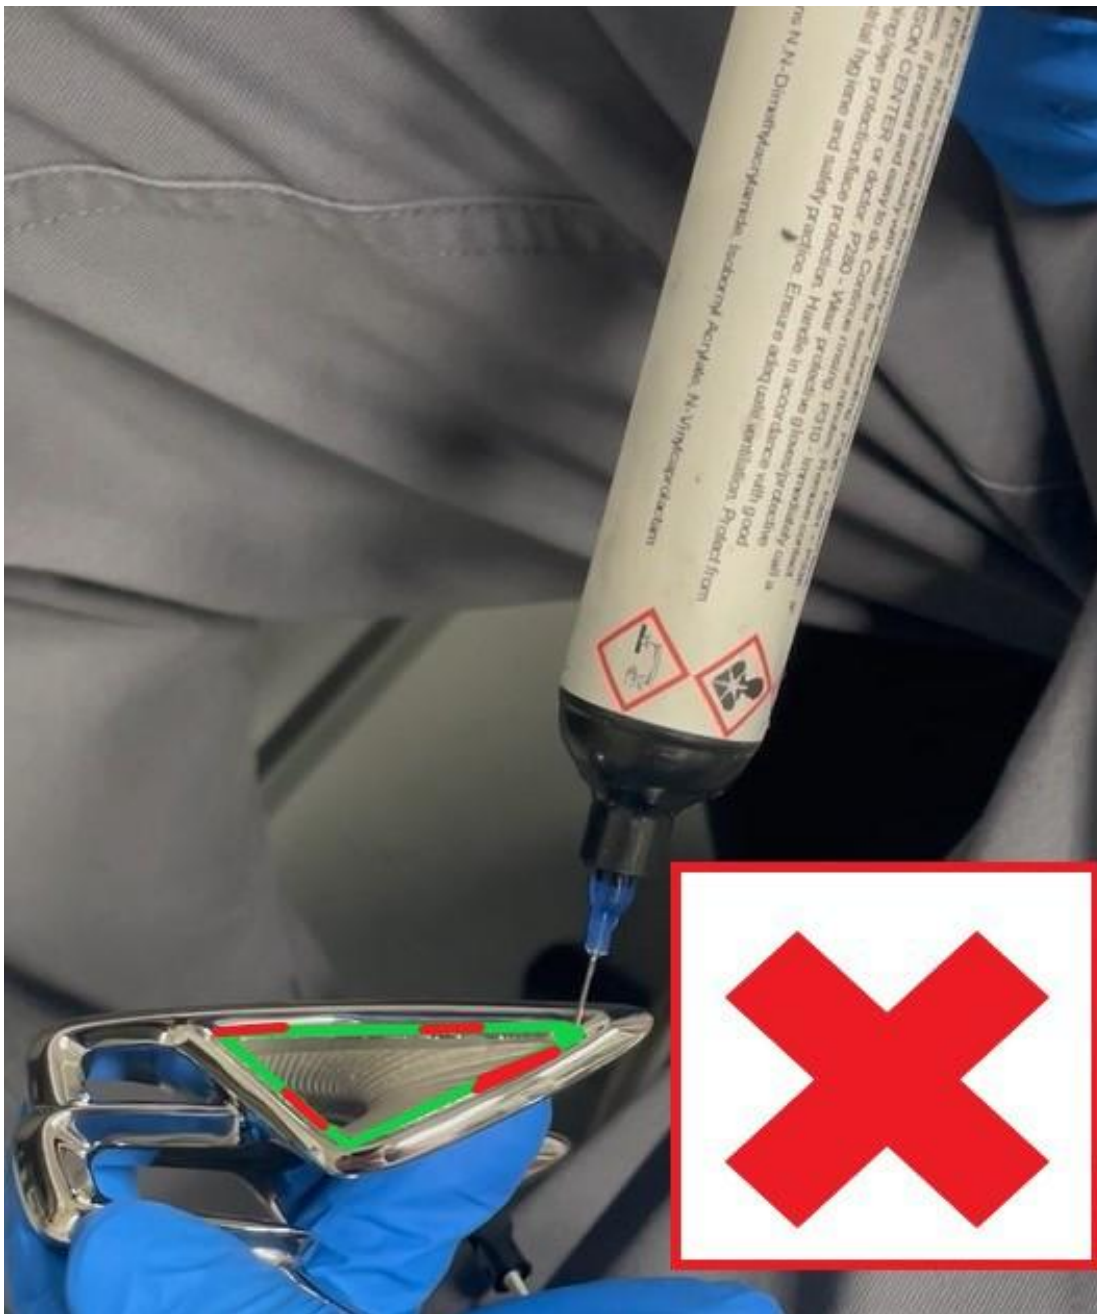
Figure 13

Should the adhesive dosage be sporadic/not consistent (Figure 13) there is a risk of insufficient sealing and water ingress

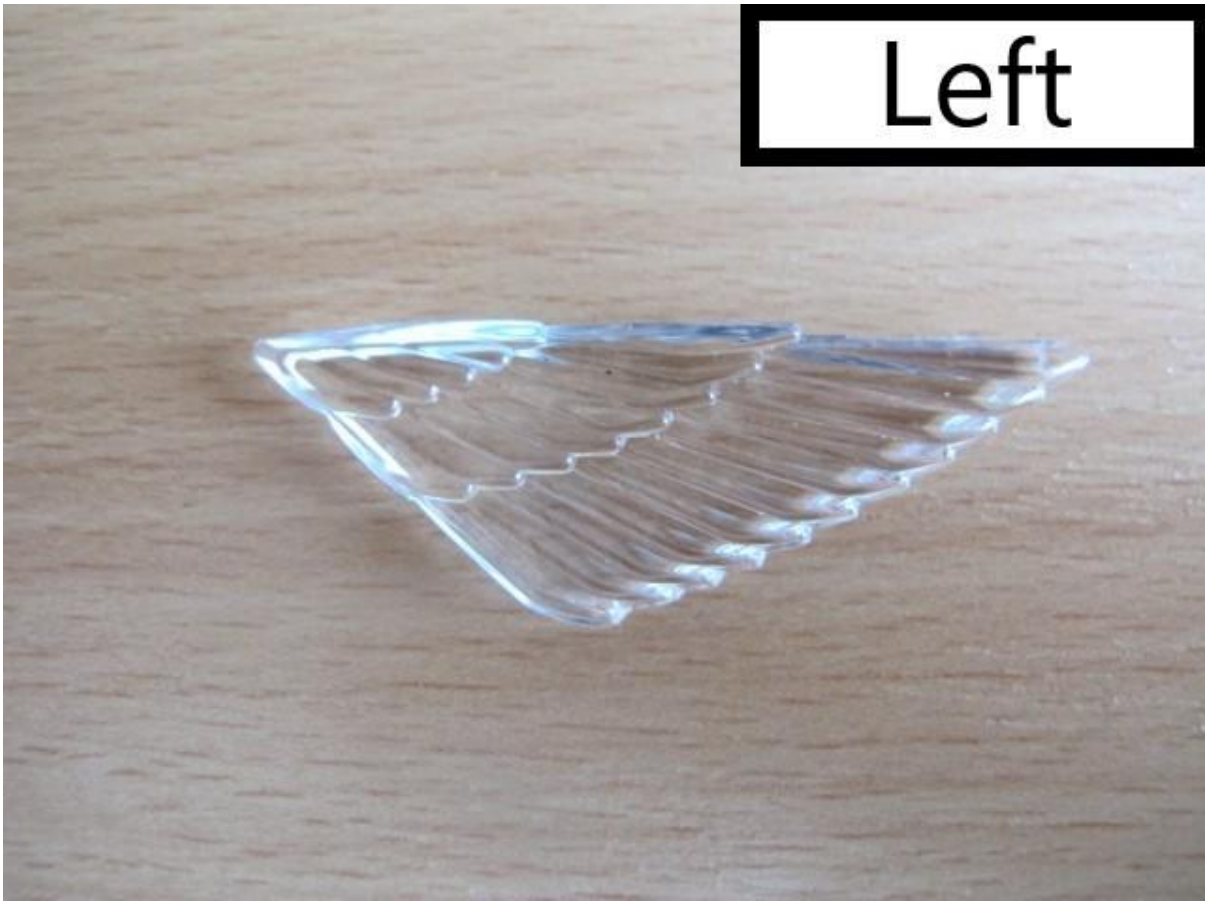
CAUTION before fitting the clear wings the operative **MUST** ensure the wings are fitted in the correct location ensuring the serrations are on the outer sides as shown in Figures 14 and 15

- Figure 14 - Left hand side

CAUTION
CAUTION before fitting the clear wings the operative MUST ensure the wings are fitted in the correct location ensuring the serrations are on the outer sides as shown back in Figures 14 and 15

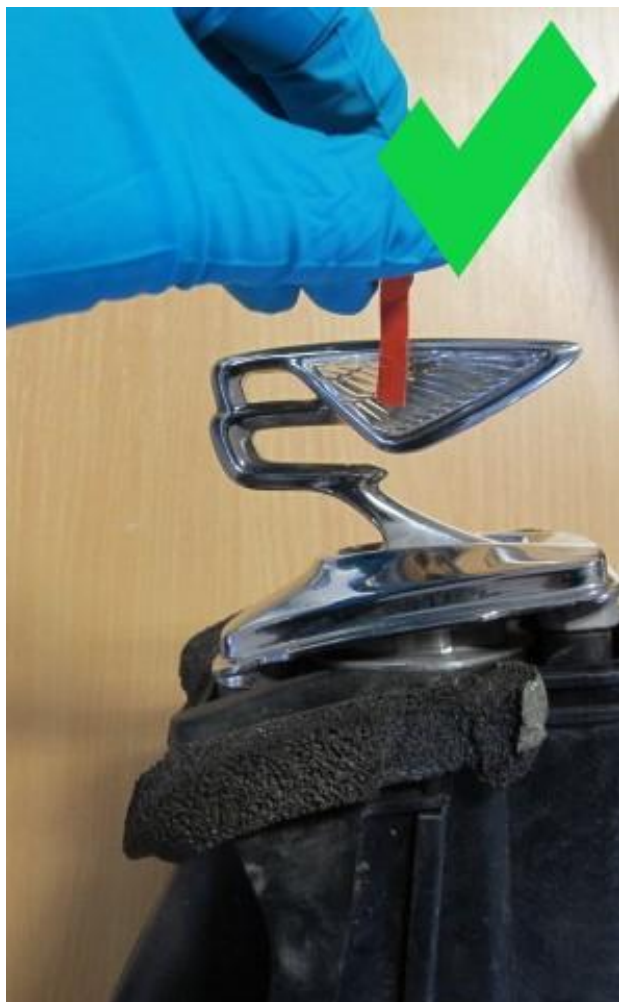
5) Referring to Figure 16 - Ensuring suitable gloves are worn – Use suitable double sided tape to hold the wing at the location shown, fit the replacement wing ensuring the adhesive is not disturbed, once fitted wipe away any excess adhesive from the outside of the clear wing and mascot using a clean cloth and 3M surface cleaner

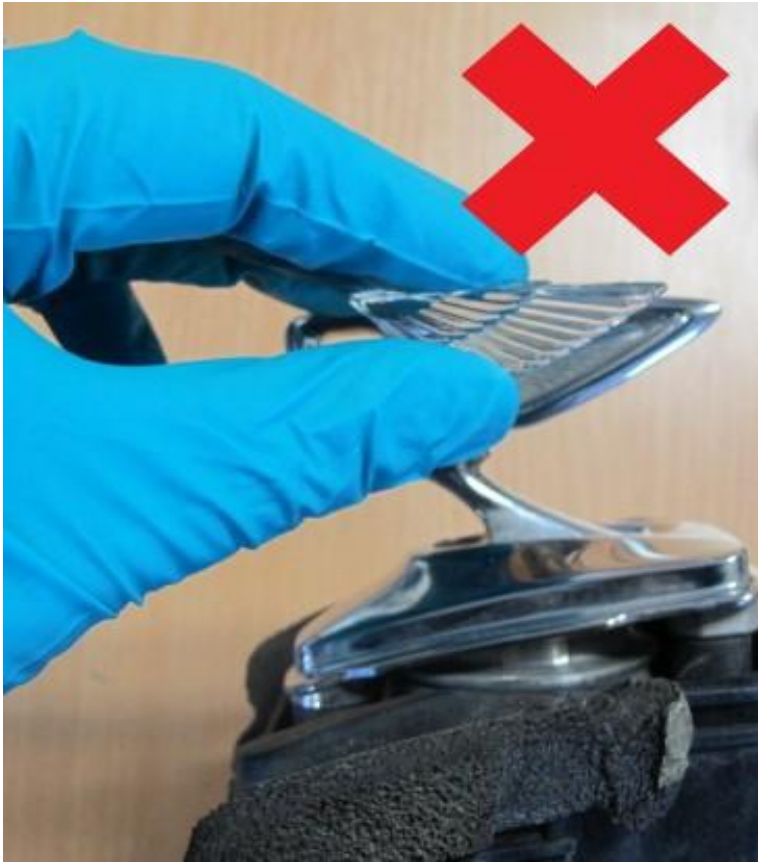
Do Not hold the wing as shown in Figure 17 as the adhesive can easily be disturbed when using this method

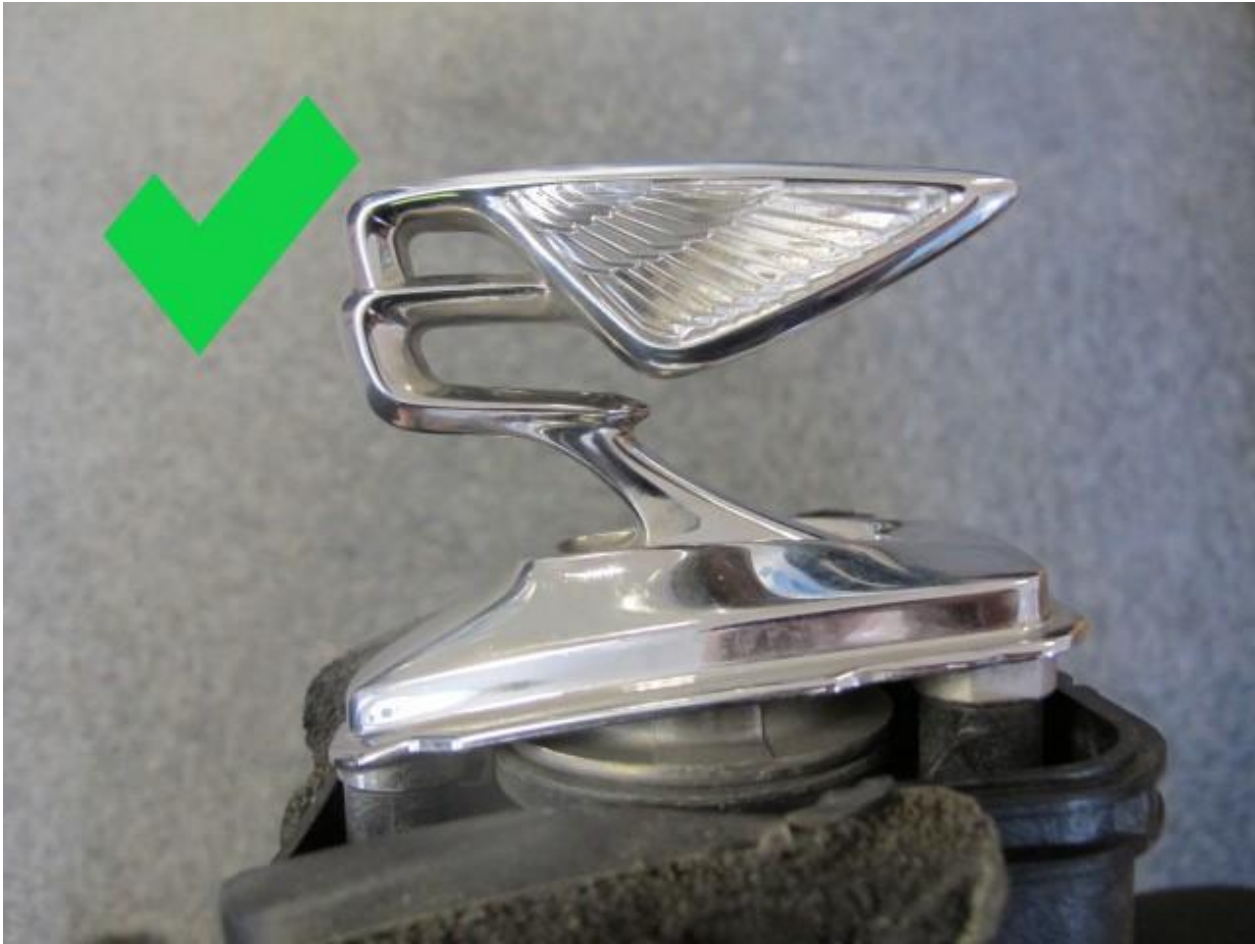
6) Once fitted the wing should be as shown in Figure 18

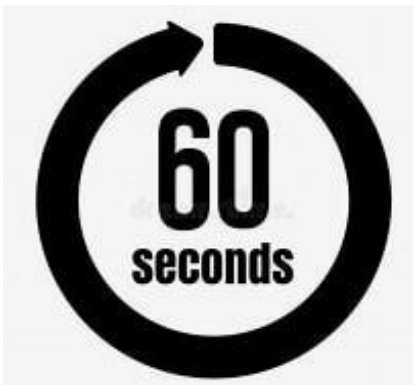
7) Referring to Figure 19 - With the Flying B assembly placed on a suitable clean surface – Ensure suitable UV safety glasses are worn - Switch on the UV lamp

Ensure the beam is projecting equally onto the newly fitted clear wing for a duration 60 seconds as shown in Figure 19

The operative should be aware that the distance quoted of 100mm and the time of 60 seconds to cure the adhesive may vary depending on the type of light which has been sourced, the operative should refer to the manufacturer's instructions of the lamp

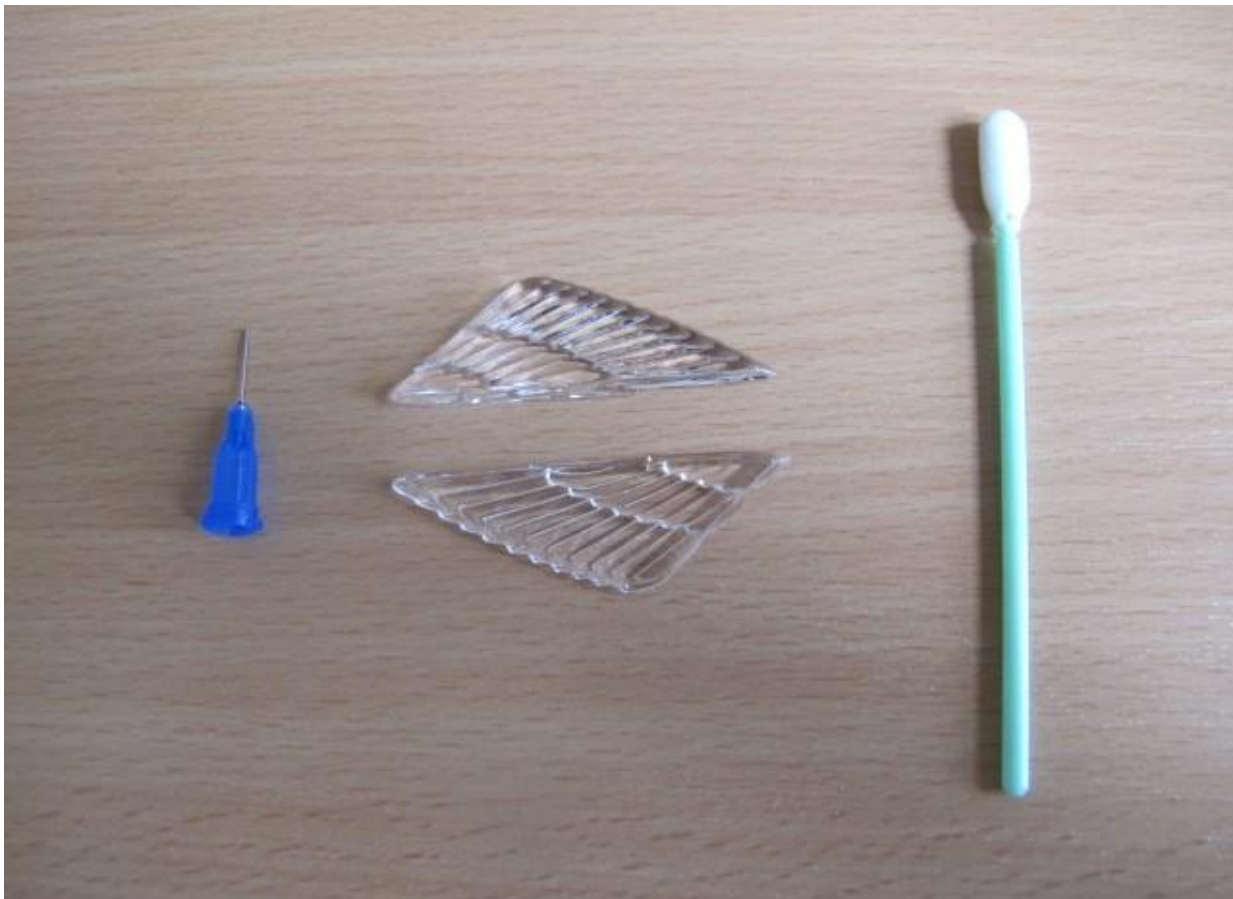
Figure 20

3SE 898 810 - REPAIR KIT FLYING B WINGS (Figure 20)

The kit contains the following and can be used on multiple vehicles

- Syringe Needles x5
- Sets of clear wings x10 (5 left hand side wings - 5 right hand side wings)
- Foam Cleaning Tips x5
