Technical product information

Topic	Engine cooling system over cooling - One or a combination of DTC's may be evident P218100 - P1BB400
Market area	Bentley: worldwide (2WBE),China 796 VW Import Comp. Ltd (Vico), Beijing (6796)
Brand	Bentley
Transaction No.	2075140/3
Level	EH
Status	Released for publishing
Release date	May 21 2026

Engine cooling system over cooling - One or a combination of DTC's may be evident
P218100 - P1BB400

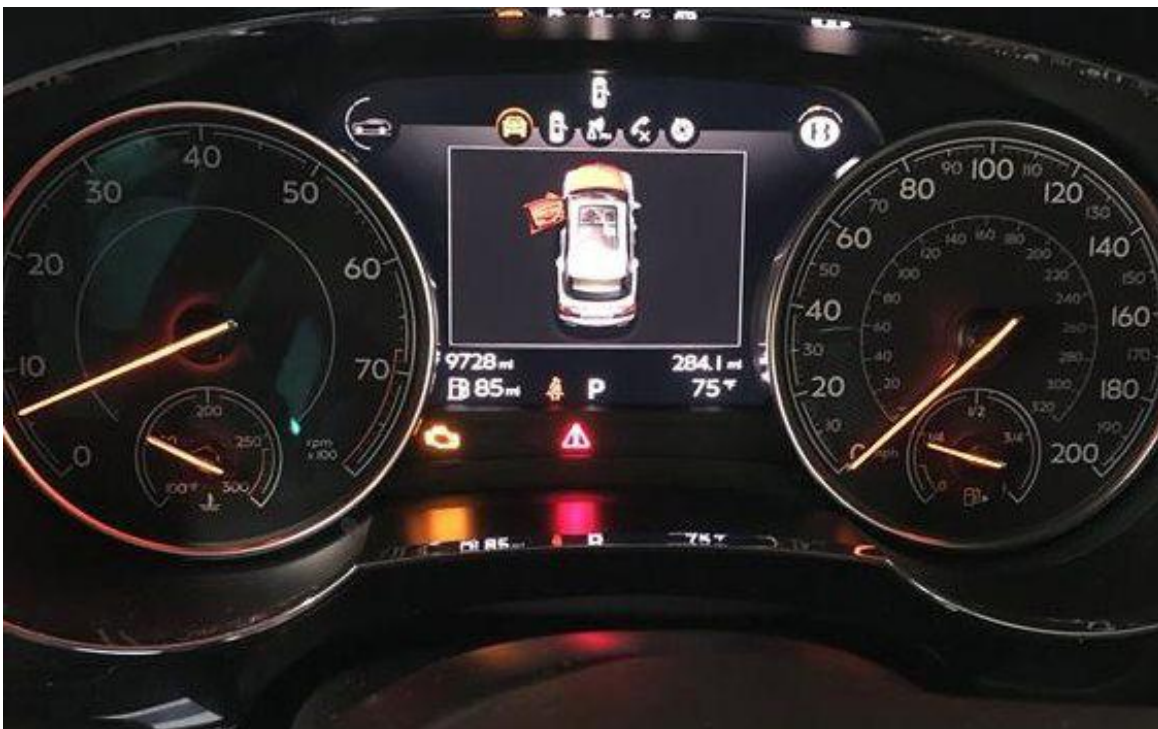
Figure 1

- DTC P218100 - Cooling System Performance and / or DTC P1BB400 Cylinder head temperature too low is stored in the Engine Control Module (ECM)
- Emission Control Lamp illuminated on the Driver Instrument Panel (Figure 1)

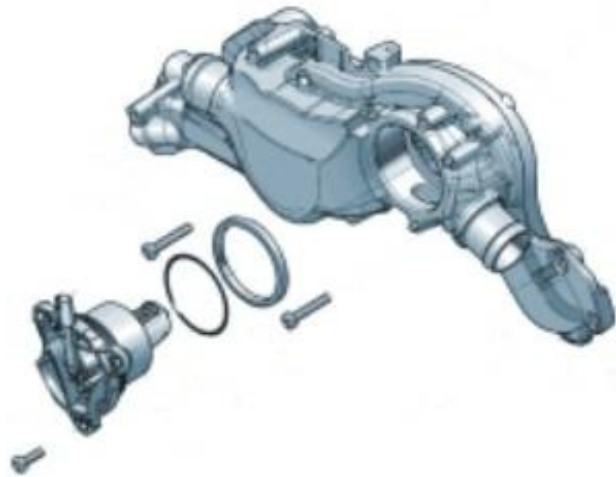
Figure 2

It is possible for the engine coolant thermostat to corrode over time, this corrosion is due to an adverse reaction of the thermostat material with the engine coolant

The corrosion and subsequent build-up of debris prevents the correct operation of the thermostat when closing, resulting in over cooling. The ECM triggers a DTC when the target engine temperature is outside of the specified parameter

1) Replace the engine coolant thermostat (Figure 2) - Refer to 19 - Engine cooling - Coolant regulator (Thermostat insert) (V8 biturbo) - To remove and fit

2) On completion conduct a road test to confirm the issue is resolved
