CRASH PLATE WELDING INFORMATION

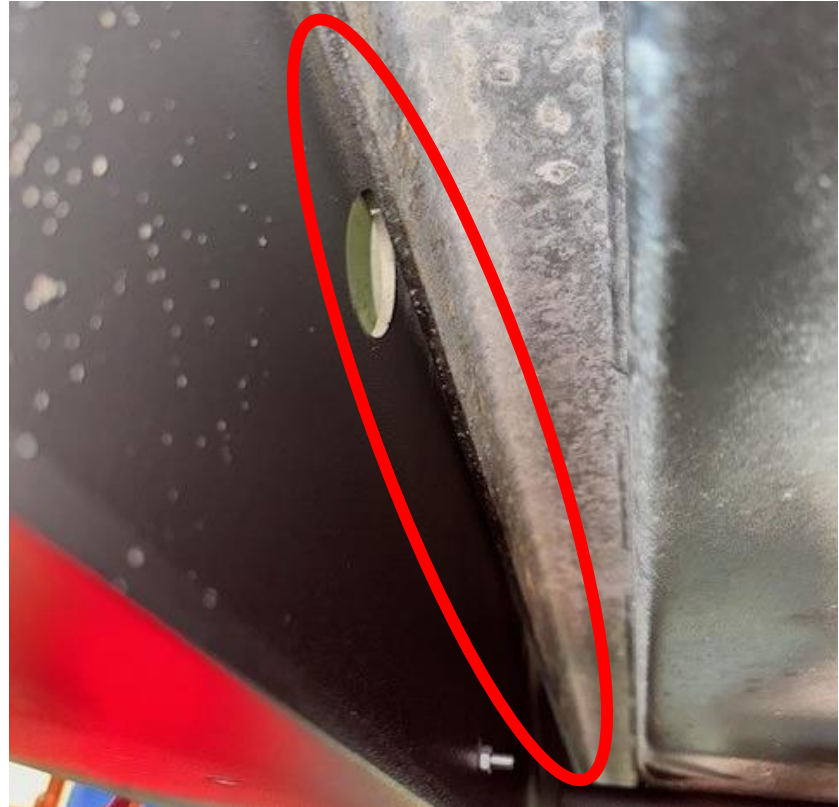
ISSUE

The issue that has occurred is the rear of the crash plate was not welded to the rear frame. The circled seam should have welds present.

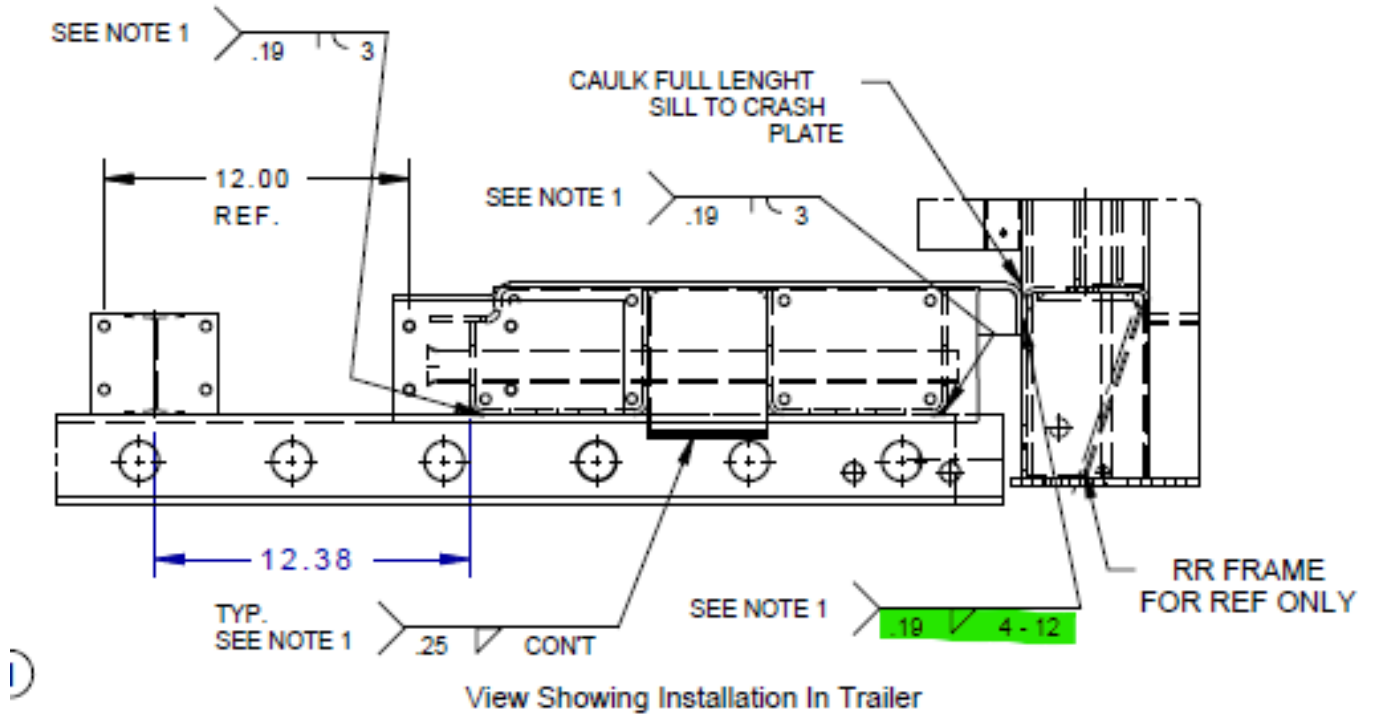
ENGINEERING DRAWING ZOOMED IN

The welds called out are highlighted on the attached drawing. There should be a 4" long 0.19" sized weld spaced every 12".

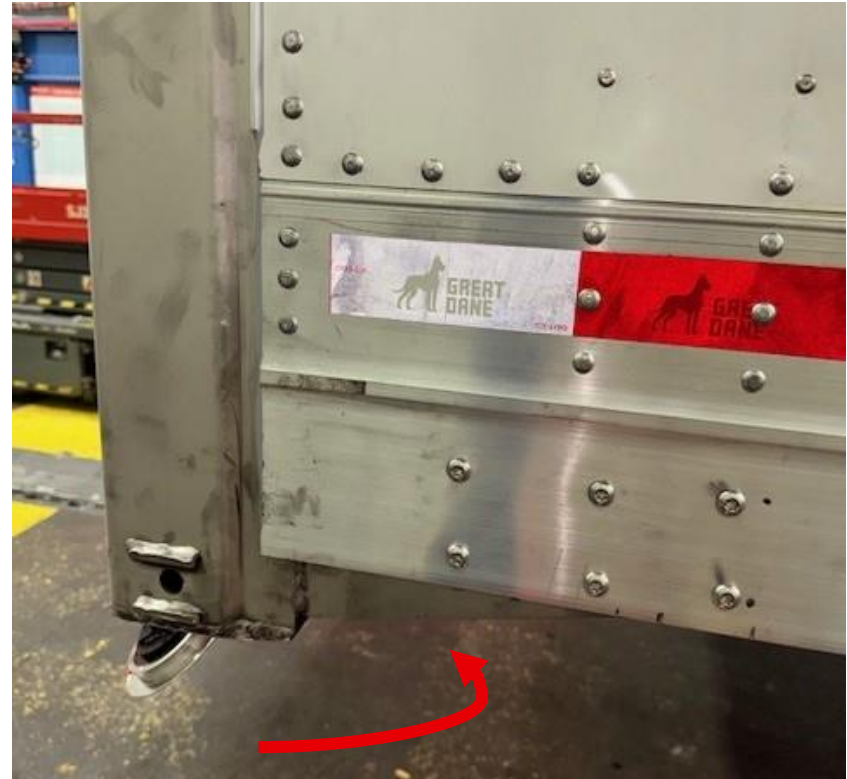
FIX

The location of the issue is at the rear of the trailer, up underneath on the front side of the rear frame. The arrow below depicts where to look

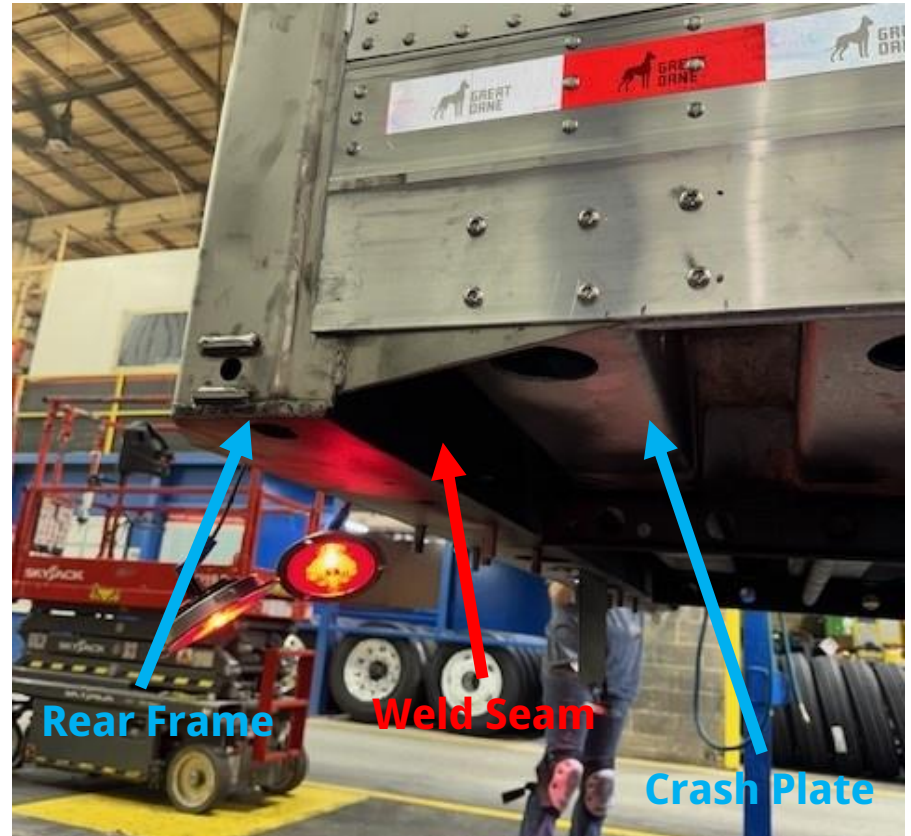
FIX (CONT.)

When looking on the underside of the trailer, the seam is located between the front side of the rear frame and the rear of the crash plate
