| <b>HYUNDAI</b><br><b>Technical Service Bulletin</b> | GROUP<br><b>CAMPAIGN</b> | NUMBER<br><b>26-01-057H</b> |
| | DATE<br><b>JULY 2026</b> | MODEL(S)<br><b>SONATA (DN8)<br/>SONATA HYBRID<br/>(DN8 HEV)</b> |
| <b>SUBJECT:</b> FUEL FILLER DOOR DIFFICULT TO OPEN – PUSH OPENER INSPECTION & REPLACEMENT (LIMITED COVERAGE CAMPAIGN LA31) | | |

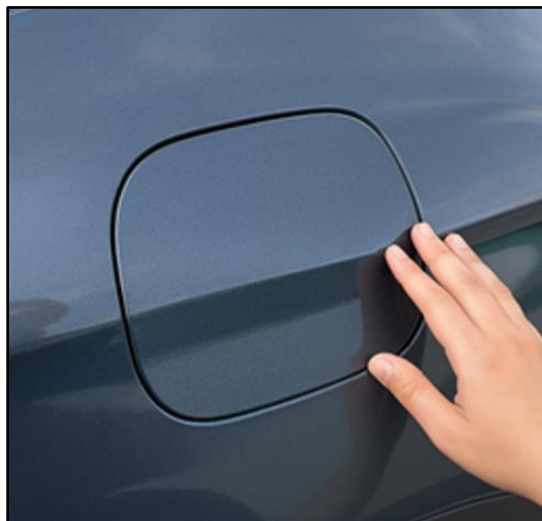
**Description:** Certain Sonata (DN8) and Sonata Hybrid (DN8 HEV) vehicles may exhibit a fuel filler door that is difficult to open due to the push-type opener mechanism. This bulletin provides instructions to inspect the fuel filler door push opener and, if necessary, replace the component to restore proper operation.

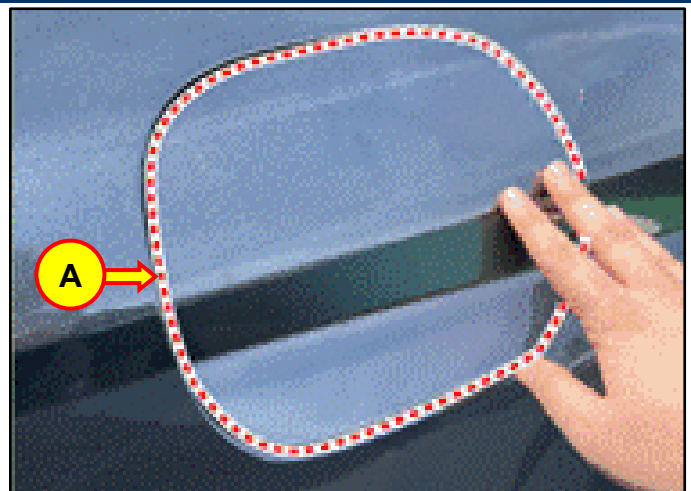
- Open the fuel filler door (A).

Fuel door may require several pushing attempts to open.

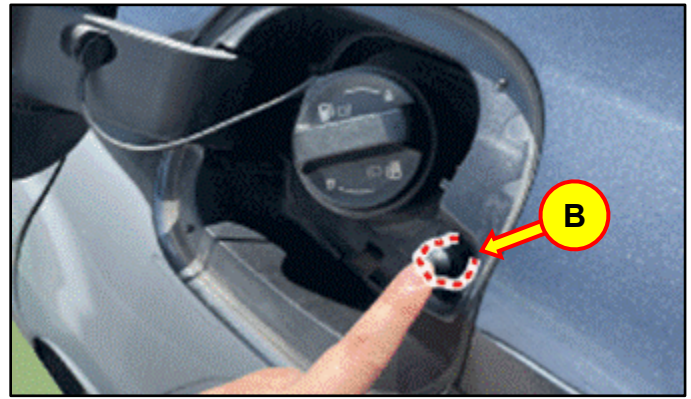
2. Inspect the push opener (B) by slowly pressing it down into the closed position, then slowly pressing down again to release it back into the open position as shown in the table:

The push opener is operating properly if **3** separate 'click' sounds are heard.

If less than **3** 'clicks' are heard when operating the push opener, it is defective.

- **PASS:** If the push opener is operating properly, replacement is not required. Proceed to **step 3** for Digital Documentation.
- **FAIL:** If the fuel filler door is difficult to open or the push opener is defective, then proceed to the [Fuel Filler Door Push Opener Replacement](#) procedure.

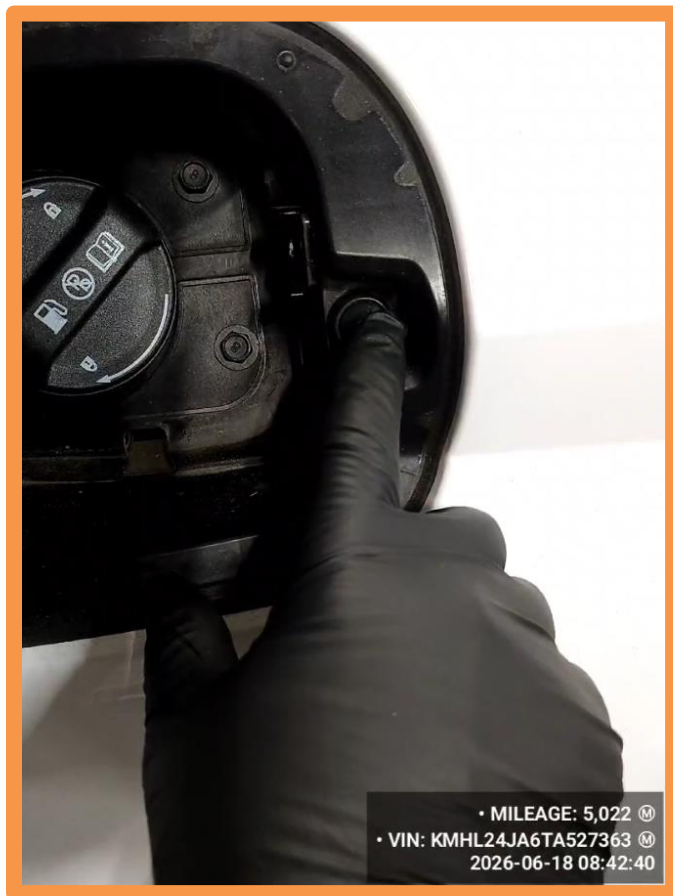
Using the STUI camera function, record a video of the push opener inspection where **3** separate 'click' sounds are clearly heard.

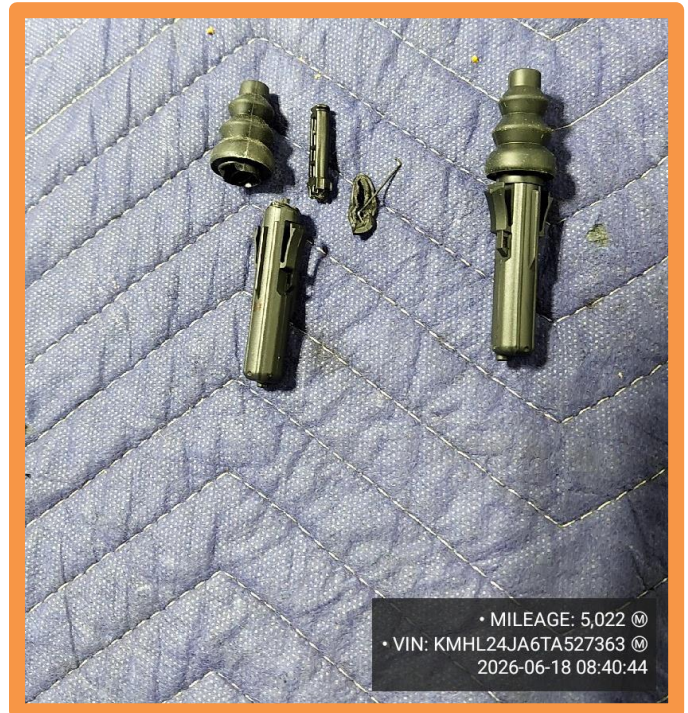
Using the STUI camera function, take a photo of the new and original push opener side by side.

12. Install the new push opener.

The new push opener will make a 'click' sound when properly installed.
