## Technical Service Bulletin

**GROUP****CAMPAIGN****NUMBER****26-01-059G****DATE****JULY 2026****MODEL(S)****G70 (IK)****SUBJECT:**

COOLANT LEAKAGE FROM 3-WAY COOLANT HOSE – HOSE & FITTING REPLACEMENT (LIMITED COVERAGE CAMPAIGN L16G)

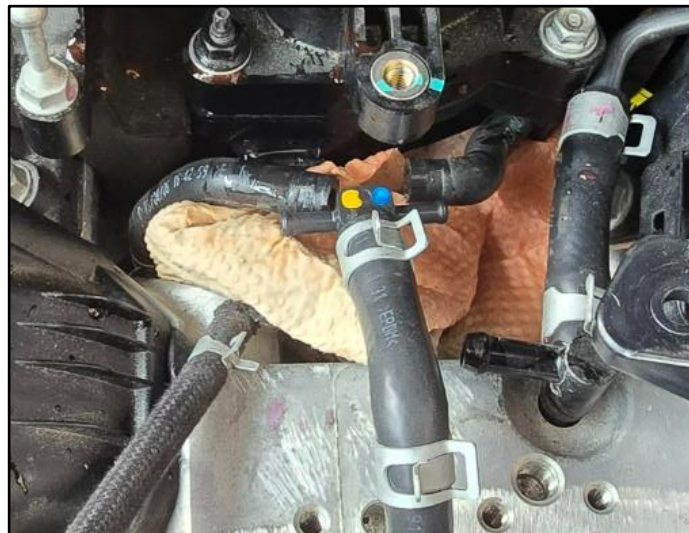
**Description:** Certain G70 (IK) vehicles equipped with the Lambda II 3.3L T-GDI engine may exhibit coolant leakage originating from the 3-way coolant hose assembly. This bulletin provides instructions to replace the 3-way coolant hose assembly and fitting to correct the condition.

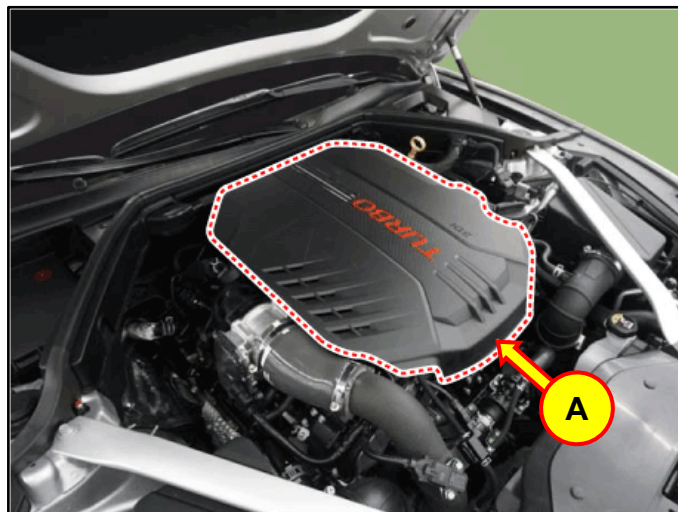
1. Disconnect the negative (–) battery terminal.
2. Remove the engine cover (A).

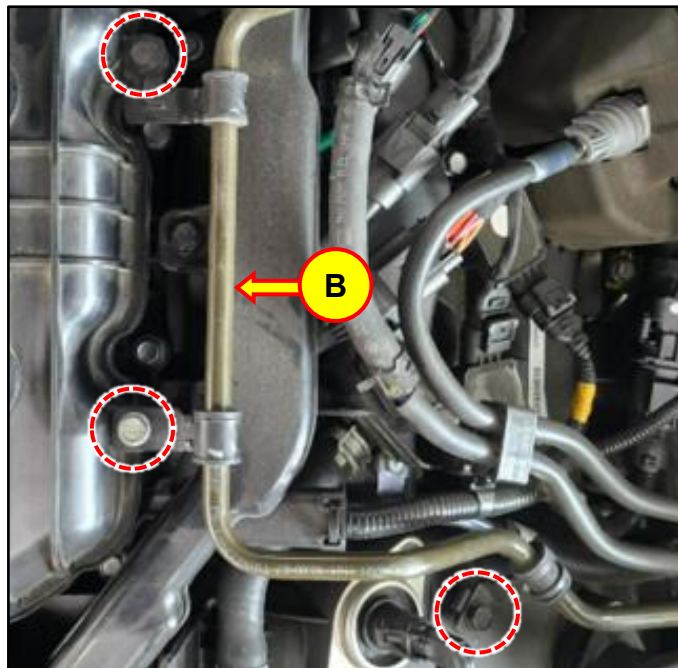
3. Remove the 3 bracket bolts, then detach the brake vacuum pipe (B).

**Tightening Torque:**

| lb-ft | 8.0 |
| lb-in | 96 |
| N.m | 11 |

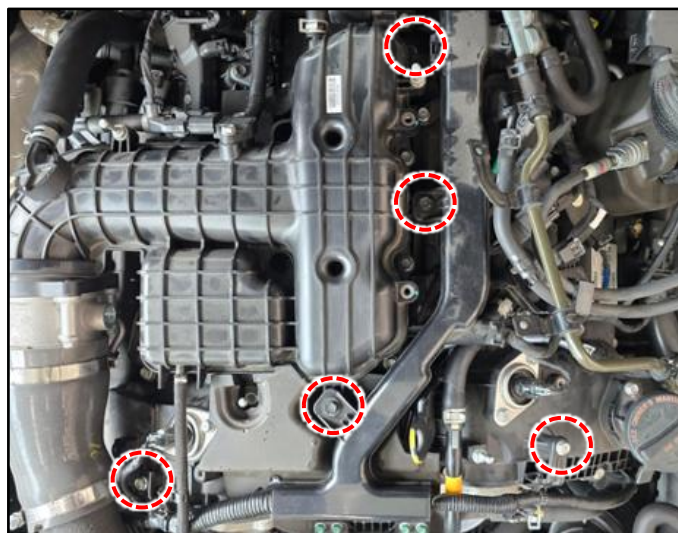
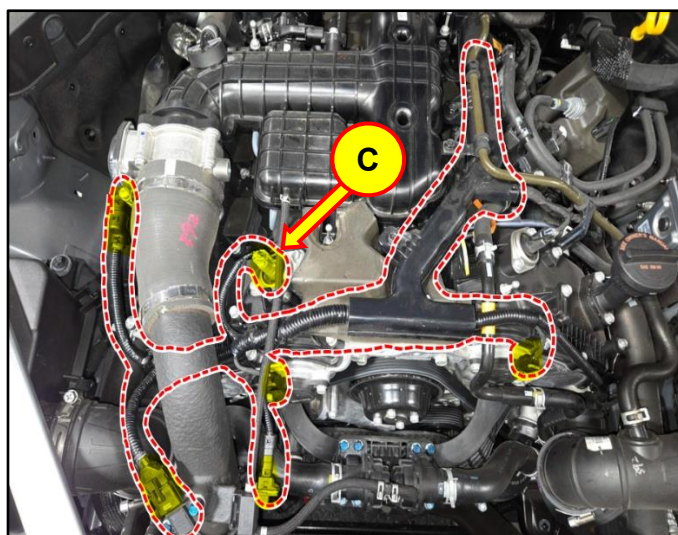
4. Remove the **5** bolts, then detach the engine control wiring (C).

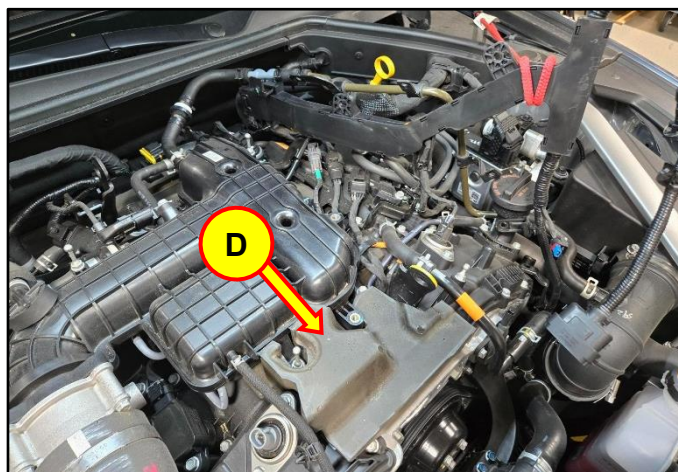
5. Position the engine control wiring away from the foam (D) above the 3-way hose.

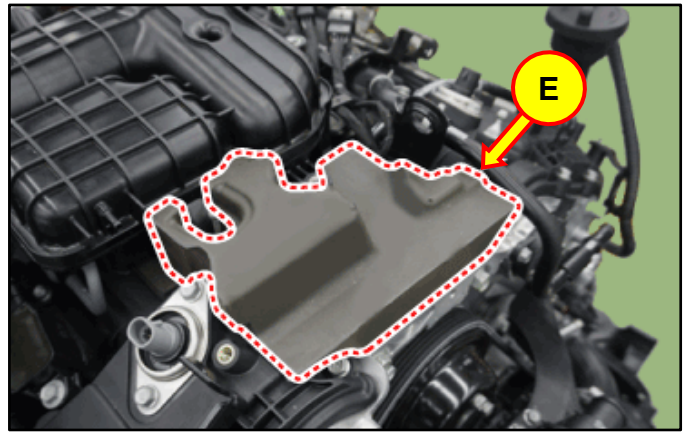
6. Remove the foam (E).

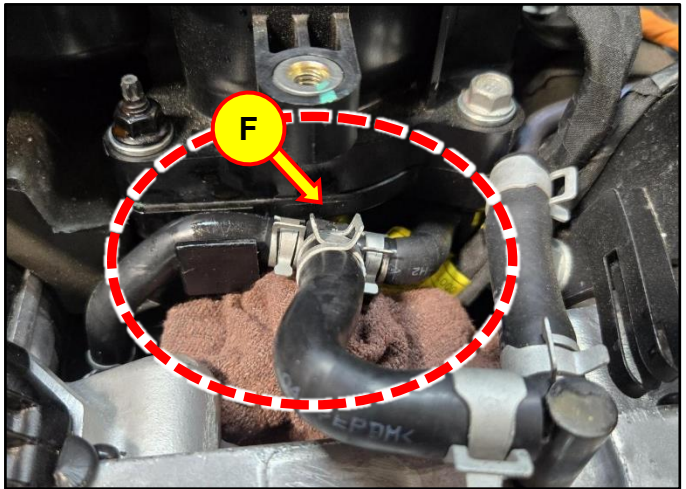
7. Inspect the 3-way hose (F) for coolant leakage:

- If coolant leakage is present, replace the 3-way hose **AND** perform coolant air bleeding.
- If coolant leakage is **NOT** present, **ONLY** replace the 3-way hose.

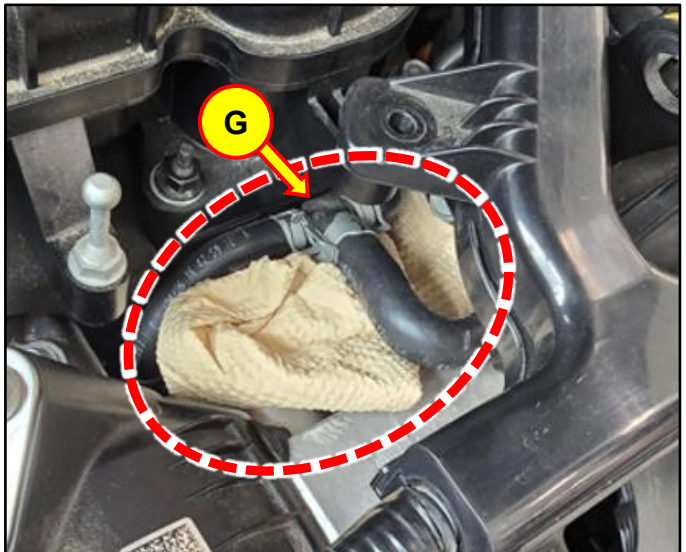
8. Place a cotton cloth or shop rag underneath the 3-way hose and fitting (G).

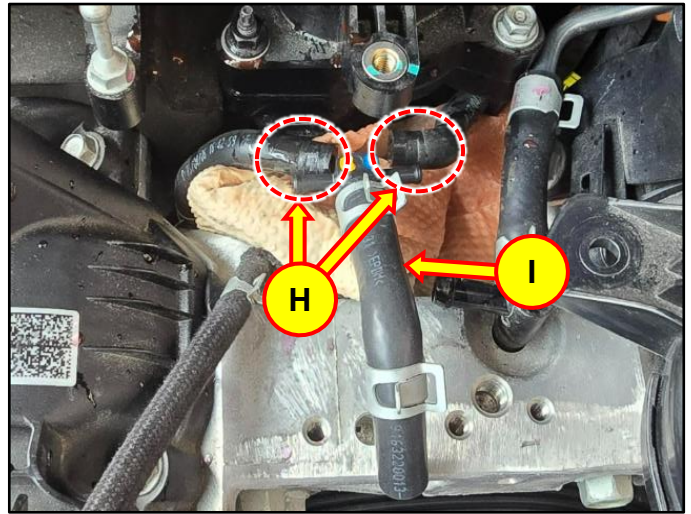
9. Remove the clamps and detach the LH and RH coolant hoses (H) from the 3-way fitting, then remove the 3-way hose and fitting (I).

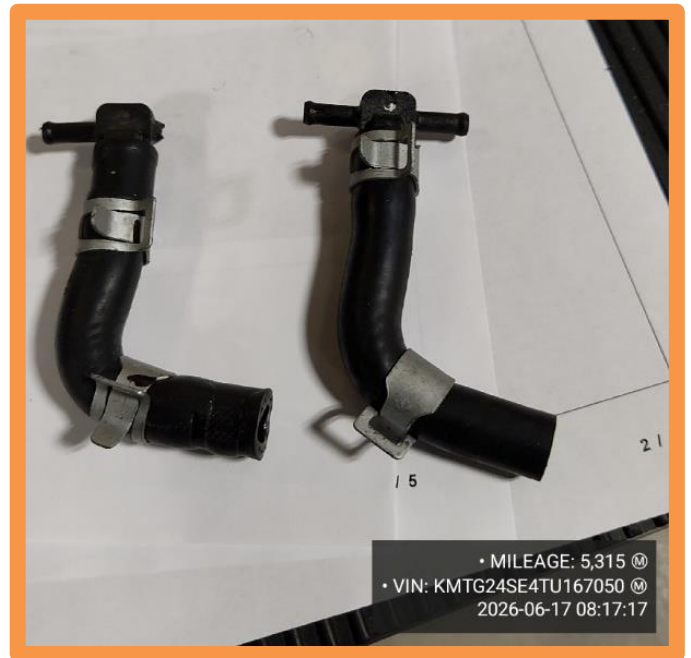
Using the STUI camera function, take a photo of the removed 3-way hose and fitting next to the new 3-way hose and fitting.

**NOTE:** If the STUI camera function is **NOT** used, write the last 6 digits of the VIN and date of repair on a piece of paper to include in the photo.

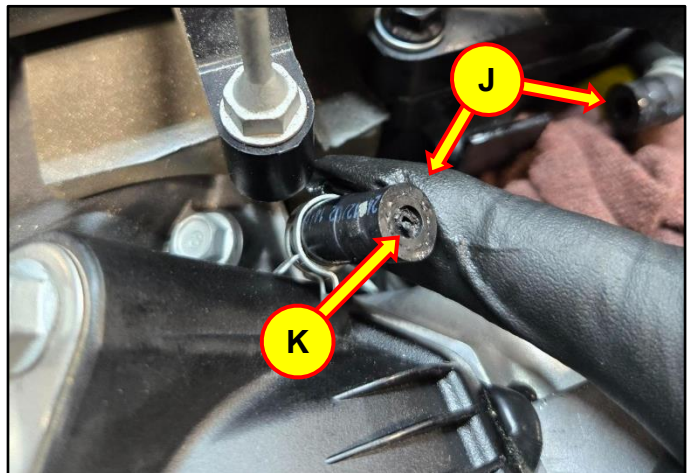
11. Visually inspect the disconnected hoses (J) for any fragments of the 3-way fitting (K) that may be lodged inside:

- If the fitting is lodged inside the hose, then proceed to **step 12**.
- If the fitting is intact, then skip to **step 14**.

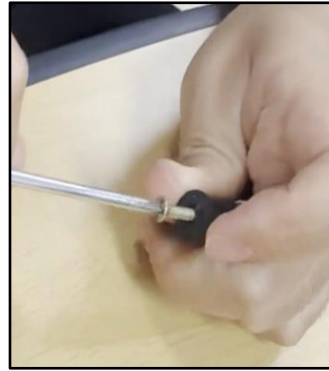
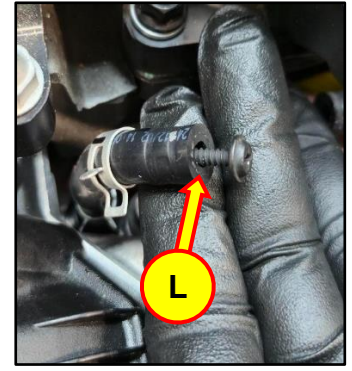
12. Use a screwdriver to insert a screw into the center (L) of the lodged 3-way fitting piece approximately 1/4".

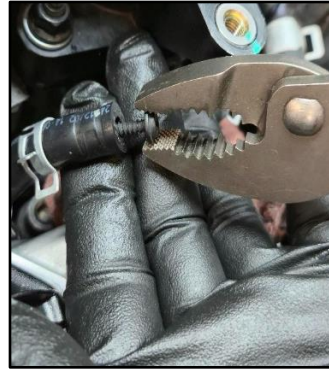
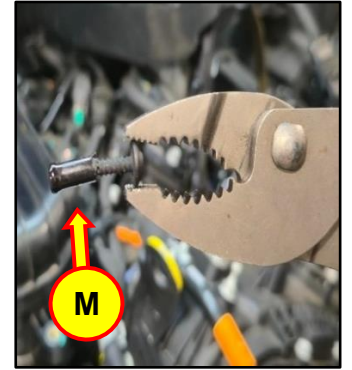
13. Use a pair of pliers to grasp the threaded section of the screw, then pull outward to remove the 3-way fitting fragment (M).
