# Technical product information

| Topic | Engine Overheating - Warning in the DIP V8 Kovomo |
| Transaction No. | 2061369/12 |

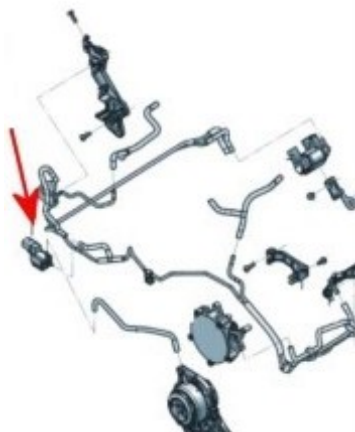
To allow the engine coolant to heat as quickly as possible (from cold start) coolant delivery from the mechanical coolant pump is interrupted by switch valve N649

Figure 2 - New Continental GT/ GTC and Flying Spur

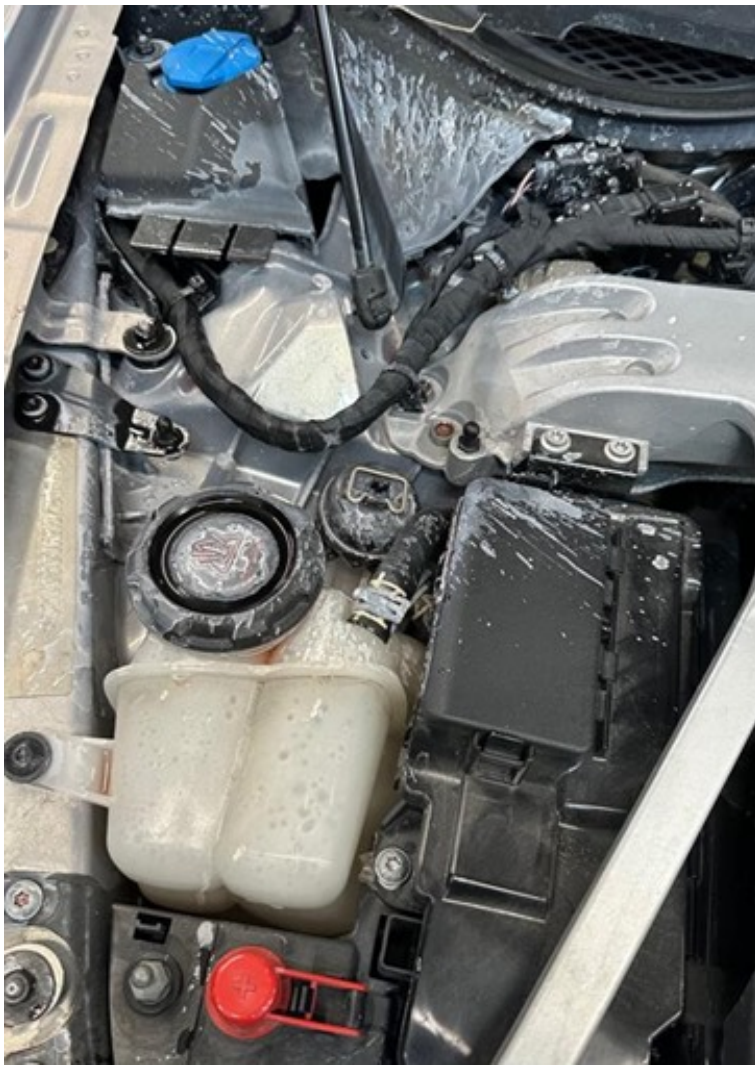
Figure 4

When inspecting the engine bay coolant residue can sometimes be seen around the reservoir when the engine has overheated (figure 4).

If this condition is found, the coolant may also be below the minimum level.

**If coolant residue is found in the engine bay, please raise a full technical DISS query and attach a photograph of the coolant residue. If the coolant level is below the minimum level please also attach photographic evidence of this.**
