**2026MY**  
**Sportage (NQ5)**  
**Sportage Hybrid/Plug-In Hybrid**  
**(NQ5 P/HEV)**

## TECHNICAL SERVICE BULLETIN

### WIND NOISE FROM FRONT LEFT DOOR (CA2601)

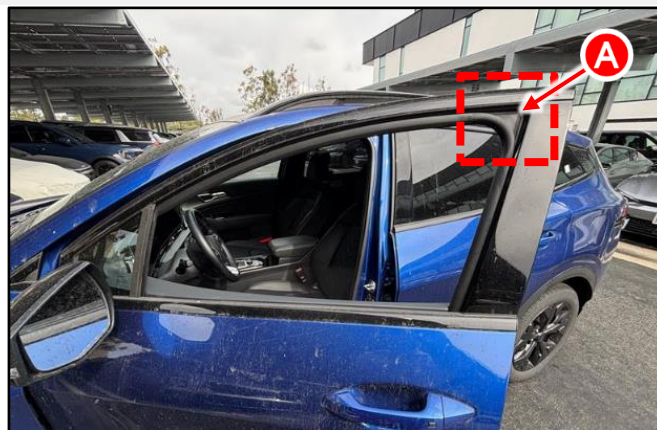
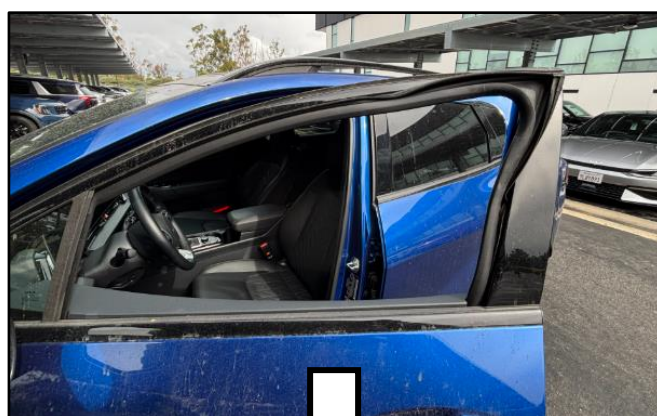
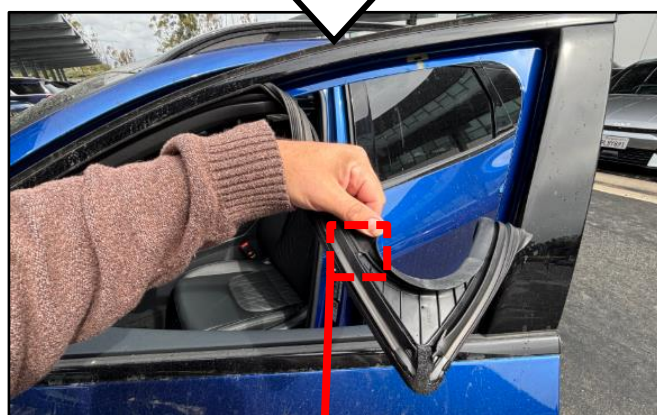
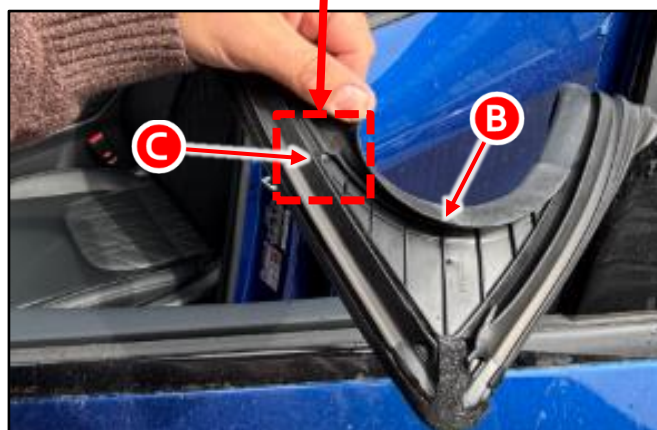
This bulletin provides information regarding a wind noise heard on certain 2026MY Sportage vehicles listed below. The affected vehicles may experience wind noise coming from the front left door while driving. Wind can travel through the run channel of the upper corner of the window run. Follow the procedure outlined in this publication to install an Ethylene Propylene Diene Monomer 'EPDM' foam pad on the front left door window run on the applicable vehicle. Before performing the repair, verify that the vehicle is included in the list of affected VINs.

1. Turn the ignition to 'ACC' or 'ON'.
2. Roll down the front left window.
3. Locate the front left door window run (A).
4. From the **outside** of the door, pull down the top right corner of the window run (A), as shown.
5. Flip the window run (A) down.
6. Peel the window run flap (B) back, as shown.
7. Locate the boundary line (C).
