**2058484/16**

Bentayga V8 Kovomo - DTC P310B00 with Symptom Code 2638 - Check Engine  
Lamp - Fuel Pressure Regulation

Release date: 16 Jul  
2026

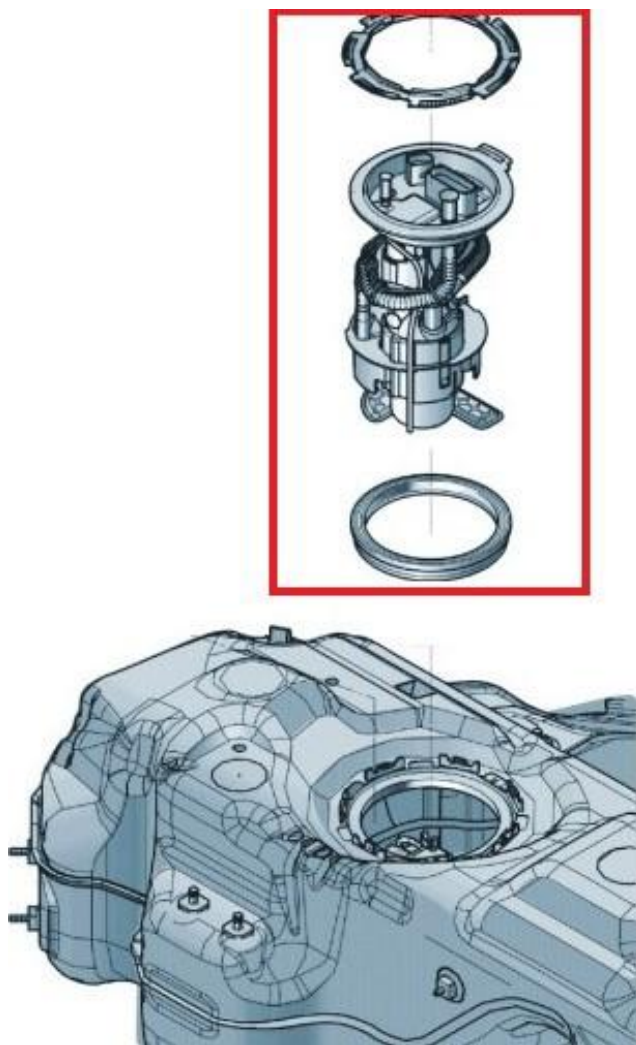
1) Referring to the example shown in Figure 1 - Check the actual pressure value

| Low fuel pressure, specified value | 450.0 | kPa |
| Fuel low pressure, actual value | 501.3 | kPa |

- In the event the fuel pressure actual value is above 450kPa the Fuel Delivery Module within the fuel tank (Figure 2) should be replaced

- In the event the fuel pressure actual value is above 475kPa (2023MY) the Fuel Delivery Module within the fuel tank (Figure 2) should be replaced

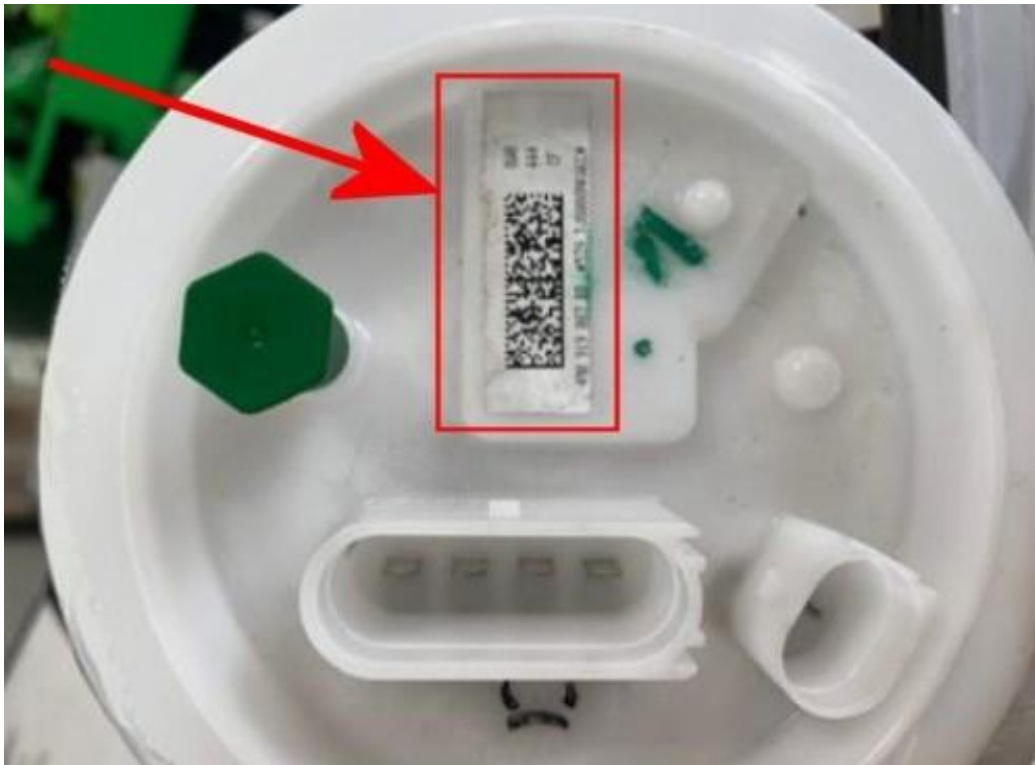
**IMPORTANT:** Once the fuel delivery module has been replaced, the operative should attach a clear photograph of the manufacture information label as shown in Figure 3
