SIB 64 06 26

WHISTLING NOISE FROM VENTS

| E-Series | Model Description |
|---|---|
| G26 | 4 Series Gran Coupe, including i4 Battery Electric Vehicle (BEV) |

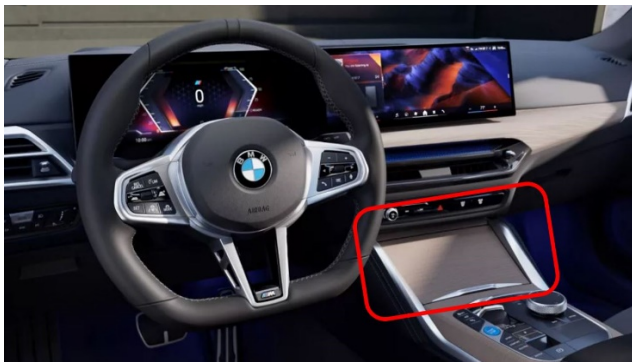
A “whistling” noise is heard from the center console/instrument panel when using the heating and air conditioning (HVAC) system.

- Heard with the blower motor set to speed 2 or above
- Noise goes away on high blower speed
- Noise is loudest with the vents on the back of the center console in the closed position
- Noise is heard the most near the charging tray (where center console meets instrument panel)

The red box shows the location of the air leak.

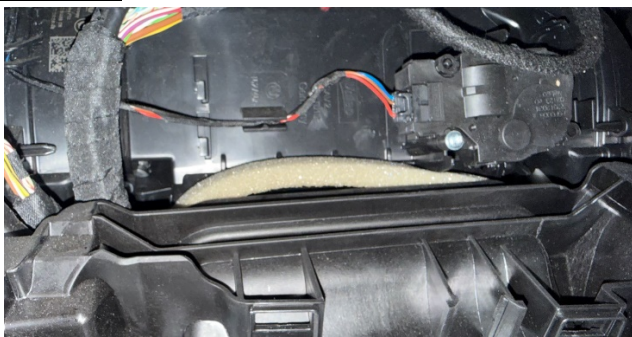
The foam seal (grey in color) that connects the HVAC box in the instrument panel to the center console ductwork is out of position.

Replace the damaged/misaligned foam seal.

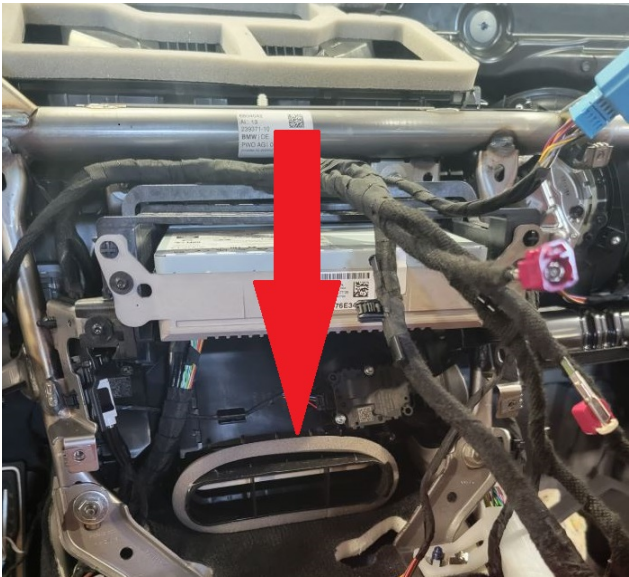
**ONLY if** the noise is confirmed to be coming from the charging tray area, then follow **Repair Instruction 51 16 165** to remove the center console. Check that the foam seal on the heater box that seals against the center console ductwork is still attached to the heater box, and not deformed/out of position.

**Note:** The instrument panel is removed in the picture for clarity; it does **NOT** need to be removed to replace this seal.

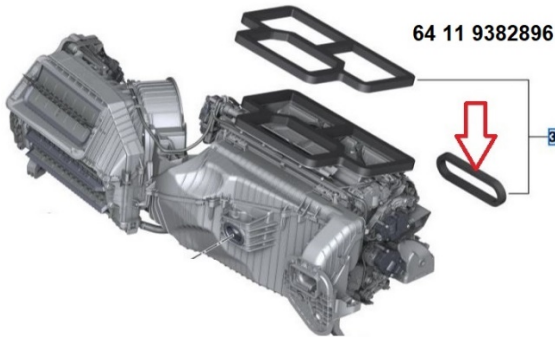
The HVAC box to the center console seal is not available separately. It is included in the seal set part number 64 11 9382896, see ETK/AIR Housing parts, heater and air condit. (example page 64\_2747 diagram as item #3).

The other upper seal in the set will not be used for this repair.

Ensure that the sealing surface is clean and dry before sticking the new seal into position.
