Service Engineering Operations  
Customer Service Division

**SUBJECT:** **Recommended Repair Prior to Sale**  
**Update Prior to Sale 26U05**  
Certain 2026 Model Year F-150 Vehicles  
Transmission Fluid Cooler Coolant Hose Push-Pin Retainer Inspection

# CERTAIN 2026 MODEL YEAR F-150 VEHICLES — TRANSMISSION FLUID COOLER COOLANT HOSE PUSH-PIN RETAINER INSPECTION

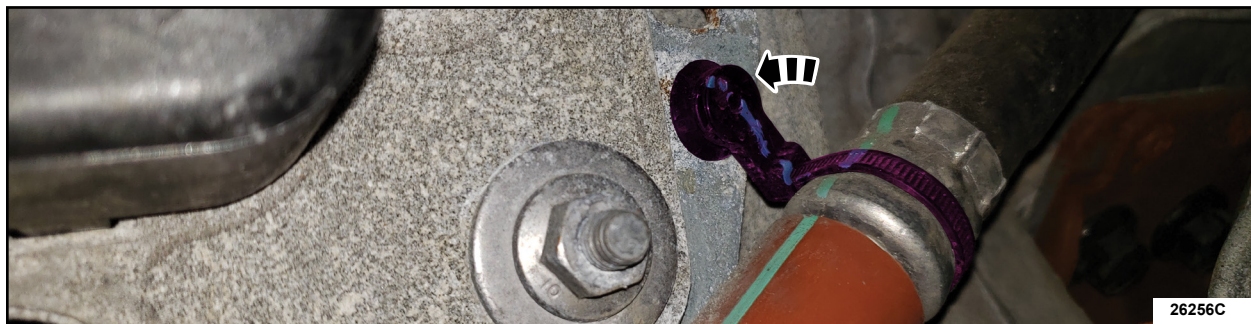
FIGURE 7

**NOTE:** A 3.5L EcoBoost is shown, demonstrating a slotted hole that is not occupied. Make sure the push-pin retainer on the transmission fluid cooler coolant hose is **fully seated in the round hole** on the transmission fluid heat exchanger bracket.

6. Fully seat the push-pin retainer on the transmission fluid cooler coolant hose into the **round hole** on the transmission fluid heat exchanger bracket as shown in Figures 7-9.

**NOTE:** For **all** powertrain variants, make sure that the push-pin retainer on the transmission fluid cooler coolant hose is **fully seated into the round hole** on the transmission fluid heat exchanger bracket.

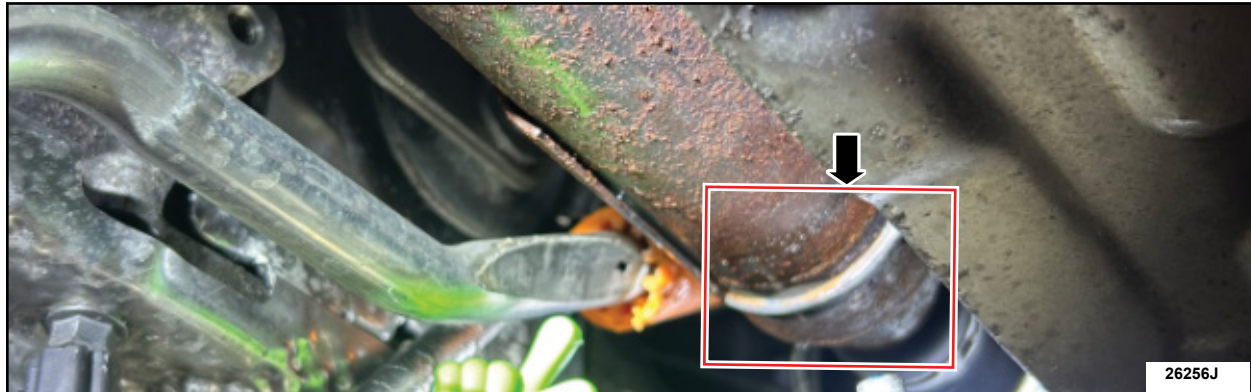
**FIGURE 10**

7. Visually inspect the front driveshaft for damage such as chafing. See Figure 10.

8. Special Service Support Center (SSSC) photo approval is required for driveshaft replacement. See Page 8 for photo submission requirements.

9. After receiving SSSC approval, remove the front driveshaft. Follow the WSM procedures in Section 205-01.

10. Transfer the original driveshaft boot onto the *new* front driveshaft.

11. Install the *new* front driveshaft. Follow the WSM procedures in Section 205-01. This FSA is complete.
