# Air Compressor Discharge Line Blocked by Ice in Cold Weather

## TSB-13-007-FTL

### Engine or Vehicle Affected:

- ▶ eM2
- ▶ eCascadia

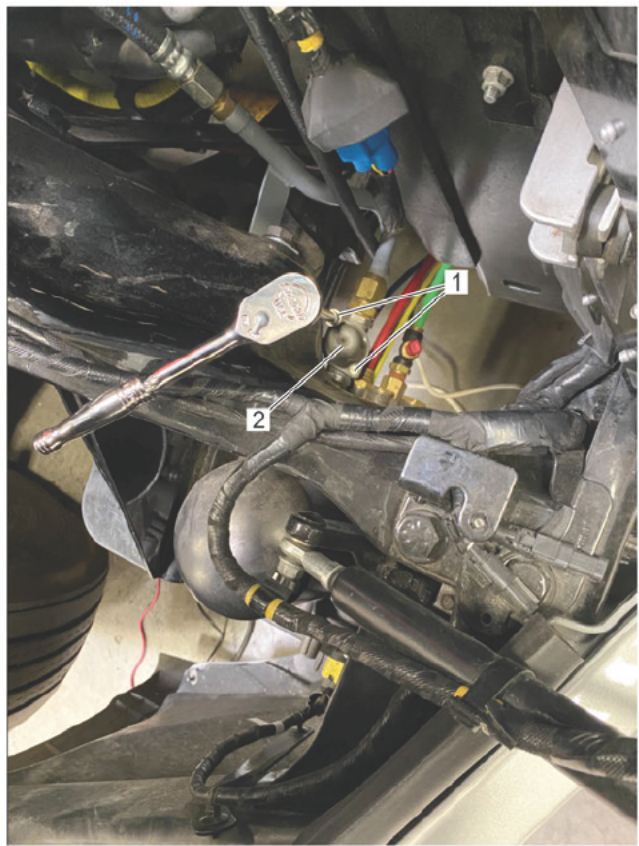
Fig. 1, Removing Bolts of the Overflow Valve

1. Bolts

2. Spring Chamber Cover

3. ☐ Remove the two bolts from the top of the overflow valve. See Fig. [1](#).

4. ☐ Replace the overflow valve.

5. ☐ Install the bolts. Tighten the bolts 62 to 80 lbf·in (700 to 904 N·cm).

3. ☐ Remove the two bolts from the top of the overflow valve. See Fig. 1.

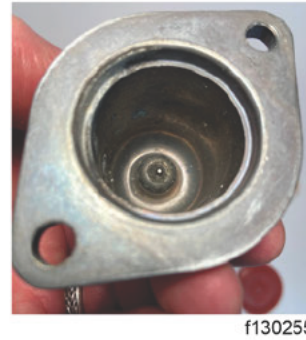
Fig. 3, Set Screw on Top of the Cover

**❗ Important:** DO NOT adjust the set screw on the top of the overflow valve spring chamber. This screw setting is precisely calibrated when the valve is manufactured, and changing the screw position will render the valve non-functional. See Fig. [3](#).

1. Set Screw

2. Spring Chamber Cover
