**Service Campaign ID: 76 – 01 Solis Poptop**

### **Reason for this Campaign**

On certain Winnebago vehicles with Winnebago manufactured poptops (60A & 60C), incorrect rivets may have been used during poptop assembly and the poptop overhead brackets may have misaligned rivet holes.

| <b>WINNEBAGO</b> | | <b>Solis Poptop 60A &amp; 60C</b> | | |

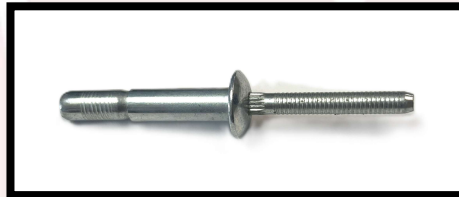
1. 3/16" Steel Rivet – 163664-01-01A (16)
2. 1/4" Steel Rivet - 152766-01-01A (12)
3. LH Lower Latch Bracket (000262194) (1)
4. RH Lower Latch Bracket (000266367) (1)
5. Upper Latch Bracket (000262184) (2)
6. Latch Draw Adjustable (000259250) (2)

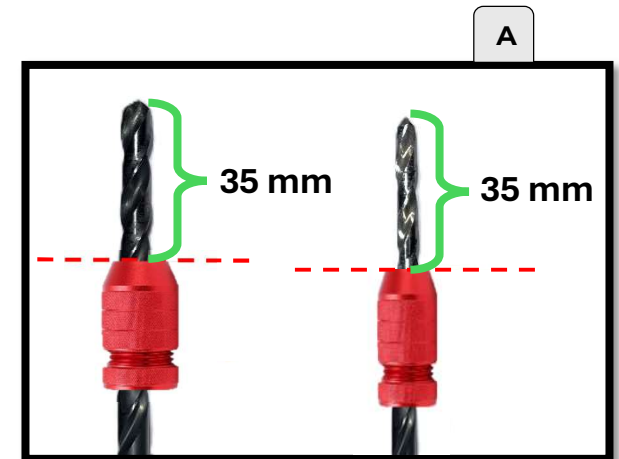
## Step 3: Prepare Drill and Bits for Bracket Rework

**NOTE:** Ensure proper depth control when drilling rivet holes for latch bracket assembly to avoid damaging vehicle's ceiling liner.

**NOTE:** It is critical to only drill up to the 35 mm mark for all rivets involved in the latch bracket assembly to ensure adequate space for rivet insertion and prevent damaging the ceiling liner.

- A. Using a drill stop (preferred) or masking tape, mark both the 3/16" and 17/64" drill bits at 35mm.

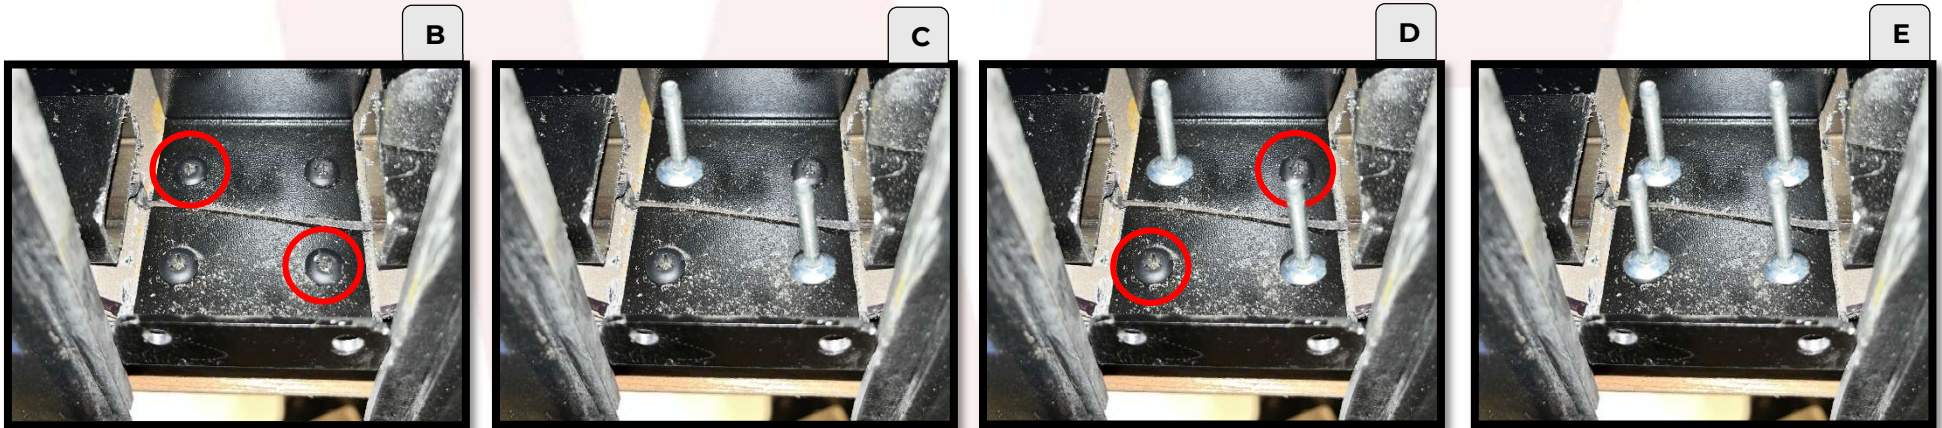
**DO NOT INSTALL THE NEW RIVETS ON THIS EXISTING BRACKET.**

**PRE-FITTING THE RIVETS IS ONLY TO ENSURE THE HOLES ARE ENLARGED IN THE APPROPRIATE LOCATIONS FOR THE NEW LOWER BRACKET.**

- B. Using the marked 3/16" drill bit, drill through 2 (opposing corner rivets) of the 4 existing bracket base rivet holes of the lower bracket. Then enlarge the 2 holes with the 1/4" inch bit. **Ensure you do not exceed the 35 mm of depth to prevent damaging the ceiling liner.**

- C. Prefit (**don't' install**) 2 of the new 1/4" rivets from the kit unto the 2 holes you drilled out with the 17/64" drill bit.
- D. Using the same 3/16" drill bit, drill through the other 2 (opposing corner rivets) of the 4 base rivet holes in the lower bracket. Then enlarge the 2 holes with the 1/4" inch bit. **Ensure you do not exceed the 35 mm of depth to prevent damaging the ceiling liner.**

- E. Prefit (**don't' install**) 2 of the new 1/4" rivets from the kit unto the 2 holes you drilled out with the 17/64" drill bit.
- F. Once you secured alignment of the holes, remove the new prefitted rivets to discard existing lower latch bracket.
