# McLaren Artura Engine Oil Leak Diagnosis Guide - Front of Engine

**Location:** Powertrain

**Topic:** McLaren Artura Engine Oil Leak Diagnosis Guide - Front of Engine

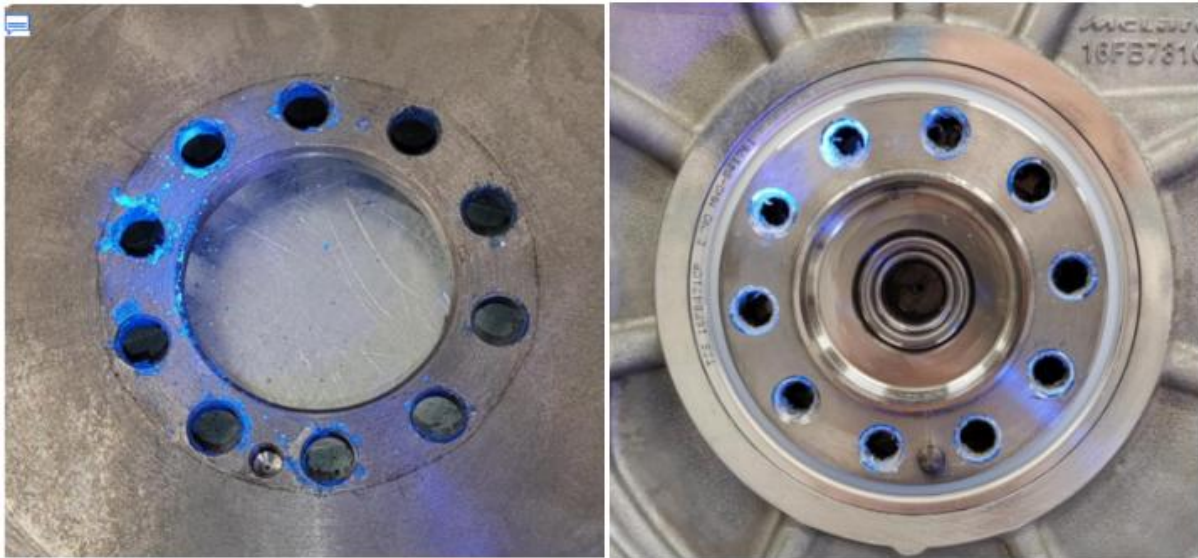
**Care Point: to avoid engine contamination, prior to attempting front crank seal removal clean the first 2-3 bolt hole threads (crankshaft flange) from residual threadlocker (from the original bolt fitment) and outer surface of crankshaft flange (threadlocker and oil) without pushing any debris into the engine (through holes), clean with standard**

automotive degreaser/solvent ensuring a thorough clean of the leak area. Do not leave the area like this:

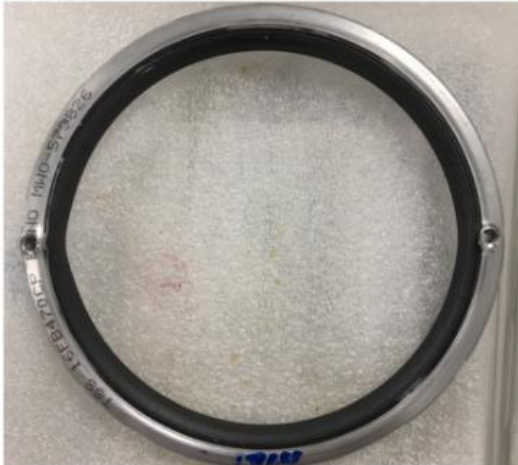
**Care Point:** Avoid damage to seal lip if this is the area that is clearly identified to have leaked by removing the seal winding two small short self-tapping screws into the aluminum outer rim and levering the seal out. Be very careful not to damage the cover plate or crankshaft. Make sure self-tapping screws go in perfectly straight.

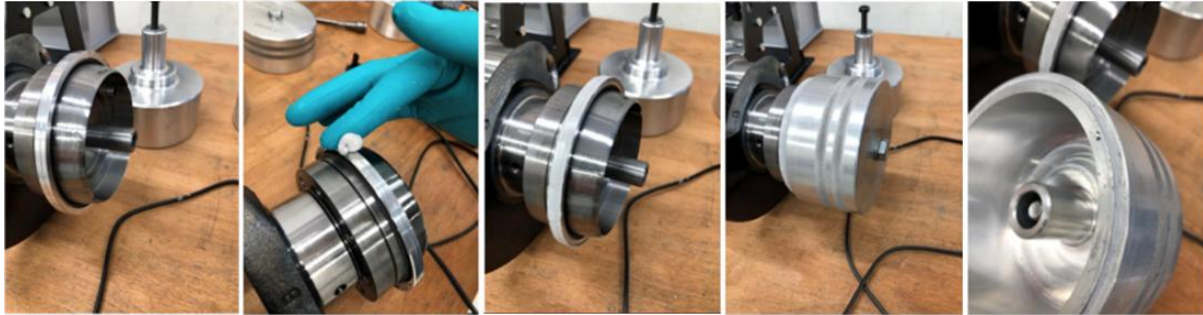
19. With the brand-new front crank seal halfway down the mandrel, apply constant thickness of RTV to the outer surface/OD of the metallic ring of the seal (complete, 360° coverage) as follows (DO NOT contaminate the lip seal or the mandrel with RTV):

**Care Point: Carefully clean (with a dry lint free cloth) the RTV squeeze-out post Front Crank Seal fitment**

**Attention! If any trace of RTV accidentally contaminates the lip seal, replace the Crank Seal and repeat Steps 17 & 18**
