To: After Sales Official Network  
Subject: Carbon Rim Circlips Corrosion  
Date: 13/07/2026  
Pages: 3

**Campaign code:**  
L634-A.14.26

**Campaign name:**  
Carbon Rim Circlips Corrosion

**Model:**  
Temerario

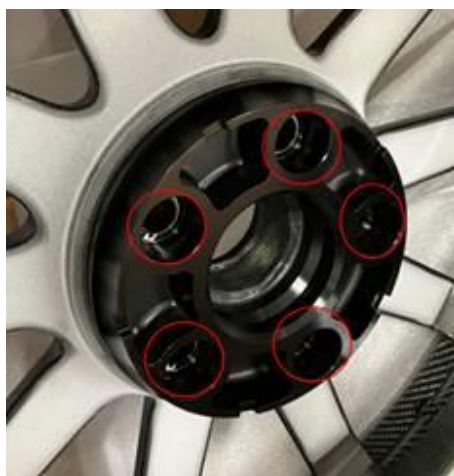
Place the wheel assembly on a flat, non-abrasive surface, with the exterior surface facing down and the support plate facing up.

To replace the five circlips highlighted in red in the image above, following these steps:

-Using circlip pliers, insert the tips into the holes of the circlip and expand it sufficiently to remove it from the nut seat.

After removing the old circlip, install the new one.

-While supporting the nut seat, insert the tips of the circlip pliers into the holes of the new circlip and expand it sufficiently to fit it over the nut seat. Position the circlip in the groove provided on the nut seat.

-Check that the circlip is correctly seated and can rotate freely around the nut seat.

-Repeat this procedure for all wheels.
