## Technical Service Bulletin

Transaction No.: **2081573/4**

20 Fuel Pump/Sender, Fuel tank level implausible, DTC B105A1A B103E29 Stored in 0017

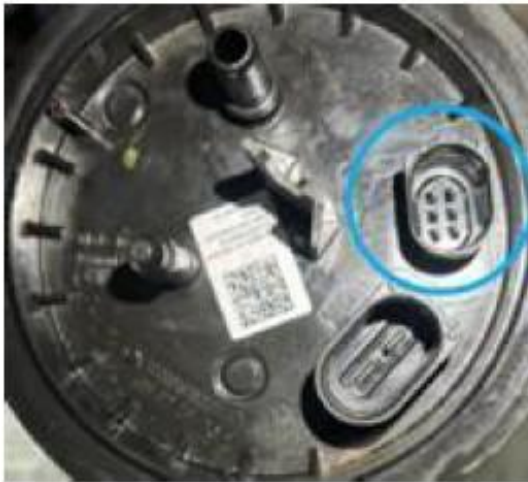
**Figure 1.** The 6-pin connector of the electric fuel pump is circled above in blue.

Please check the 6-pin connector of the electric fuel pump using a multimeter. As part of this check, measure the resistance between all pin combinations. If available at your dealership, VAS5260A Vehicle Diagnostic Tester - Test Adapter can be used as well to help measure the resistances.

The measurement must be performed with the fuel pump removed and the fuel tank senders unplugged (2x 3-pin connector from below).

- Resistance smaller than 1 M $\Omega$  = not OK (except for pins 1-2 as these are internally short-circuited).

If the measured values are implausible, please replace the fuel pump.
